**STORAGE EQUIPMENT
SAFETY SERVICE LTD**

RACK INSPECTION REPORT FOR:

**PARKER HANNIFIN
MANUFACTURING LTD**

27th JANUARY 2025

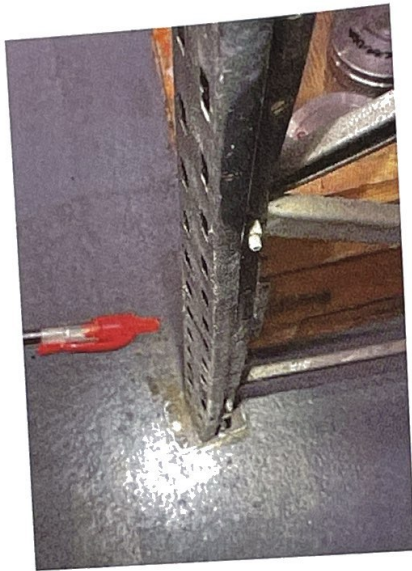
RED RISK damaged
upright

| WH-AREA-RACK | LOCATION | LEVEL | FRAME TYPE | COMPONENT | POSITION | DEFECT | ACTION | QTY | REPAIR |
|---|---|---|---|---|---|---|---|---|---|
| 06-Repairs-N | 01/02 | N/A | Bolted | Upright & Base Plate | Front | Damaged & Twisted | Replace | 1 | - |

3.03 One upright was found to be damaged and should be replaced as indicated. Under no circumstances should any attempt be made to repair an upright.

| Replace | 1 | Upright & Base Plate x 4650 |
