2012 FREIGHTLINER 114SD |  
1FVHG3DV6CDBK4199

Deficiencies

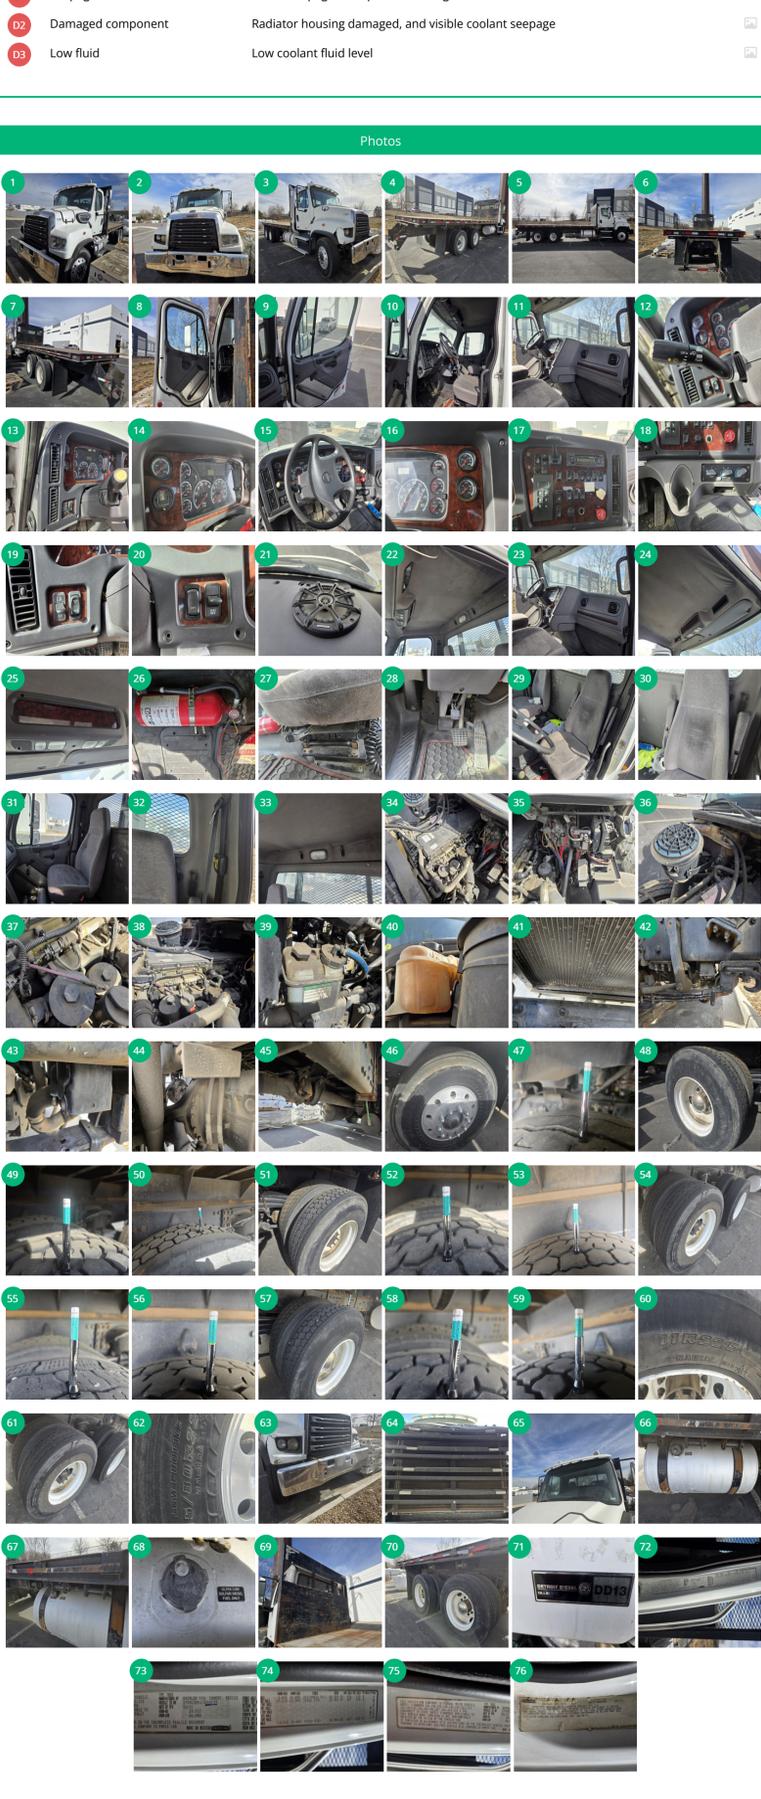
Issue #	Check	Comment	Photo
D1	Seepage	visible seepage from power steering reservoir	
D2	Damaged component	Radiator housing damaged, and visible coolant seepage	
D3	Low fluid	Low coolant fluid level
