| Inspection Detail | | | |
| | <b>Inspected by:</b> | | Anel Tapia |
| | <b>Year:</b> | <b>Make:</b> | Waldon |
| | <b>Model:</b> | <b>SN:</b> | 8500C 32956 |

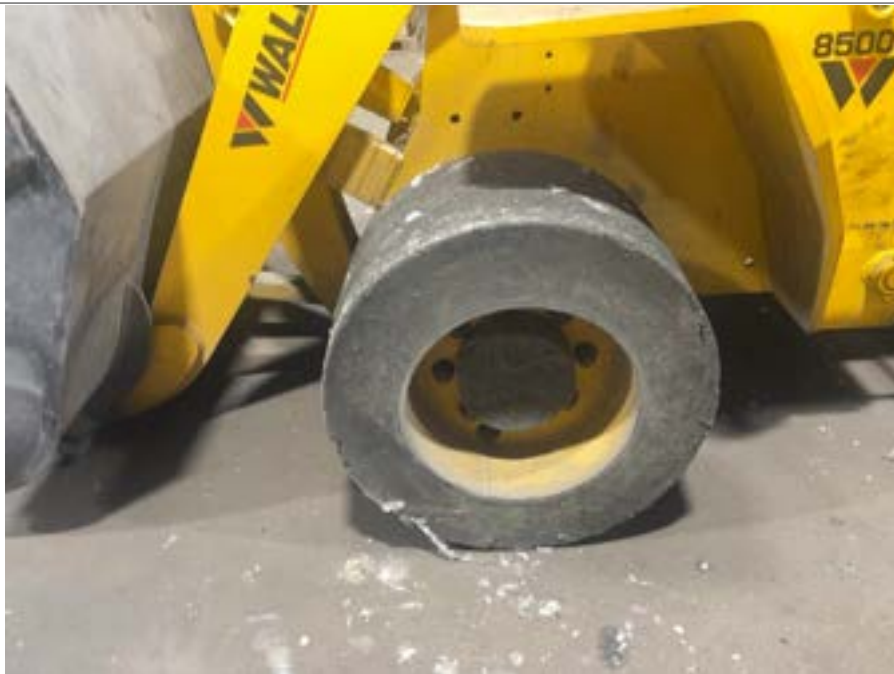
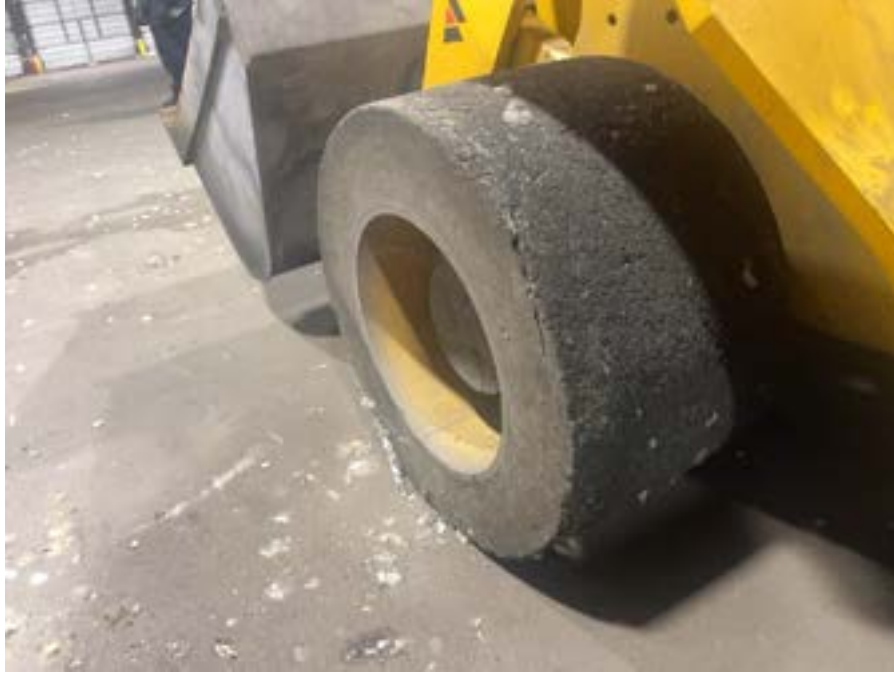
**Front Left Tire Condition**

| <b>Front Left Tire Condition:</b> | See Notes | <b>Front Left Tire Brand:</b> | Obstructed | <b>Front Left Tire Size:</b> | Obstructed |

| Wear and Tear Items | |
|---|---|
| Tires | All the tires have gouges in the material. |

| Repair Items | | | |
|---|---|---|---|
| Tires | \$450.00 | \$8,500.00 | \$8,950.00 |

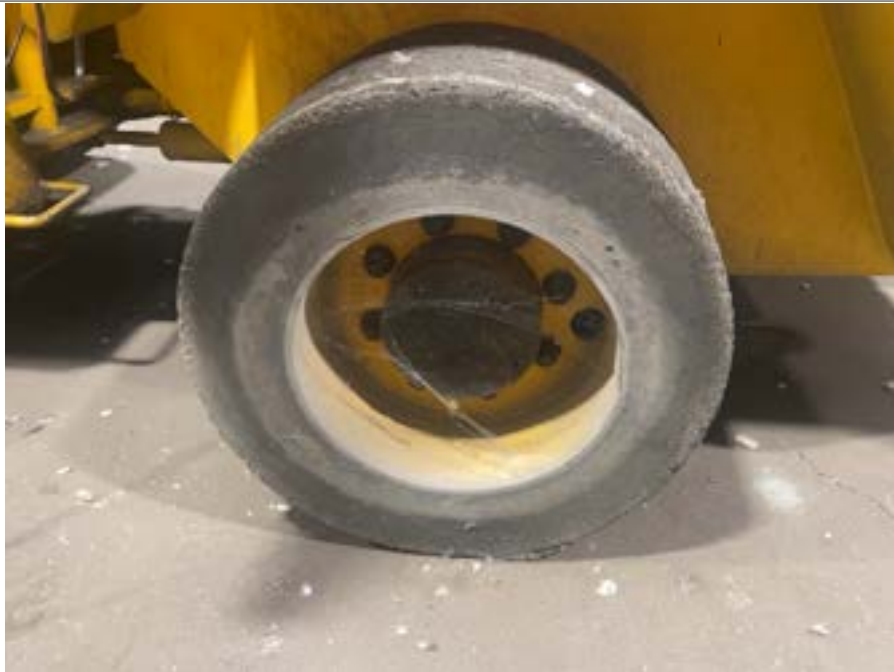
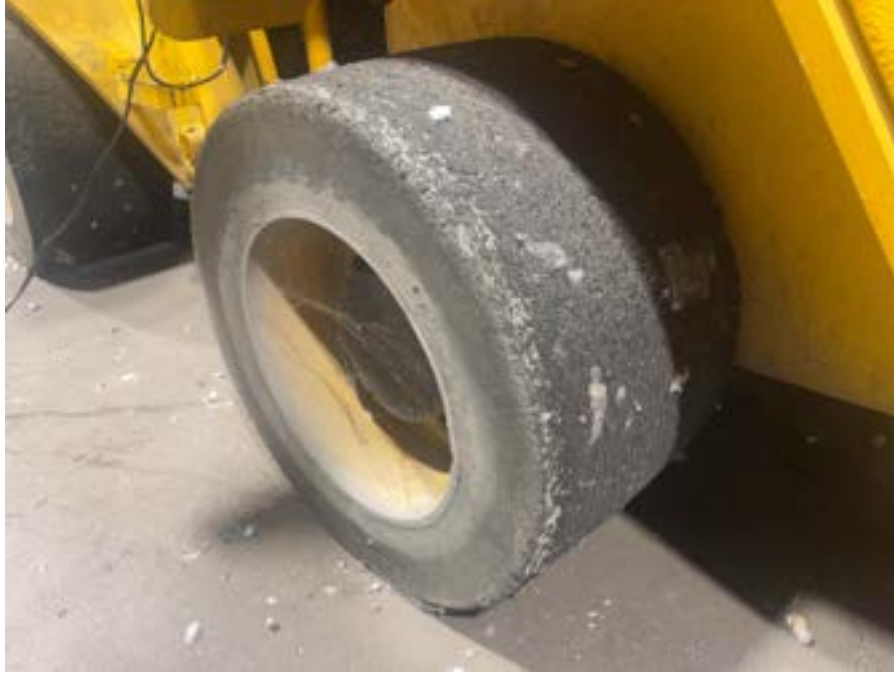
**Rear Left Tire Condition**

| <b>Rear Left Tire Condition:</b> | See Notes | <b>Rear Left Tire Brand:</b> | Obstructed | <b>Rear Left Tire Size:</b> | Obstructed |

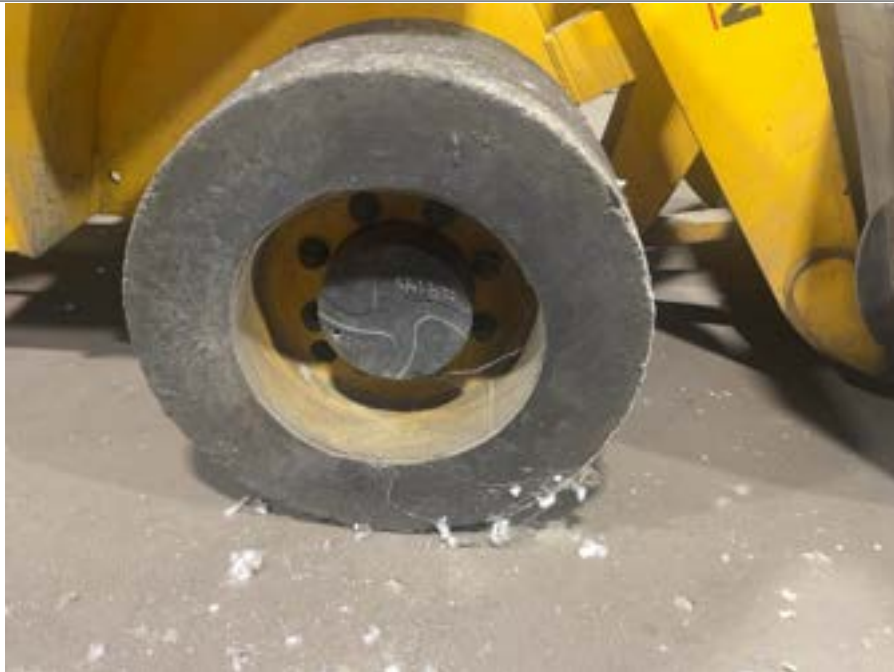
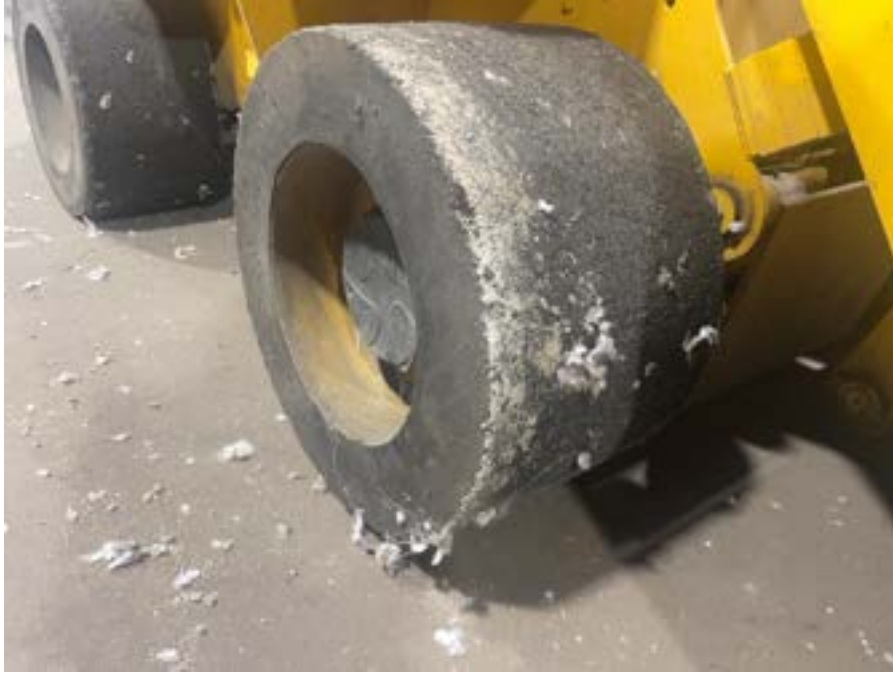
**Front Right Tire Condition**

| <b>Front Right Tire Condition:</b> | See Notes | <b>Front Right Tire Brand:</b> | Obstructed | <b>Front Right Tire Size:</b> | Obstructed |

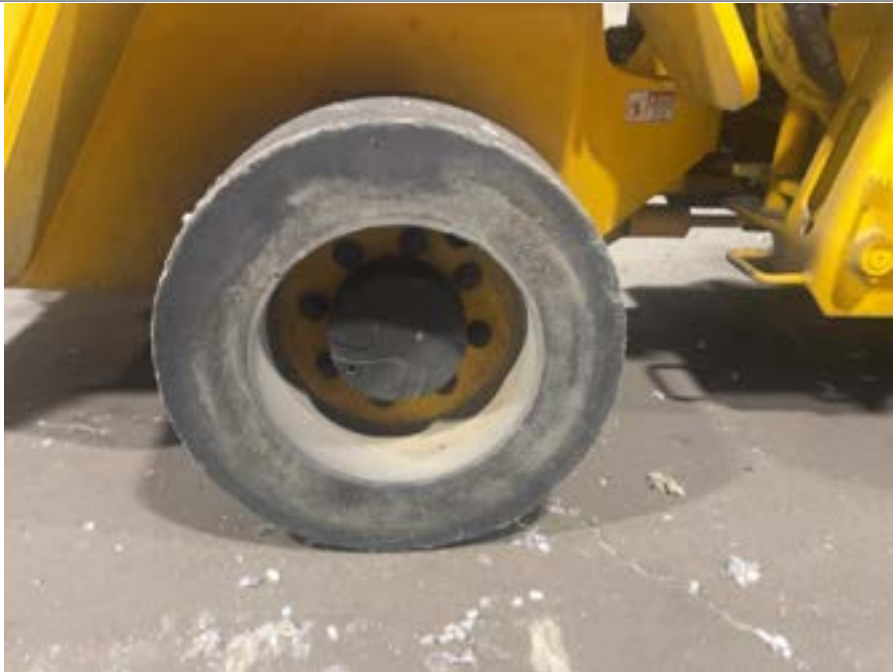
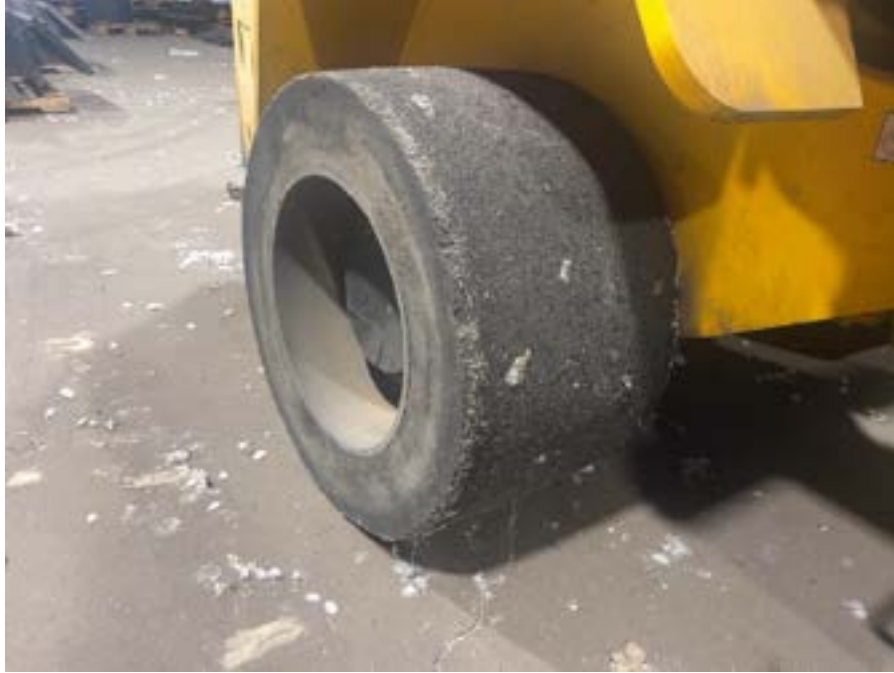
**Rear Right Tire Condition**

| <b>Rear Right Tire Condition:</b> | See Notes | <b>Rear Right Tire Brand:</b> | Obstructed | <b>Rear Right Tire Size:</b> | Obstructed |
