GENERATOR ROTOR INSPECTION & TEST REPORT**OKLAHOMA GAS AND ELECTRIC****MUSTANG TINKER STATION****UNIT 5****J03-01106****December 18, 2003****Prepared By****Robert E. Rettler
Electrical Engineer****Gregory J. Krystek
Mechanical Engineer****Approved By****Michael Novak
Project Manager****ReGENco LLC
6609R W. Washington Street
West Allis, WI 53214*****We'll make a difference!***

1.0 SUMMARY / INTRODUCTION

This report covers the initial inspection of the Unit #5 generator rotor from the Oklahoma Gas and Electric, Mustang Tinker Generating Station. This Electric Machinery rotor was sent to the ReGENco repair facility in West Allis, WI for electrical testing to investigate a winding ground. In addition, a visual inspection of the shaft ends and end windings with the rotor coil retaining rings removed was performed. Initial findings are contained in this report.

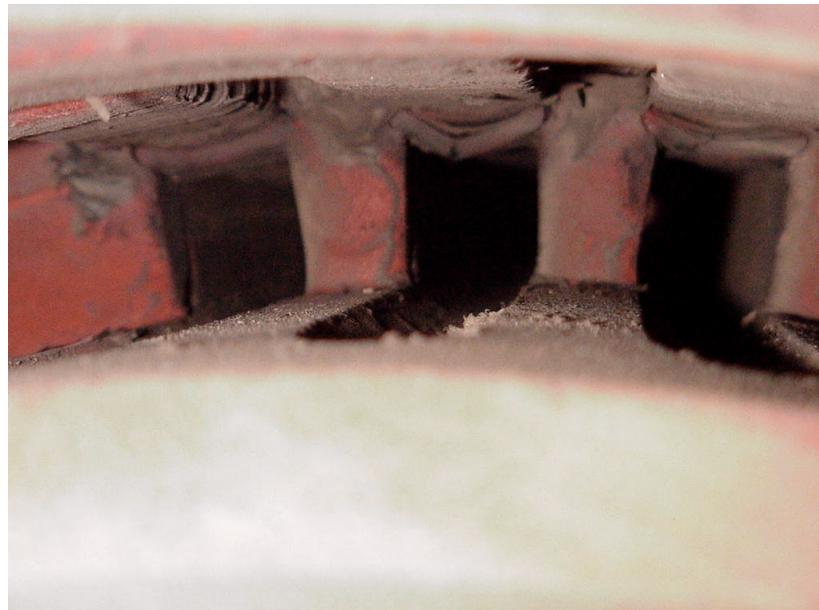
There are approximately 1 dozen sub-slot bottom fillers that are clearly visibly fractured and are likely sources of current high resistance grounds. (See Photos 1 & 2). These areas are potentially future sources for direct groundfaults. Fractured sub-slot filler will not have the mechanical strength to adequately support the groundwall slot channel. The lack of support to the slot channel provides another mechanism for direct ground condition.

PHOTO 1, Fractured Sub-slot Filler, Exciter End

Subsequently, the long-term reliability of this unit can be best served by a complete rewind of the rotor. ReGENco recommends that this rotor be rewound with all new insulation materials, and the existing copper conductors. The new insulation system would utilize class F temperature rated materials of current (non-asbestos) insulating material technology. Teflon slip planes and ReGENco's winding end turn blocking design would be employed to reduce future end winding distortion. The materials used in ReGENco's slot cell liners and fillers strips possess superior mechanical properties.

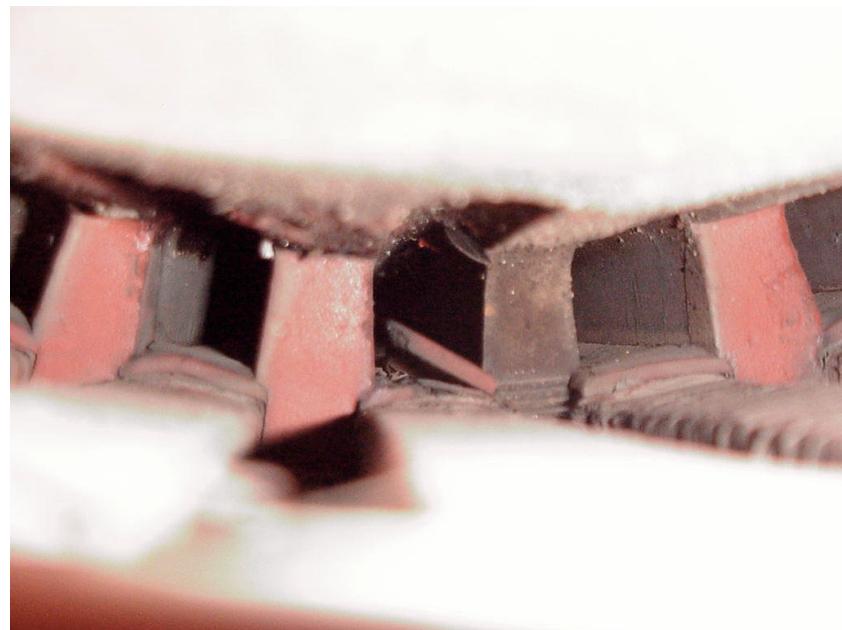
PHOTO 2, Fractured Sub-slot Filler, Turbine End

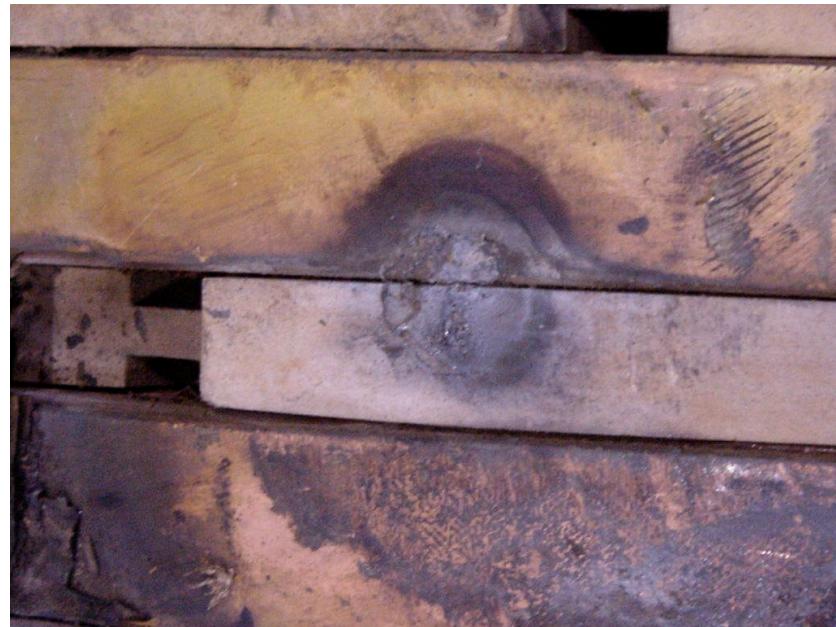
There are also locations on the endwinding where it appears localized heating had occurred. Photo 3 illustrates one such example. It is likely that this represents a high resistance ground that generated heating during operation. Since the retaining rings' removal disturbed any confirming evidence of this theory, it is impossible to conclusively prove.

PHOTO 3, Localized Heating at Top Turn Exciter End

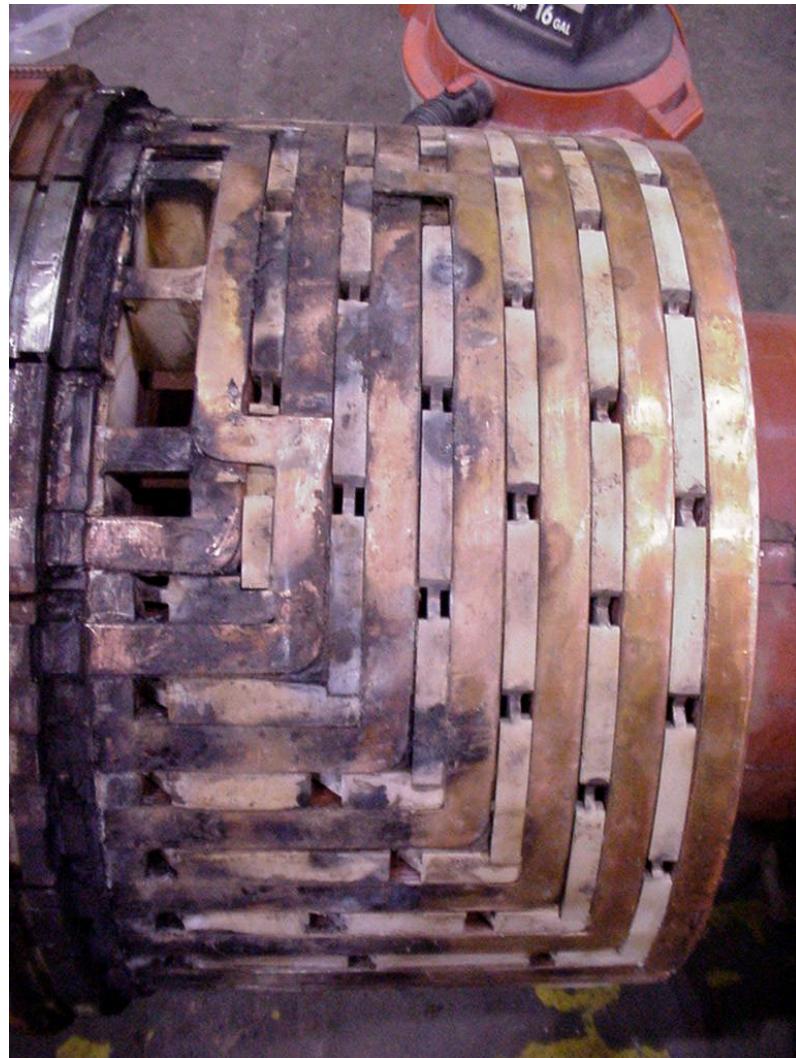
The endturn alignment is generally in good condition for both the exciter and turbine ends. Photo 4 represents coil stack alignment and support blocking condition typical to this entire machine.

PHOTO 4, Turn Exciter End Endwinding

Reuse of the original winding conductors is recommended for cost and schedule savings. Additionally, the coil stack alignment is in generally good condition which further supports the recommendation for conductor re-use.
