Oklahoma Gas & Electric

ESN:675497

Shop Report

Model: GG4A-9

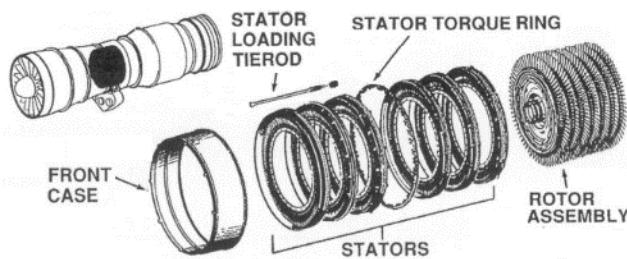
Diffuser Case, 15th stator, #4 Sump Area 2-3-3 fig 1 / 2-3-5 fig 1 / 2-3-6 fig 1

Findings: Visually inspected with no findings.

Conducted: Reassembled.

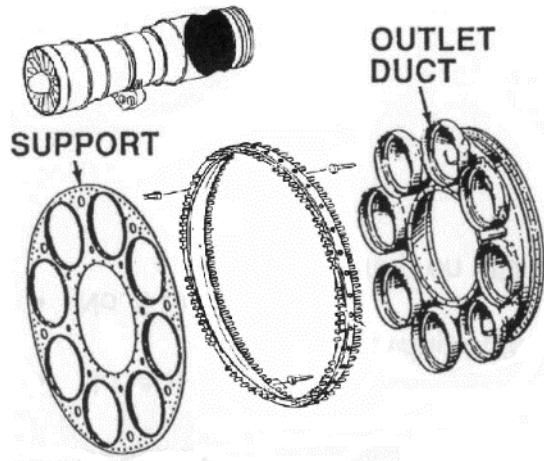
Nozzle Case and Supports 2-3-11 fig 1

Findings: Visually inspected with no findings. T-1 Outer airseal had damage to the knife edges

Conducted: No repairs were performed to nozzle case of vane support. Replaced T-1 Outer airseal. T-2 and T-3 outer airseals had no repairs performed.

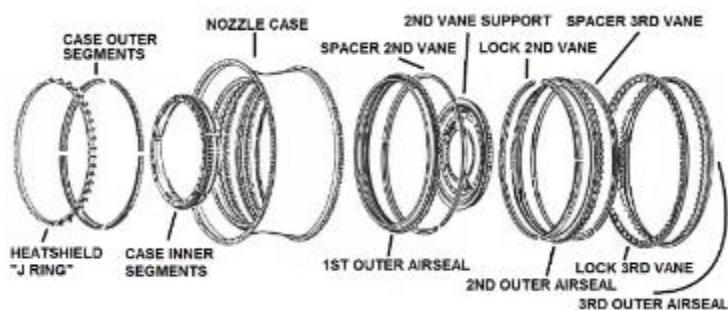
Nozzle Guide Vanes 2-3-11 fig 1

Findings: (15) 1st stage vanes had heavy DOD from the broken T-1 blade. (1) 1st stage vanes had over temp. (3) 2nd stage vanes had DOD. (5) 3rd stage vanes had DOD.

Conducted: (16) 1st stage vanes were replaced with overhauled parts. Replaced 2nd and 3rd stage vanes with overhauled parts.
