Oklahoma Gas and Electric

ESN:675502

Shop Report
1/11/2019

Model GG4A-9

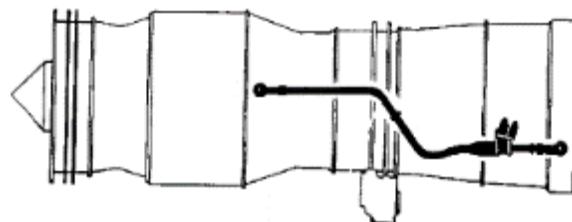
Anti Icing Tubes 2-1-9 fig. 1 and 2

Findings: Anti ice tube was received with out actuator and valve assembly.

Conducted: Replaced missing anti ice valve and actuator assembly.

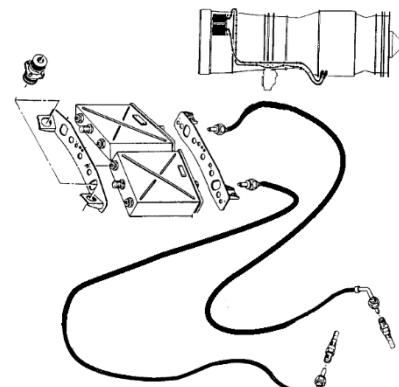
Ignition System 2-1-5 & 2-1-6 fig. 1

Findings: Igniter boxes were tested and found to be in serviceable condition. Cables were tested and both sides functioned.

Conducted: Right and left side ignition cables were tested and reinstalled on engine. Igniter boxes were tested and reinstalled on engine.

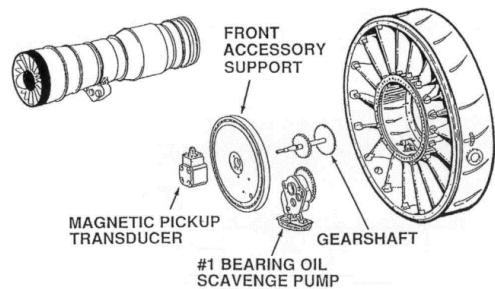
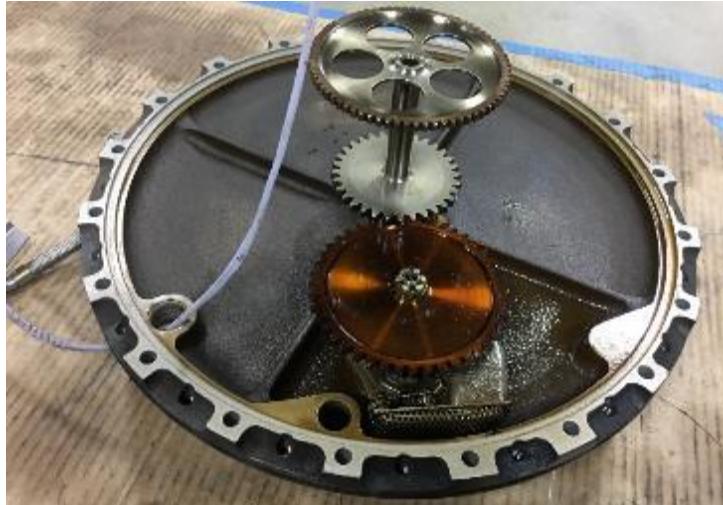
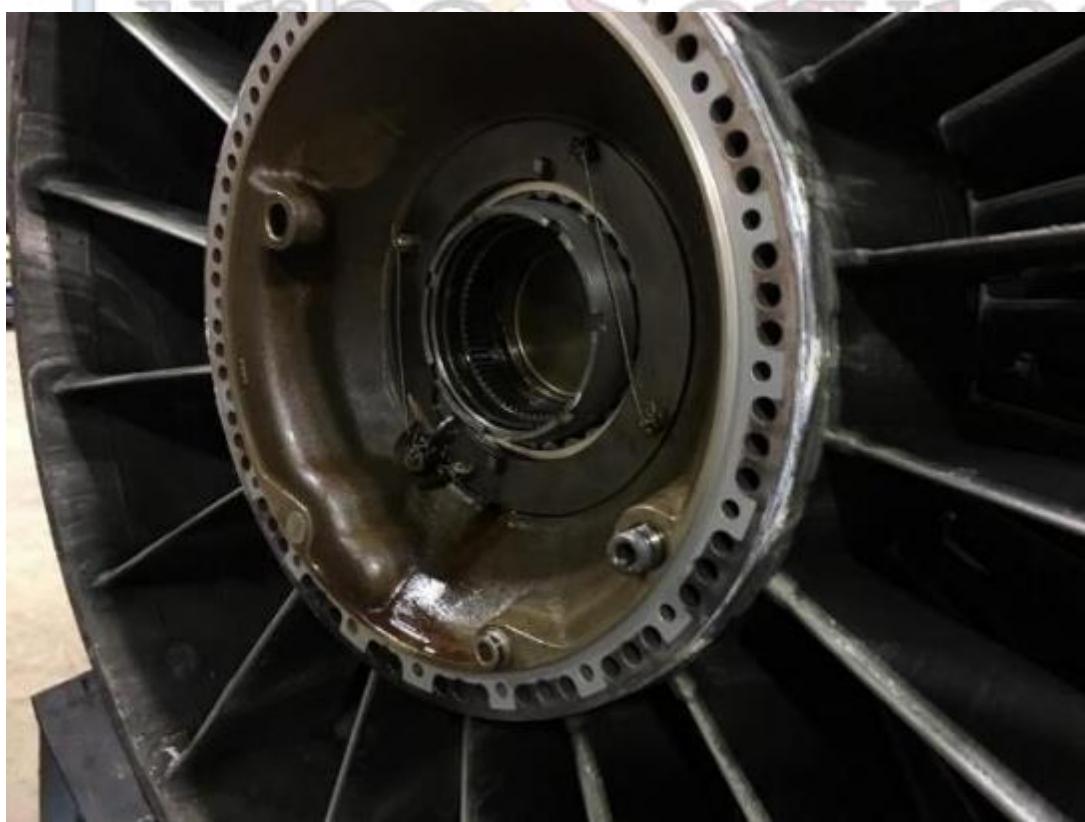
Inlet Case & #1 Housing Area 2-2-1 fig. 1

Findings: Front accessory dive was inspected with no findings. Inlet case had coating loss.

Conducted: Front accessory dive was cleaned and reassembled. Inlet case was stripped, NDT inspected and coated.

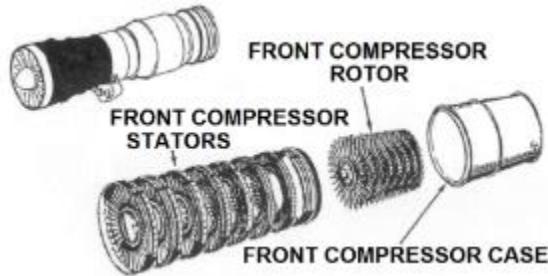
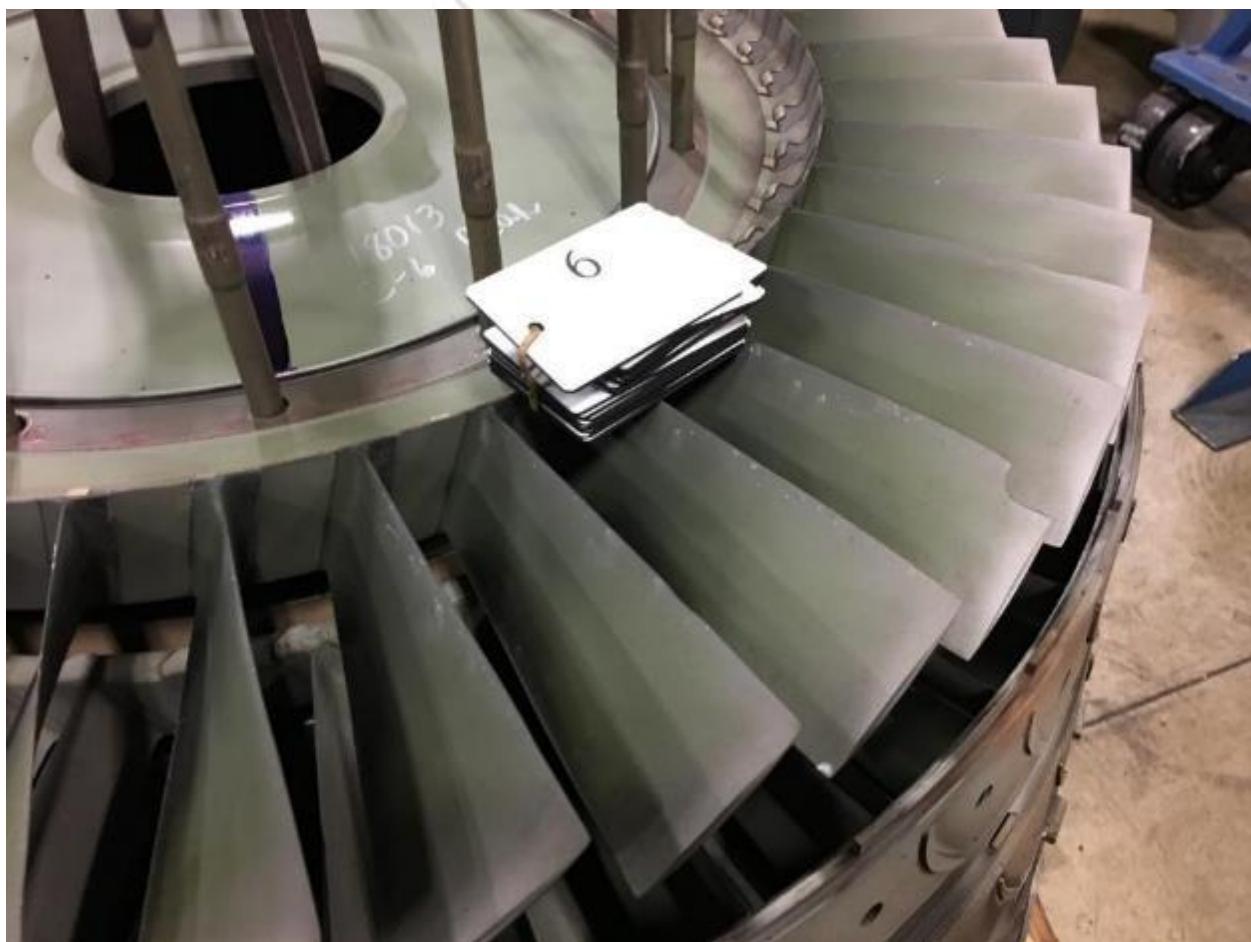
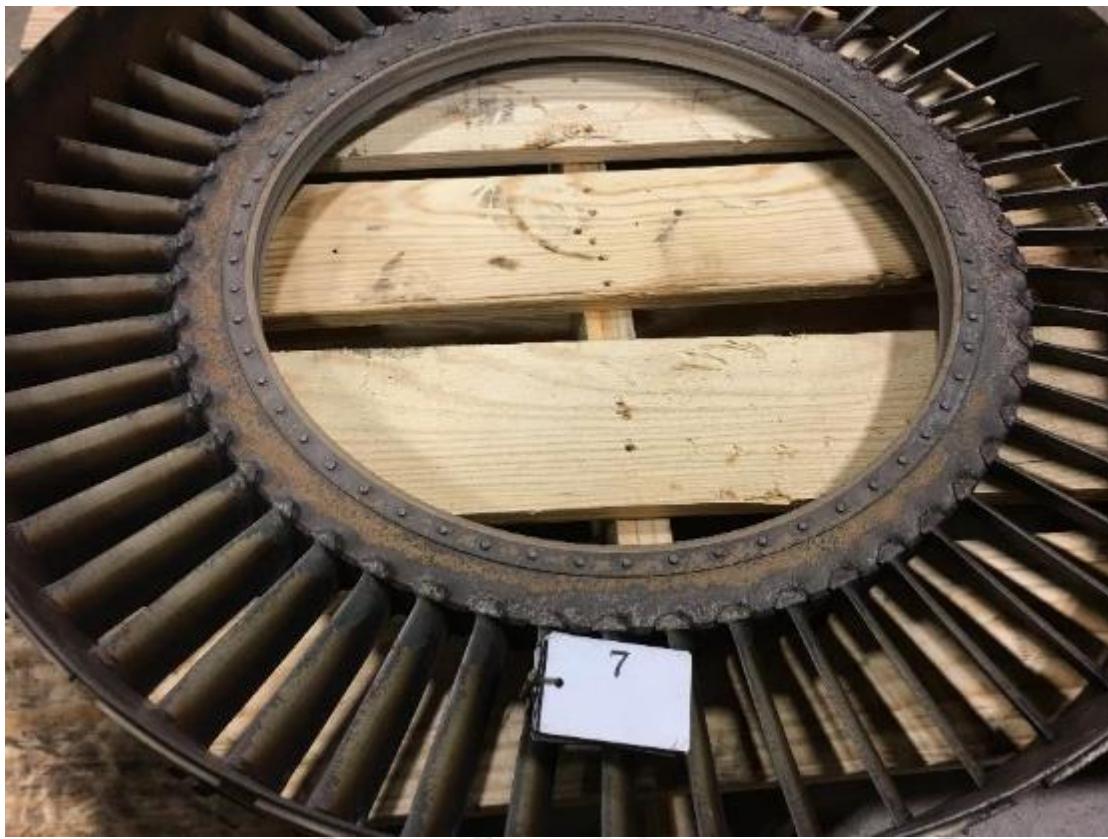
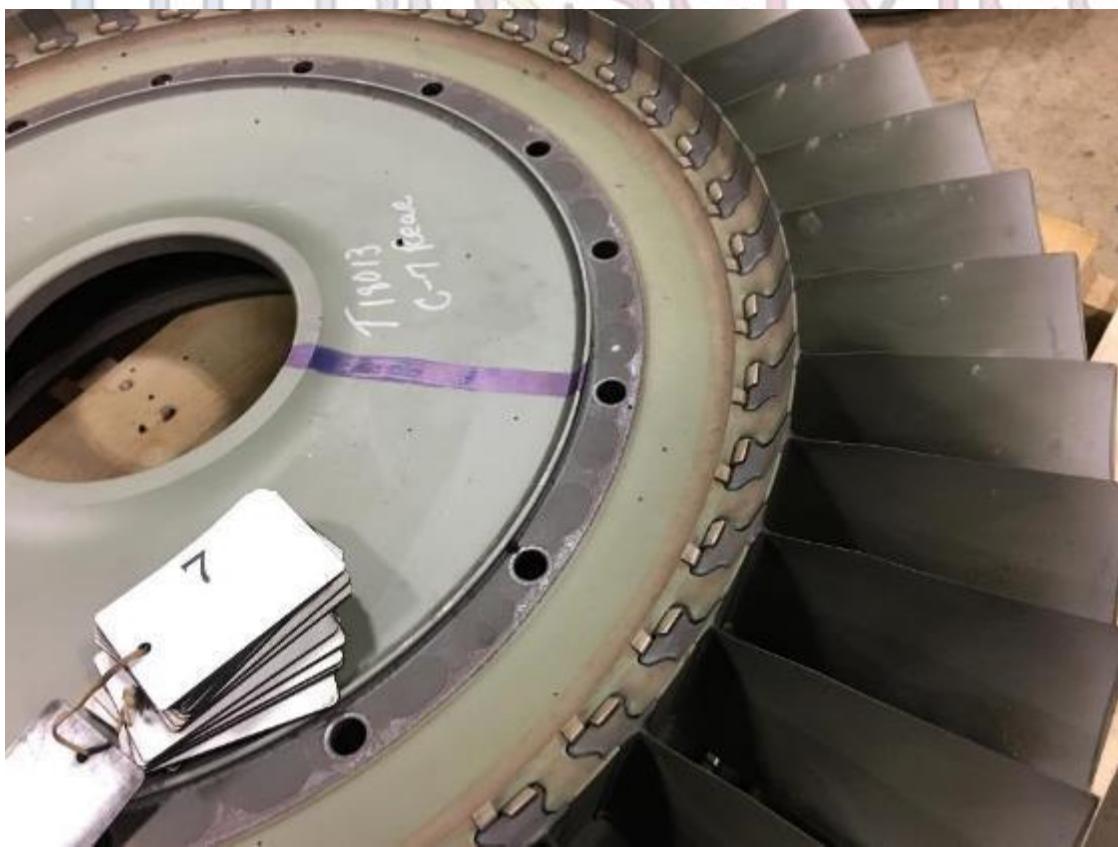
2-2-3 fig 1 / 2-2-4 fig 1 / 2-2-5 fig 1

Findings: C-6 blade had a portion of the trailing edge break off.

Conducted: LPC rotor was exchanged with an overhauled module from TSI. The installed rotor had the following work completed.

LPC case – Stripped, inspected and coated.
C-8 duct – Stripped, inspected and coated.

Stator –Stator C-1 to C-7 were stripped, NDT inspected and coated.

Disk C-1 to C-8 – C-1 to C-4 disk were stripped, inspected and cadmium plated. Disk C-5 to C-8 and rear hub were stripped, inspected and coated.

Spacers – Restored snaps to achieve proper fit to disk. Stripped, NDT inspected, and coated.

Blades C-1 to C-8 – Blades C-1 to C-4 were cleaned, blended, NDT inspected and replaced bumpers. Blades C-3 to C-6 were cut back per SB 72B6, stages C-7 and C-8 were cut back per SB 74B07. Blades C-5 to C-8 were, NDT inspected, and coated.

Tierods – Front and rear tierods were dimensionally inspected and the threads were anti galled.

LPT coupling – Installed cleaned and inspected parts including having restored plating on coupling, lock and lock plate

Rotor was assembled and check balanced.

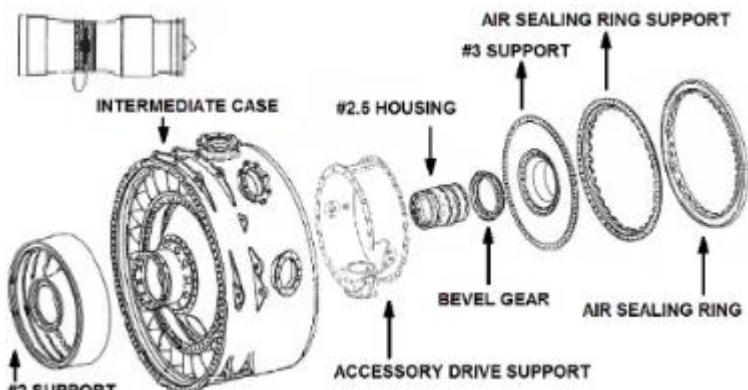
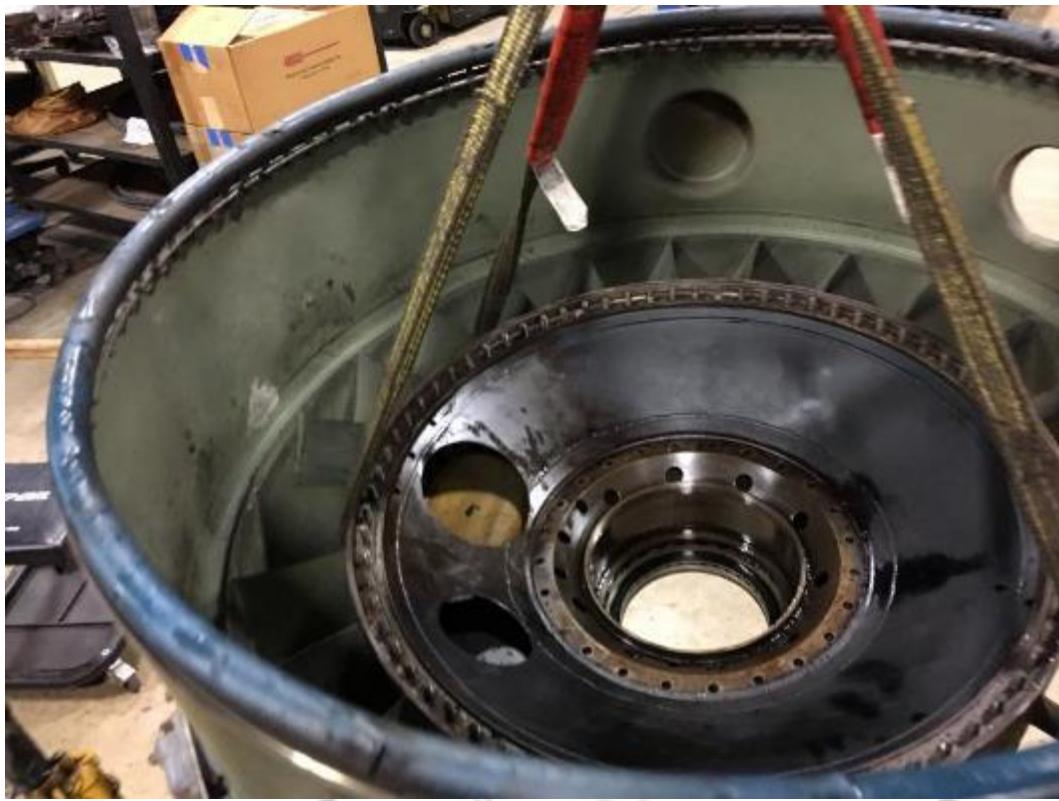
Intermediate Case

Findings: Intermediate case had coating loss. Broken nut on one gang nut plate. #2 support has coating loss. #3 support and seal rings were cleaned and inspected with no findings. Heatshields for #3 support were old configuration which allowed for carbon build up in the compartment. #2.5 housing was worn.

Conducted: Intermediate case was dimensionally inspected, and pressure tested with no findings. Case was then stripped, NDT inspected and coated. Replaced damaged gang nut. #2 support was stripped, NDT inspected and coated. #3 support and seal rings were blasted to clean and inspected. Installed upgraded heat shields per SB72B19. #2.5 housing had the silver plating restored. Restored silver plating on bevel gear.

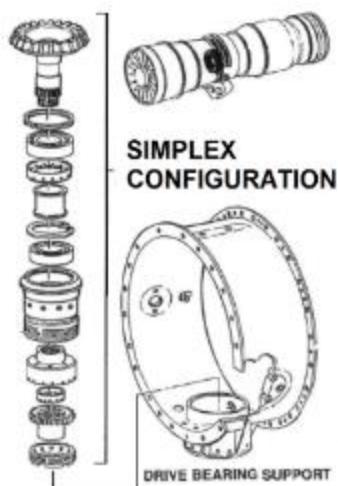
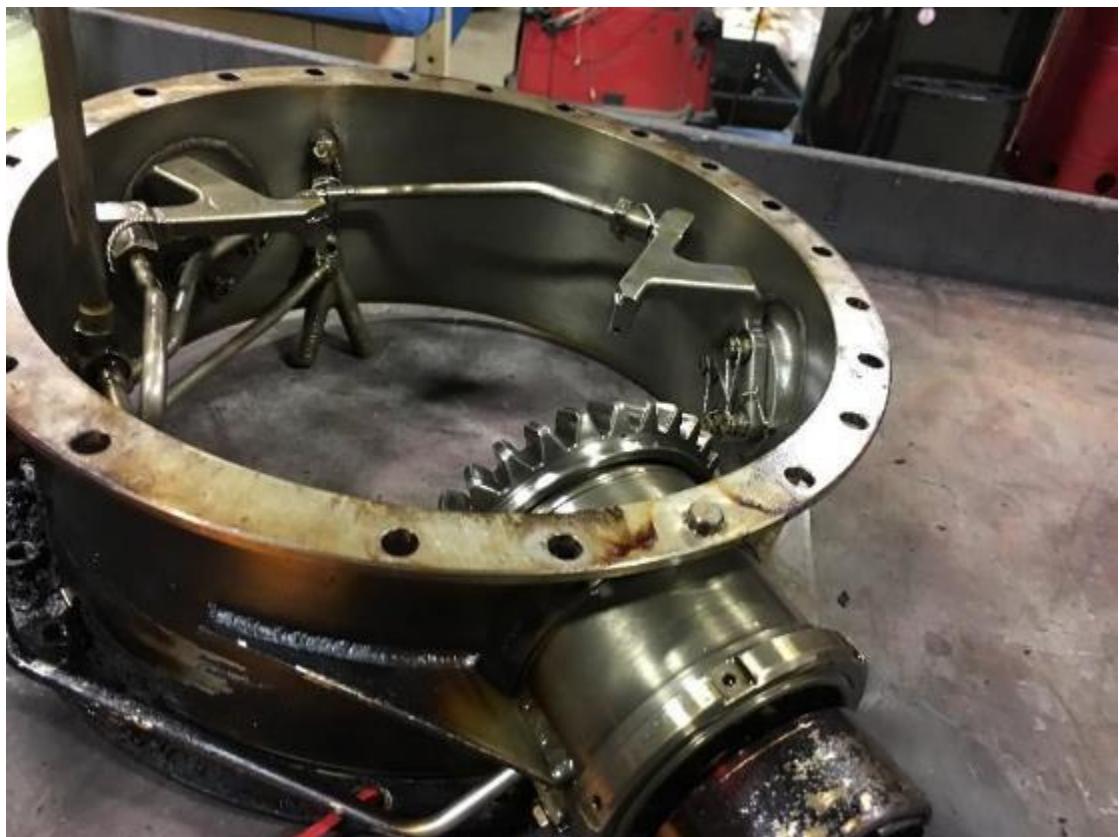
2-2-8 fig. 1

Findings: Accessory drive housing and bushing should be dimensionally inspected. One broken nut on gang nut plate. Replace both tower shaft bearings.

Conducted: Accessory drive housing and bushing were dimensionally inspected. Replaced one gang nut channel. Upper and lower tower shaft bearings were replaced. Remaining parts were cleaned and inspected prior to use.

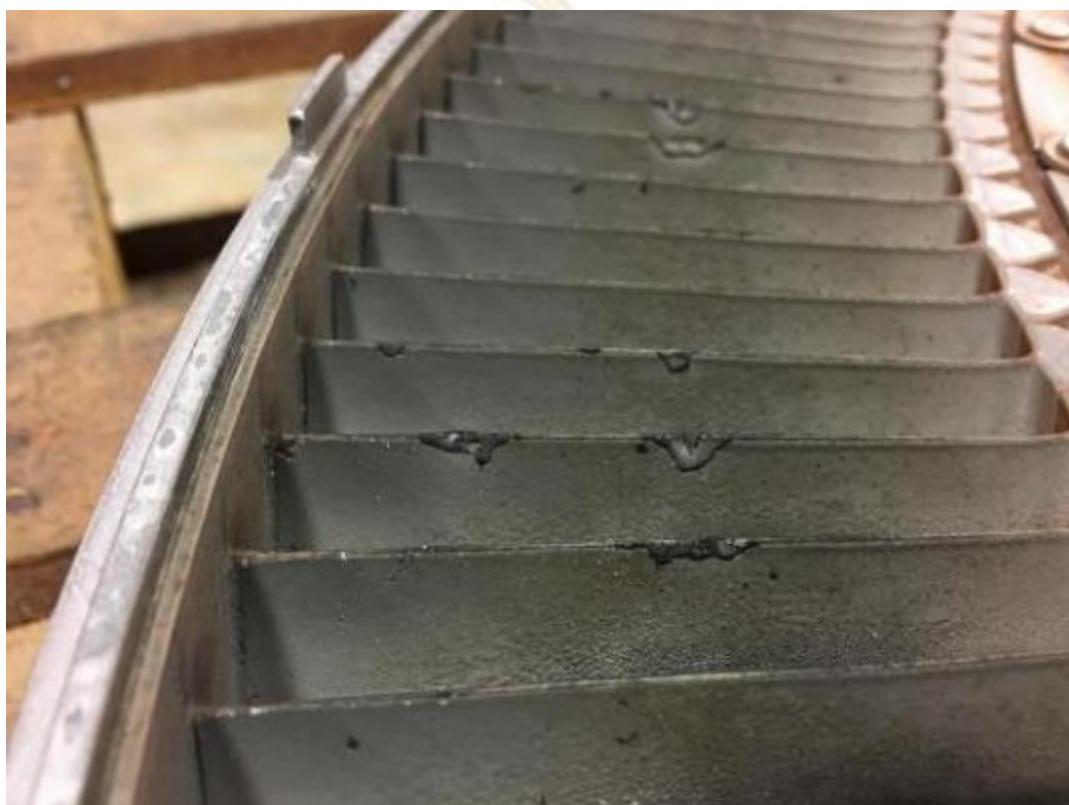
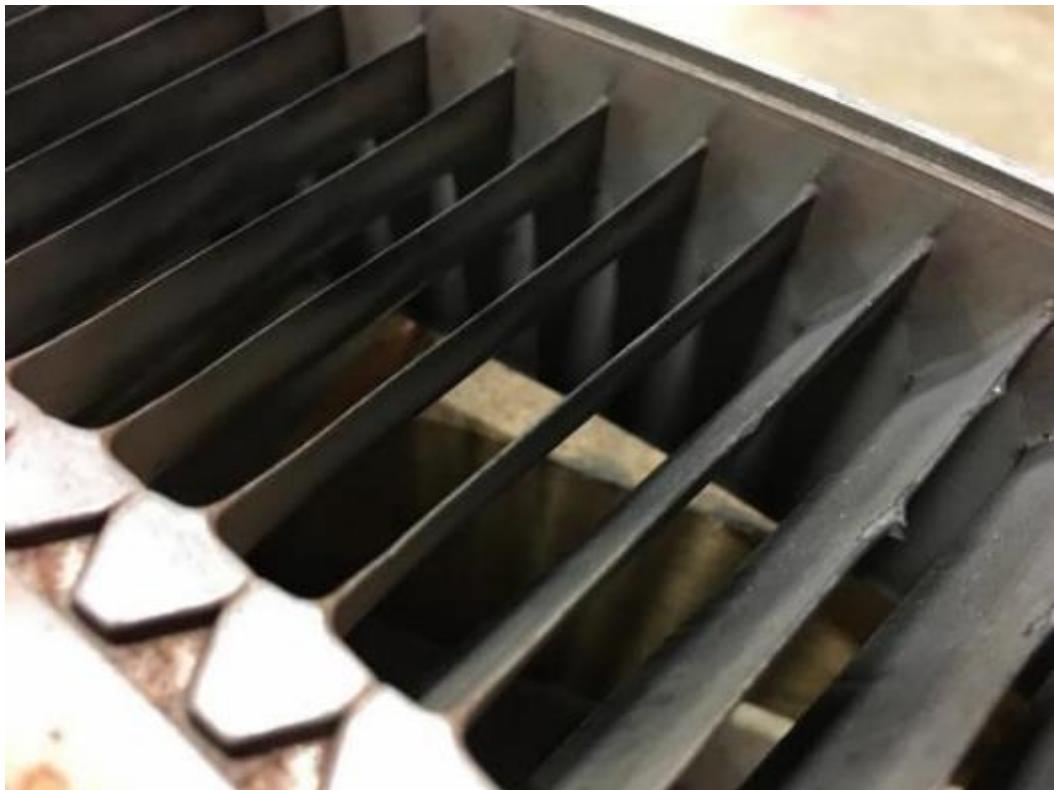
C-9 Stator

Findings: Missing portion of C-6 blade is the most likely cause of impact damage that occurred in the HPC.

Stators – C-9 to C-14 stator were stripped, NDT inspected and coated. C-9 and C-10 were zinc filled per SB 77M10. C-11 was zinc filled per SB 78M06

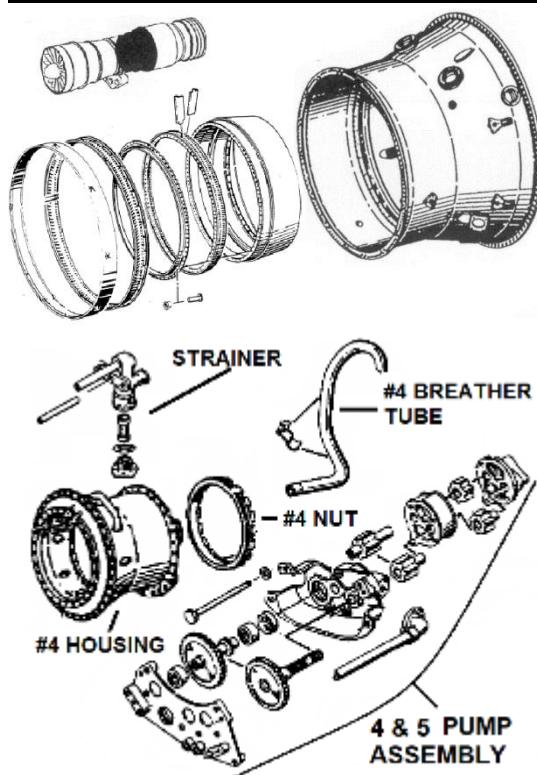
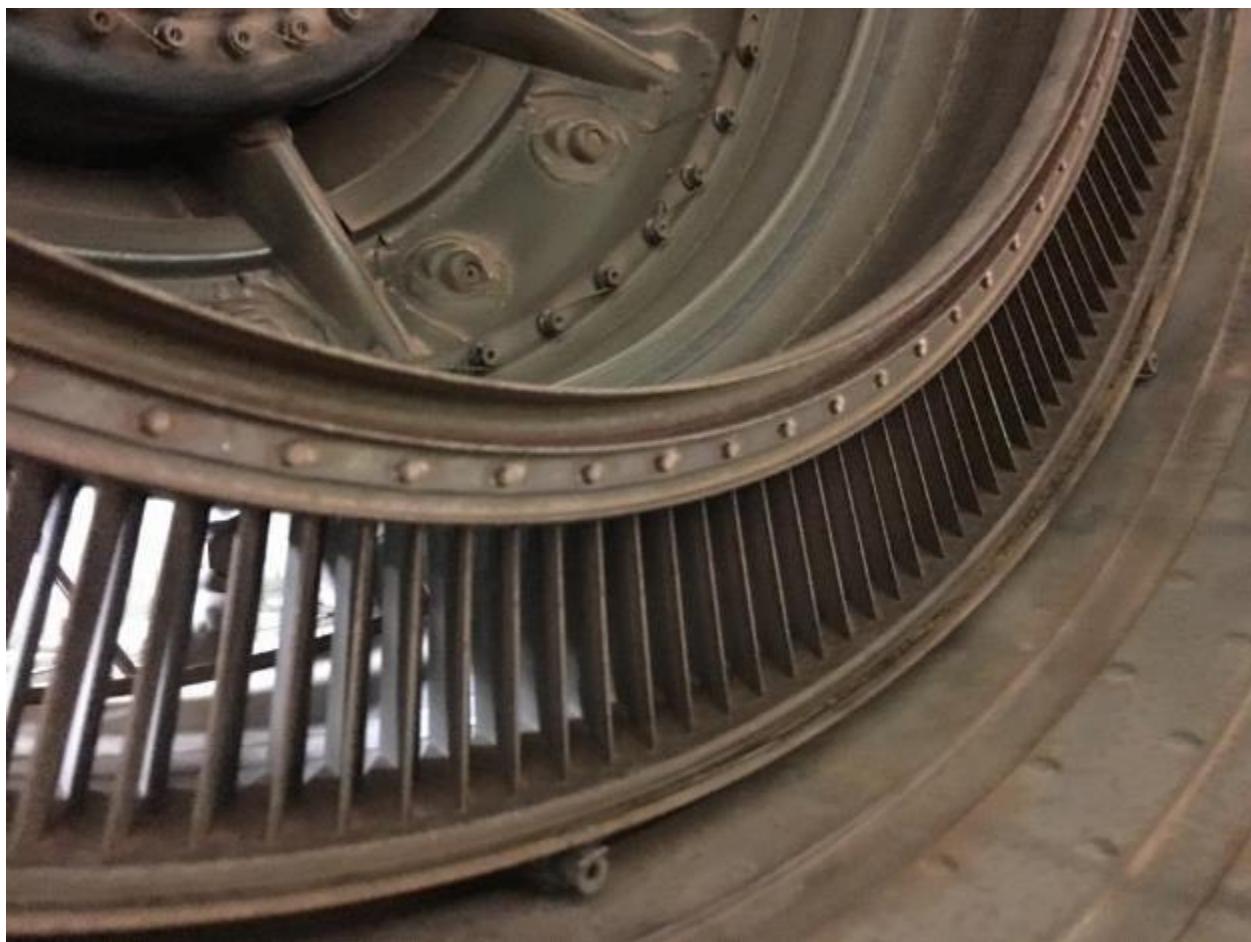
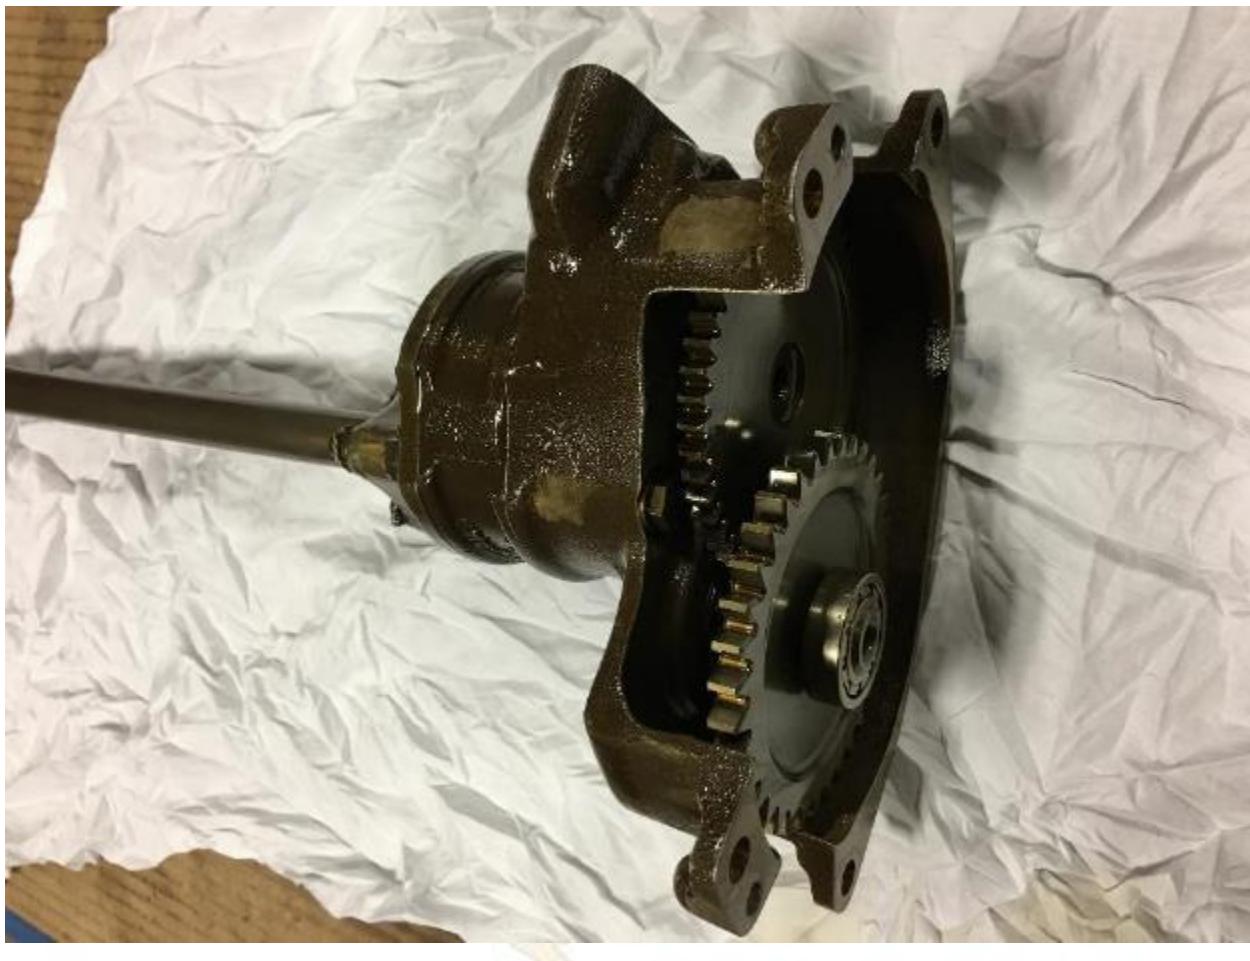
2-3-3 fig 1 / 2-3-5 fig 1 / 2-3-6 fig 1

Findings: Diffuser case had coating loss. C-15 stator and stator seat have coating loss.

Conducted: Diffuser case passed pressure test. Case was then stripped, NDT inspected and coated. C-15 stator and stator seat were stripped and coated. #4 housing was visually and dimensionally inspected with no findings. 4&5 pump was inspected with no findings. Upgraded scavenge tube per SB 80B14.

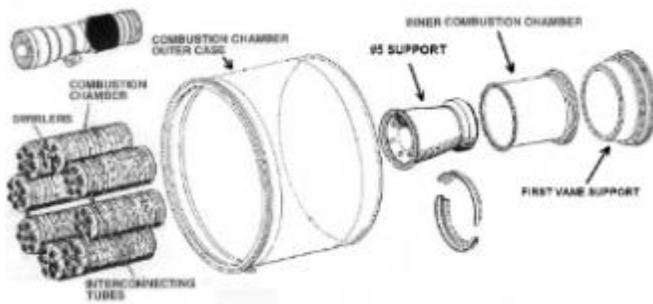
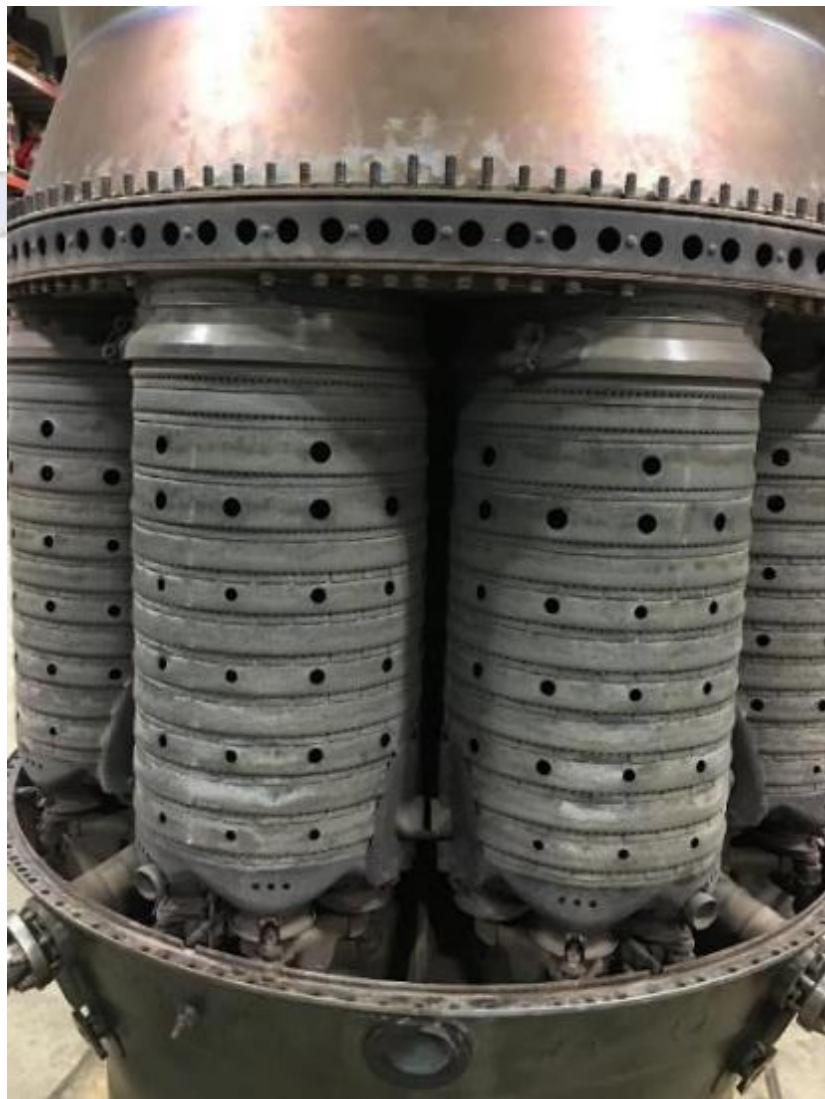
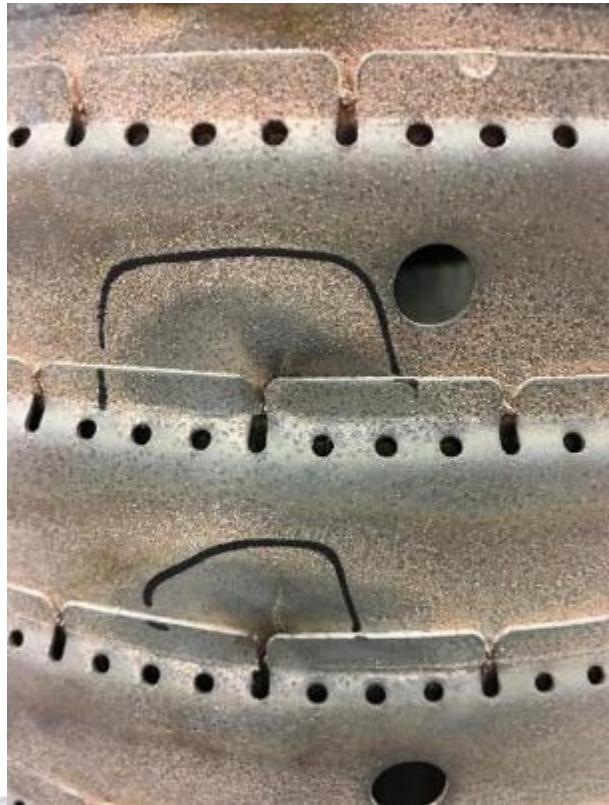
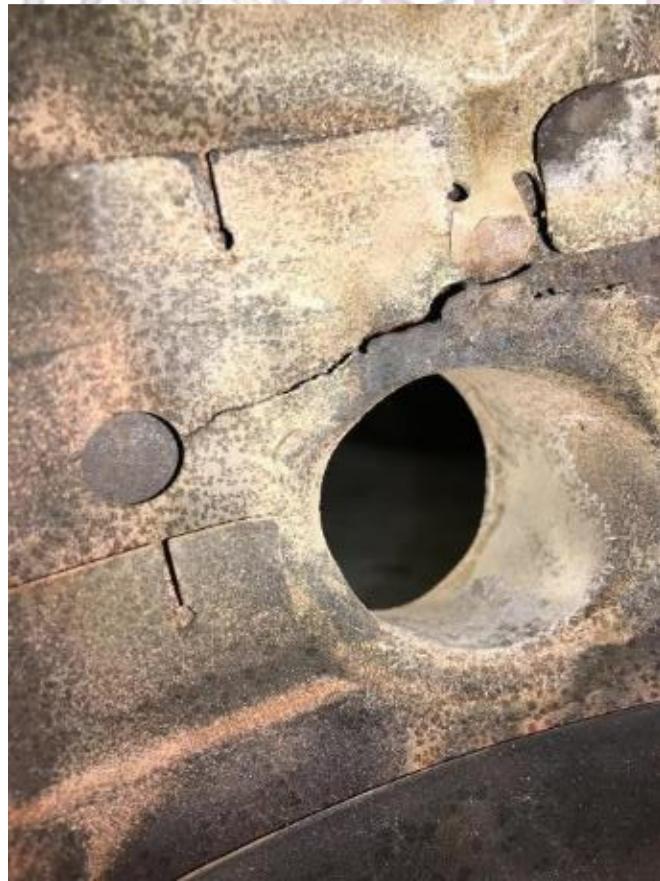
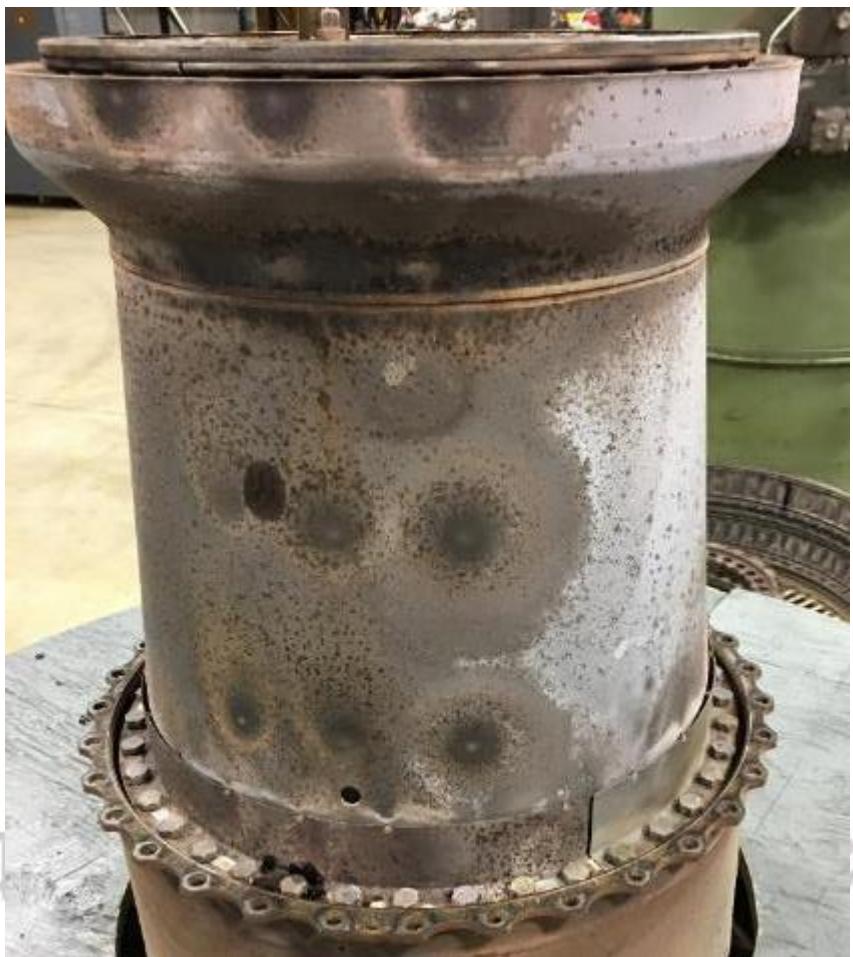
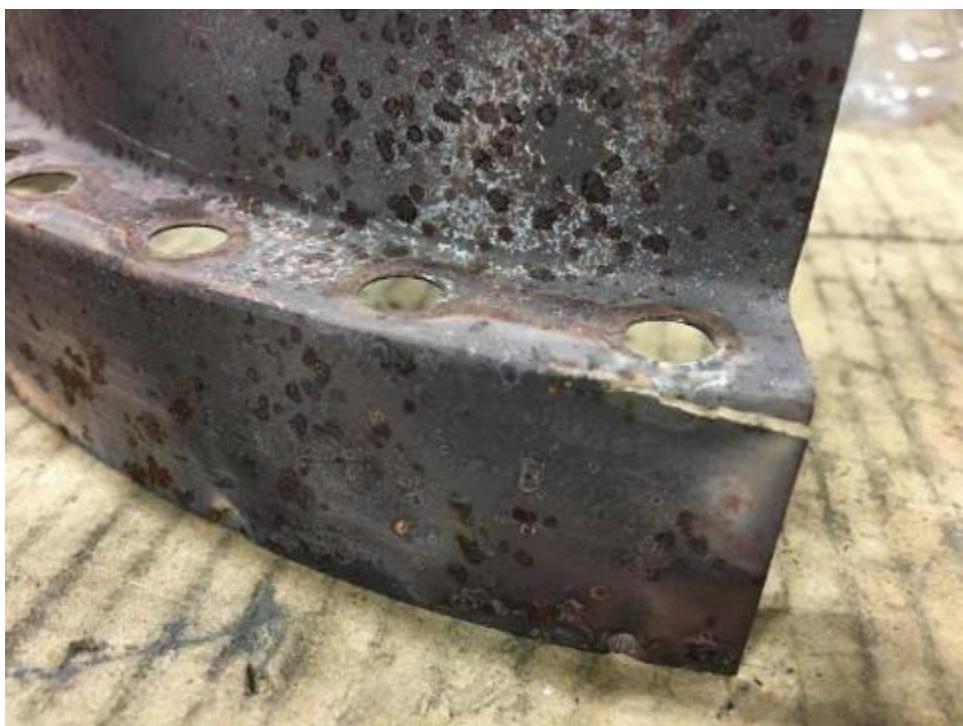
Combustion Chambers 2-3-7 fig 1

Outer combustion case has coating loss. The number 3, 6, and 8 combustion chambers all require weld repair and cleaning. The remaining five combustion chambers each require cleaning. Combustion chamber clamps were inspected with no findings. Inner combustion case was inspected with no findings. #5 support passed pressure test. Half moon heatshields were both cracked and had coating loss. 1st vane support was missing rivets for the vane seats. 1st vane support all 12 vane segment seats were worn.

Conducted: Outer combustion case was stripped and coated. Combustion chambers were weld repaired as required and cleaned. Inner combustion case was cleaned and inspected. #5 support passed pressure test and was grit blasted to clean. Half moon heatshields were both weld repaired and coated per SB 73B36. 1st vane support replaced all 12 vane segment seats and riveted and tack welded seats in place.

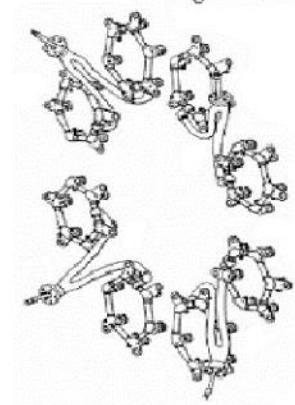
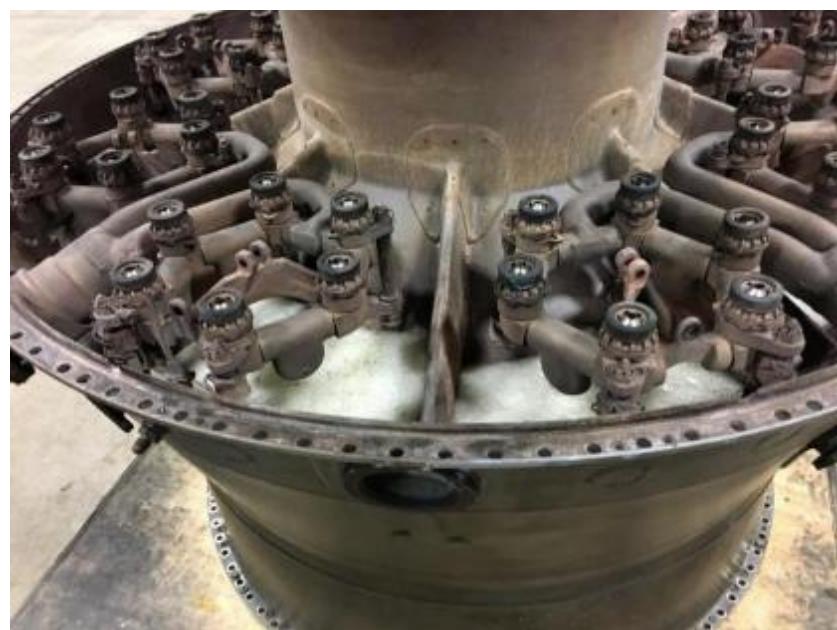
2-4-8 fig 3

Findings: Perform initial flow and pressure test, disassemble to clean and or make repair, remap nozzles.

Conducted: Fuel manifolds were overhauled.

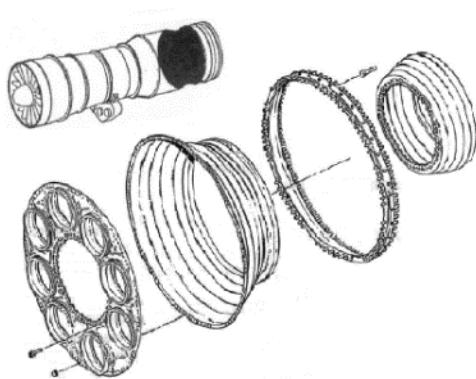
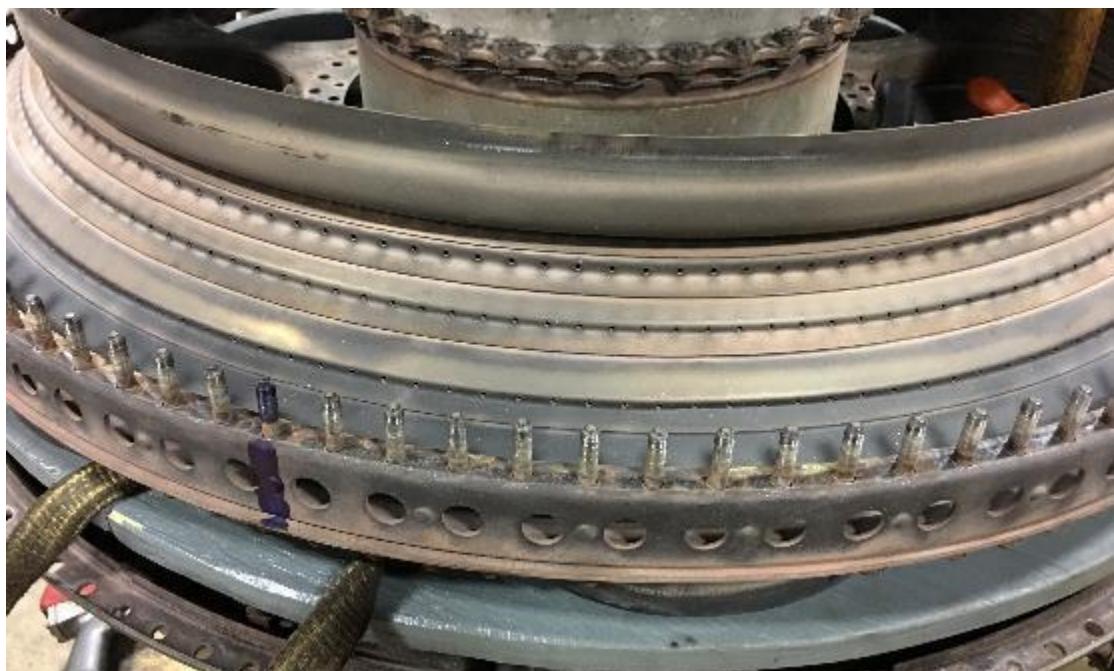
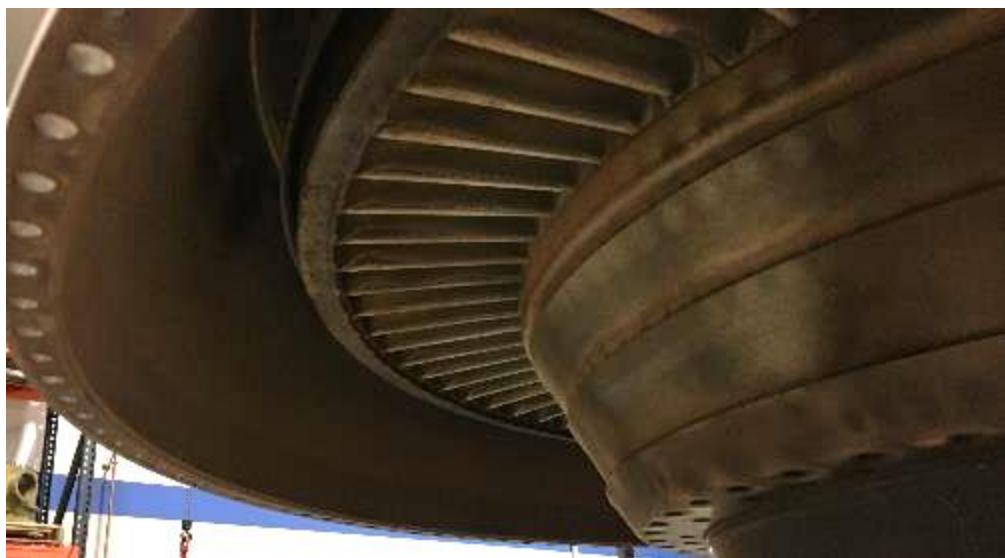
2-3-9 fig 1

Findings: Loss of Mag Zirc coating, no cracks noted. T-duct plate and bolt ring were inspected with no findings.

Conducted: Inner and outer T-ducts were stripped and recoated with Mag Zirc. T-duct plate and bolt ring required no work.

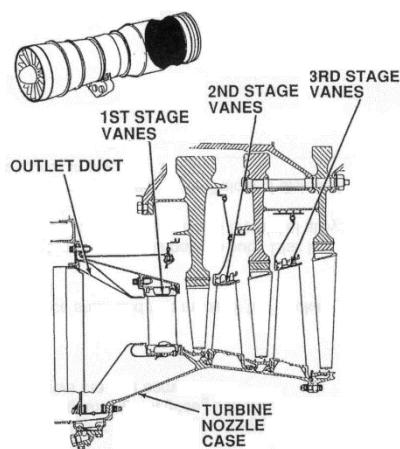
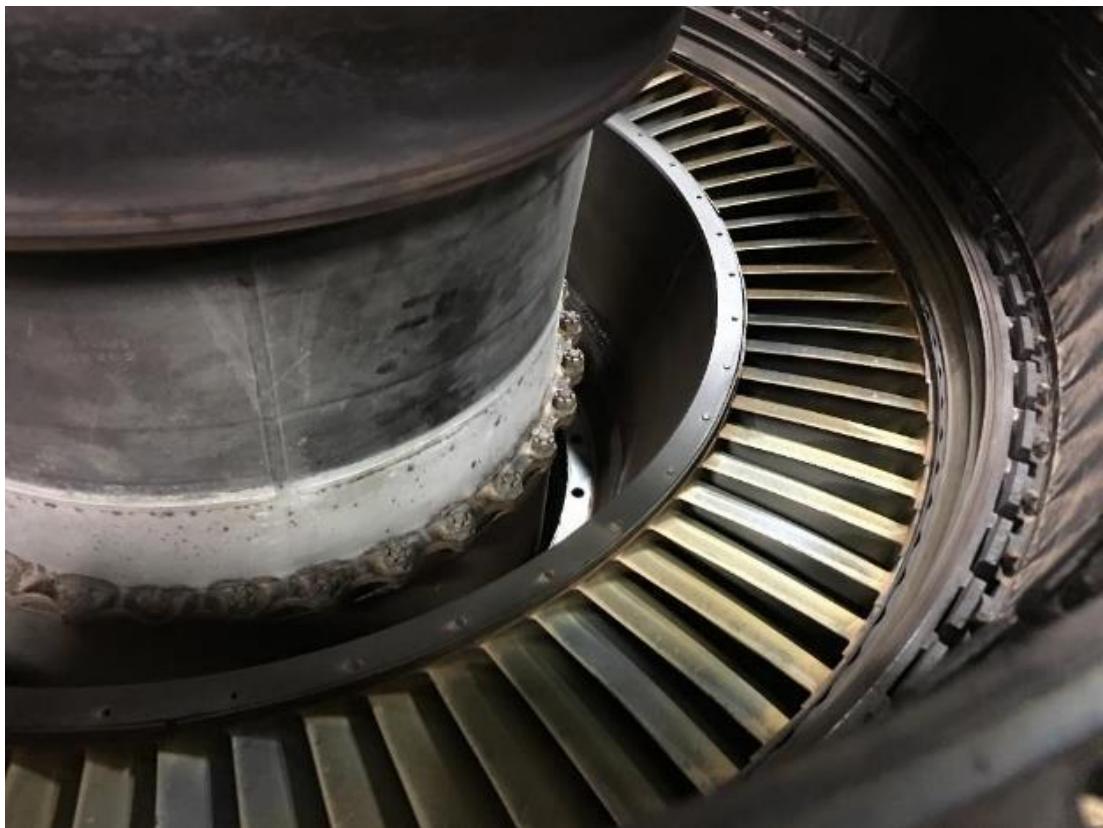
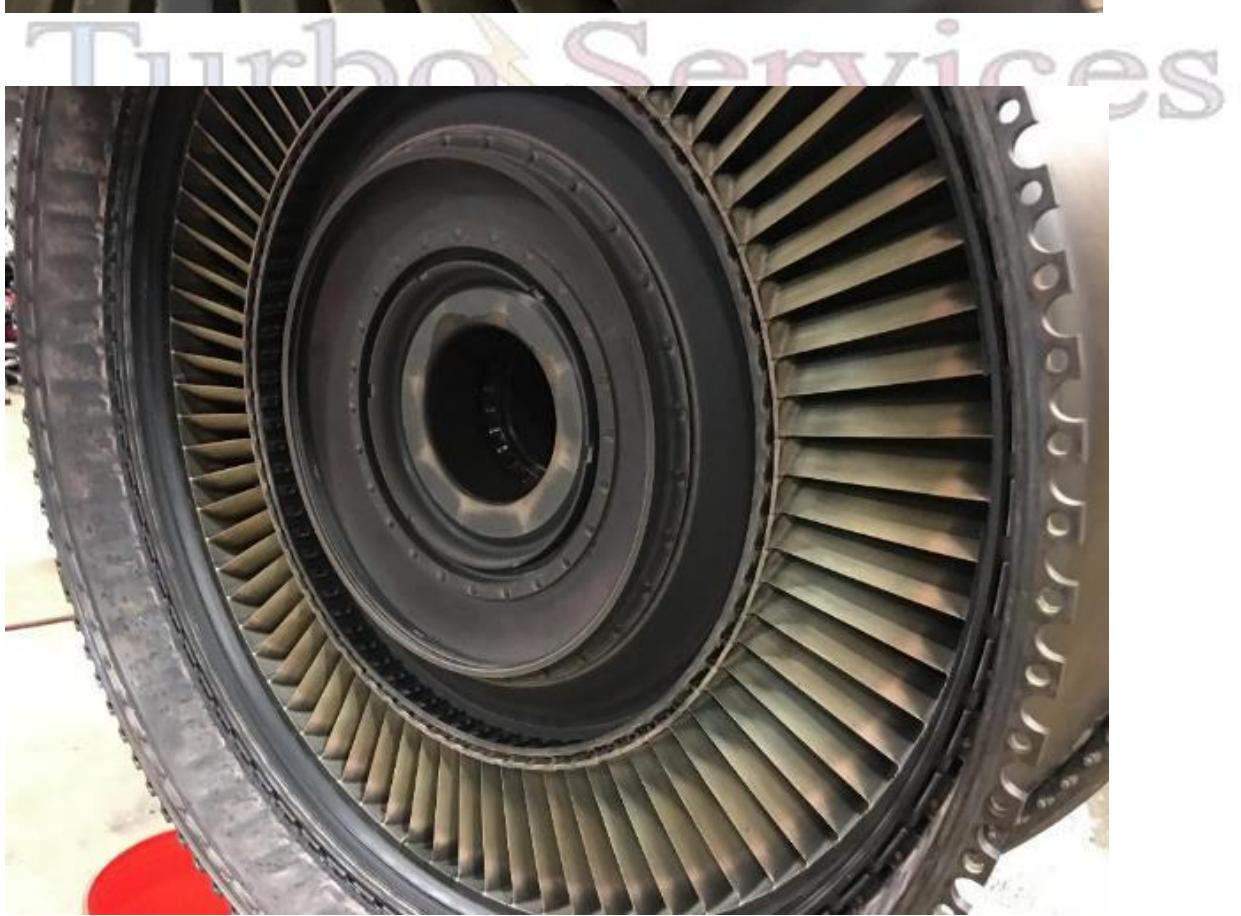
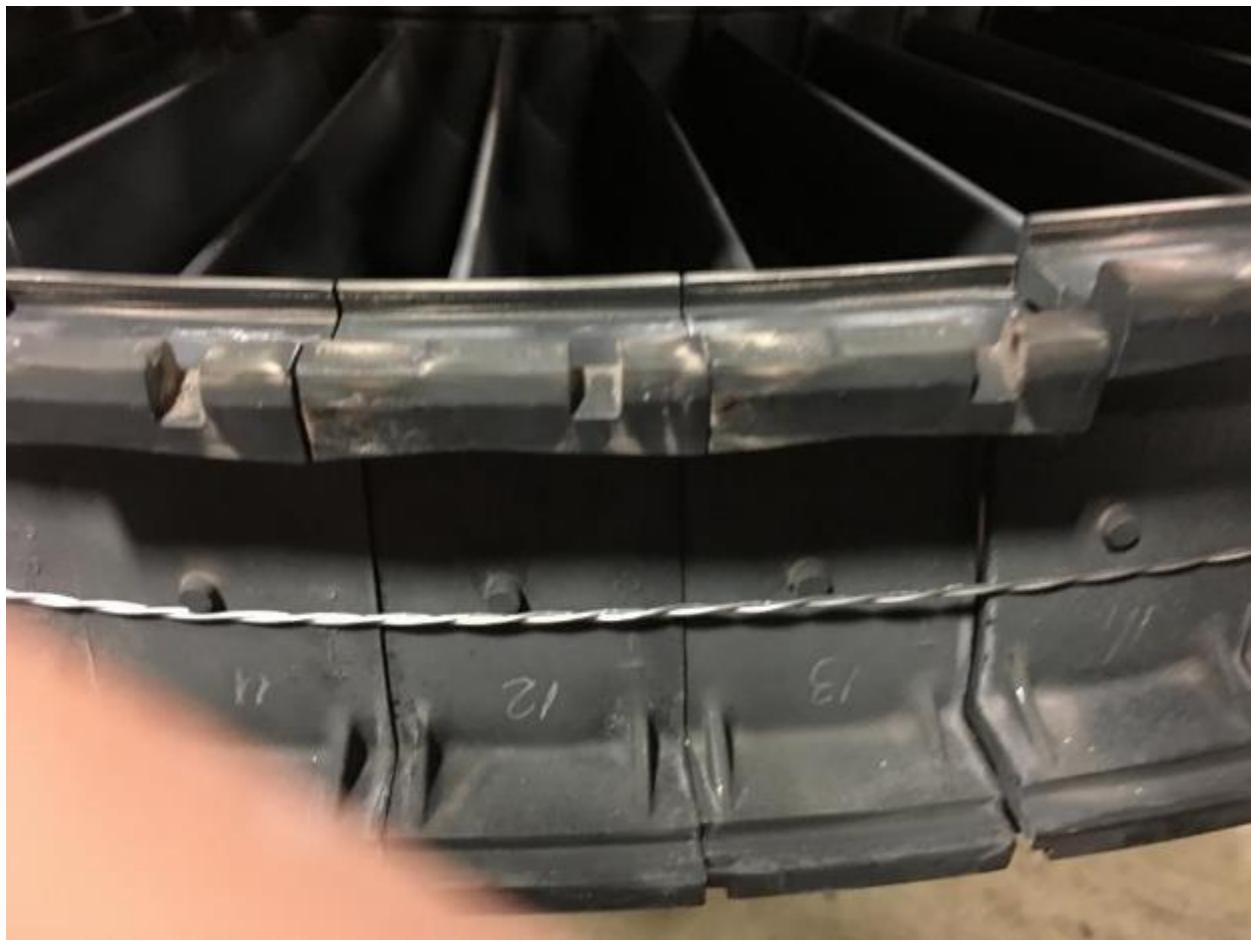
Nozzle Guide Vanes 2-3-11 fig 1

Findings: 1st stage vanes had some bowing to the airfoil.

2nd stage vanes recommend to overhaul vanes.

3rd stage vanes recommend to overhaul vanes.

Conducted: 1st stage vanes were sent out for overhaul.

Quantity 45 vanes were deemed scrap, the remaining 35 were overhauled. Issued overhauled T-1 vanes from TSI stock.

2nd stage vanes were sent out for overhaul. All 76 pieces were overhauled. Issued overhauled T-2 vanes from TSI stock.

3rd stage vanes were sent out for overhaul. All 68 pieces were overhauled. Issued overhauled T-3 vanes from TSI stock.
