Oklahoma Gas and Electric

ESN:675502

Shop Report
1/11/2019

Model GG4A-9

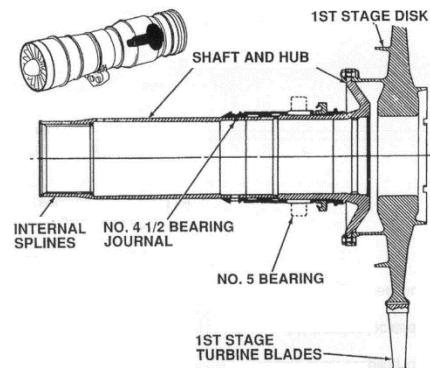
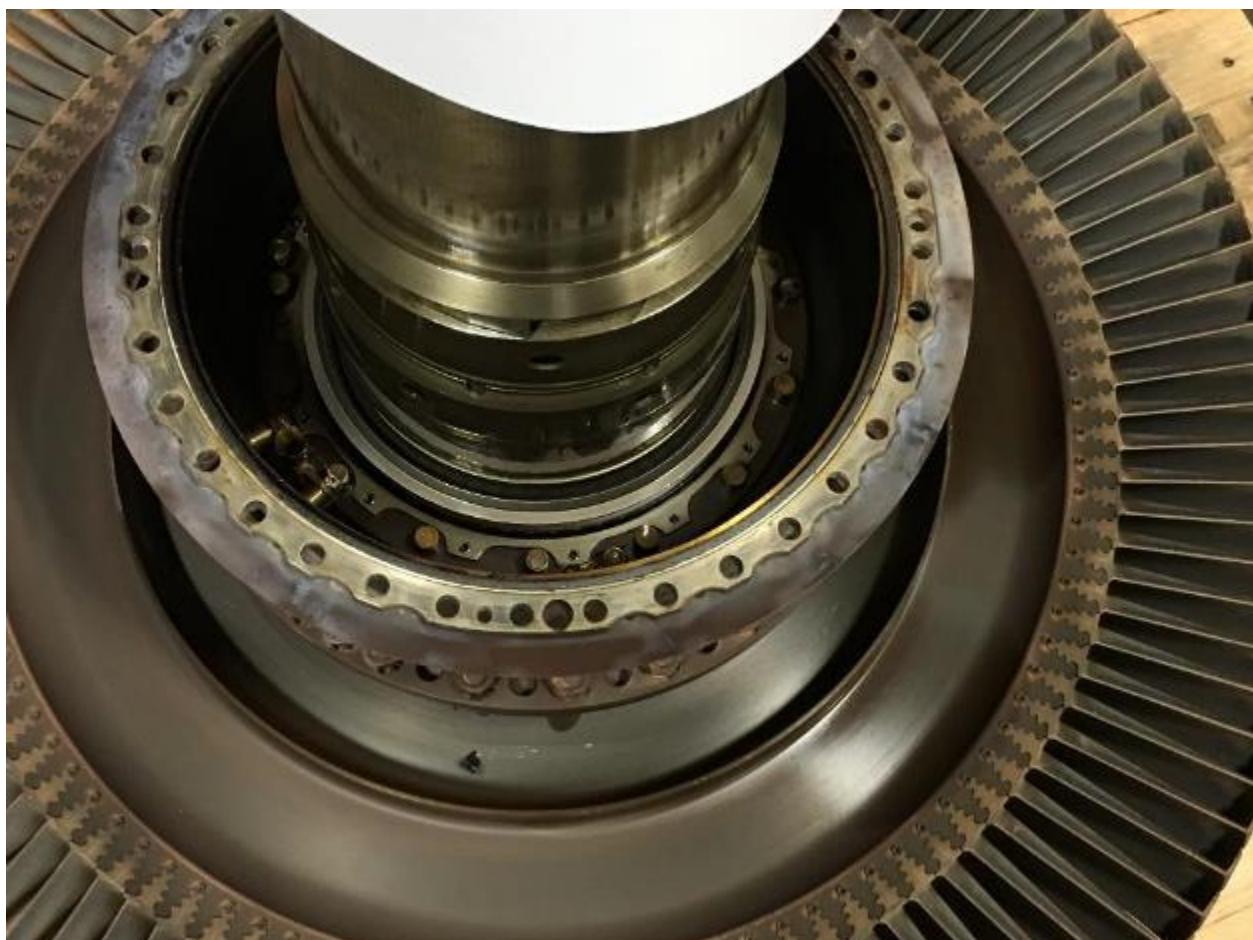
High Pressure Turbine Rotor 2-3-12 fig 1

Findings: Disk and shaft were inspected with no findings.
Overhaul T-1 blades.

Conducted: HPT rotor was exchanged with an overhauled module from TSI. The installed rotor had the following work completed.

Cleaned and inspected HPT disk and shaft. T-1 blades were sent out for overhaul. All 108 pieces were deemed scrap.
Issued overhauled T-1 blades from TSI stock

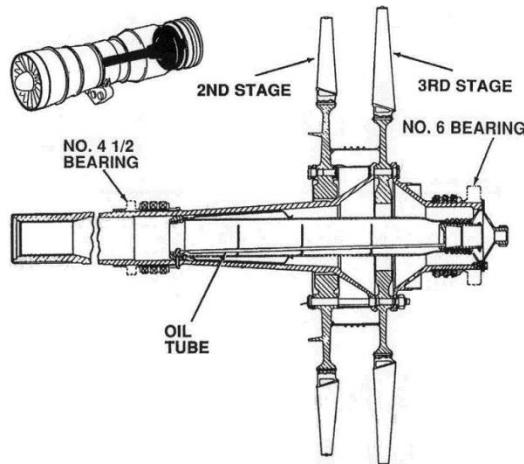
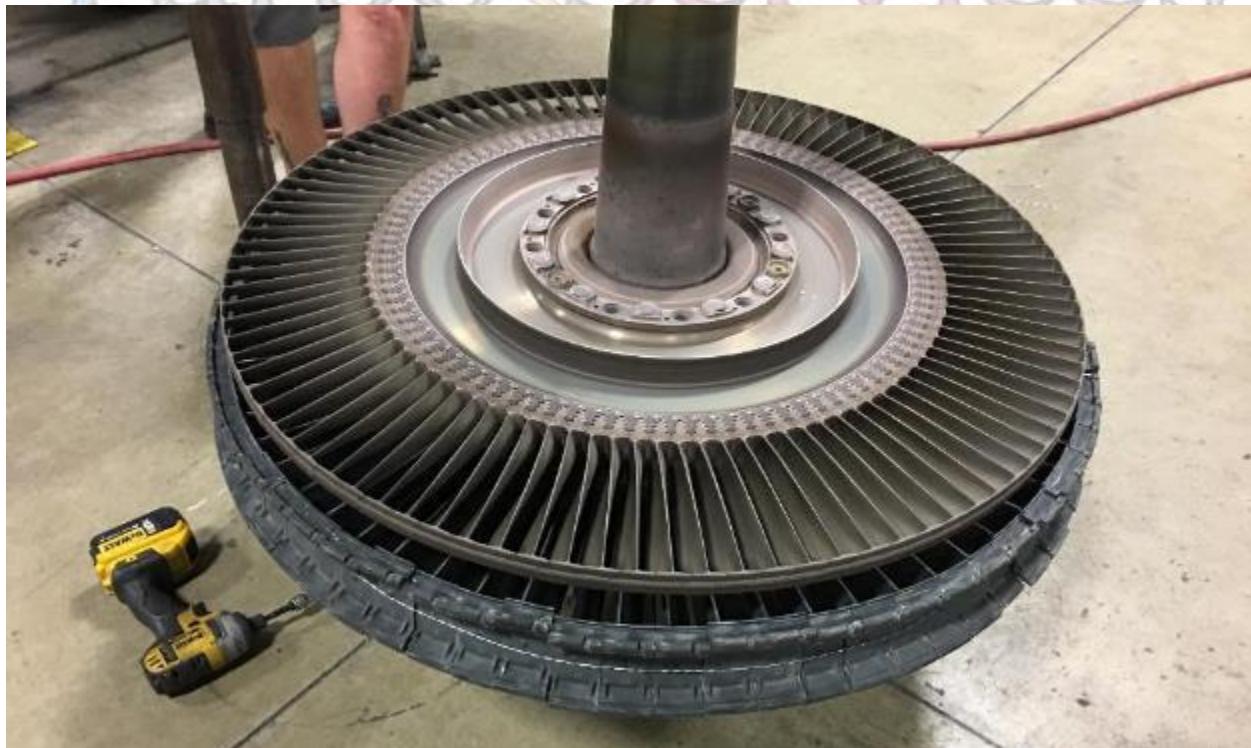
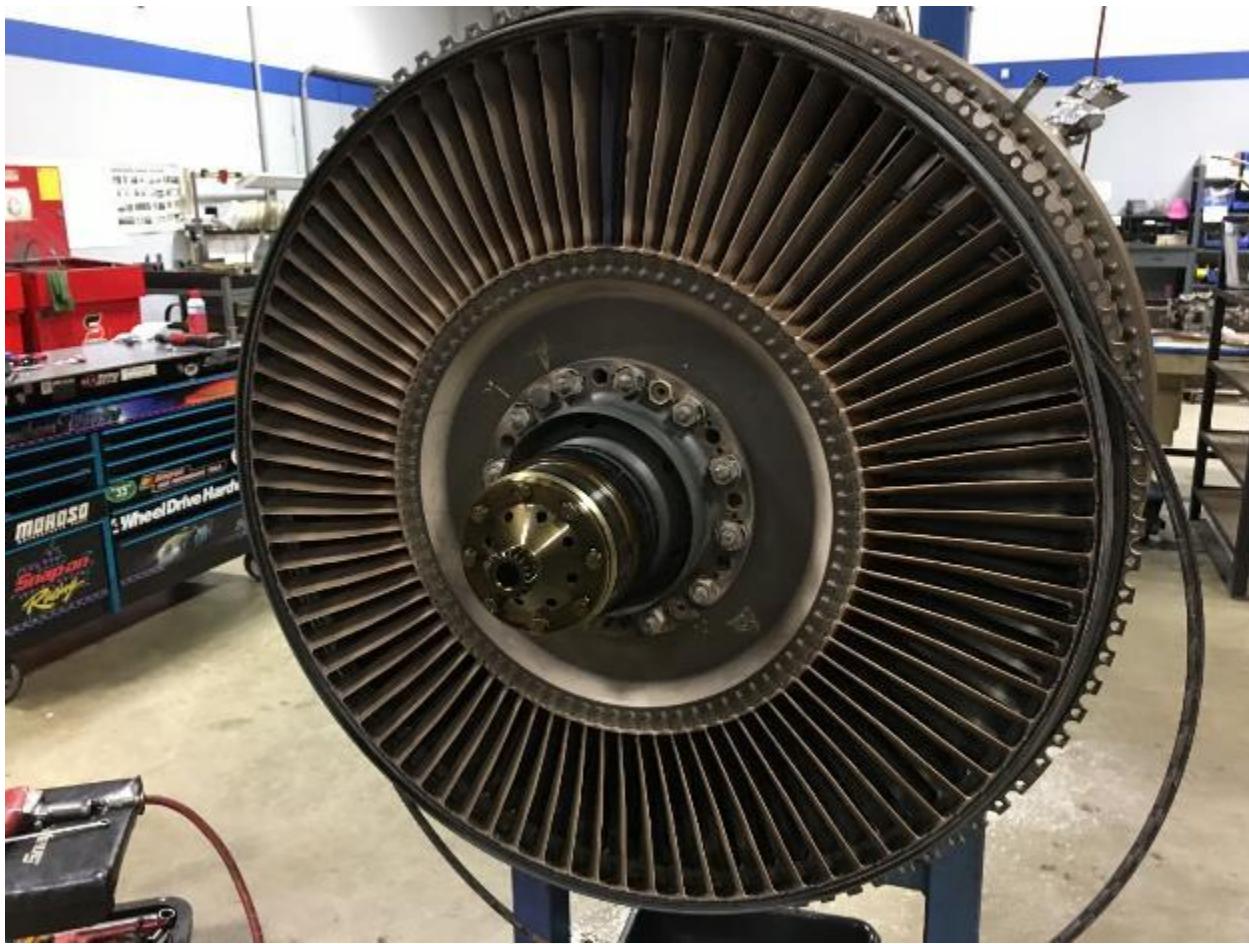
2-3-13 fig 1

Findings: 2nd blades recommend to overhaul. 3rd blades recommend to overhaul. LPT shaft has coating loss. Rear hub has coating loss. 2nd and 3rd stage disk were cleaned and inspected with no findings. Inner airseal had a loose front snap and surface corrosion. 3rd vane support had wear on the vane seat. Tierod ring and support spacer were inspected with no findings. Tierods were visually and dimensionally inspected with no findings.

Conducted: LPT rotor was exchanged with an overhauled module from TSI. The installed rotor had the following work completed.

T-2 blades were sent for overhaul. Quantity 1 of the blades were deemed scrap. Quantity 99 were overhauled. Issued overhauled T-2 blades from TSI stock. T-3 blades were sent for overhaul. Quantity 16 of the blades were deemed scrap. Quantity 66 were overhauled. Issued overhauled T-3 blades from TSI stock. LPT shaft and rear hub were both stripped, NDT inspected and coated. Turbine disk were both cleaned and NDT inspected. Inner airseal was stripped and coated. 3rd vane support had the vane land machined and plasma sprayed then final machined. Tierod ring and support spacer were both cleaned and inspected. Tierods were dimensionally inspected and anti-galled.

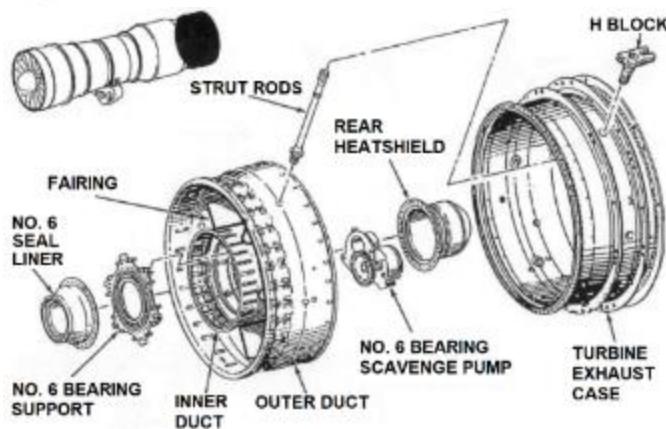
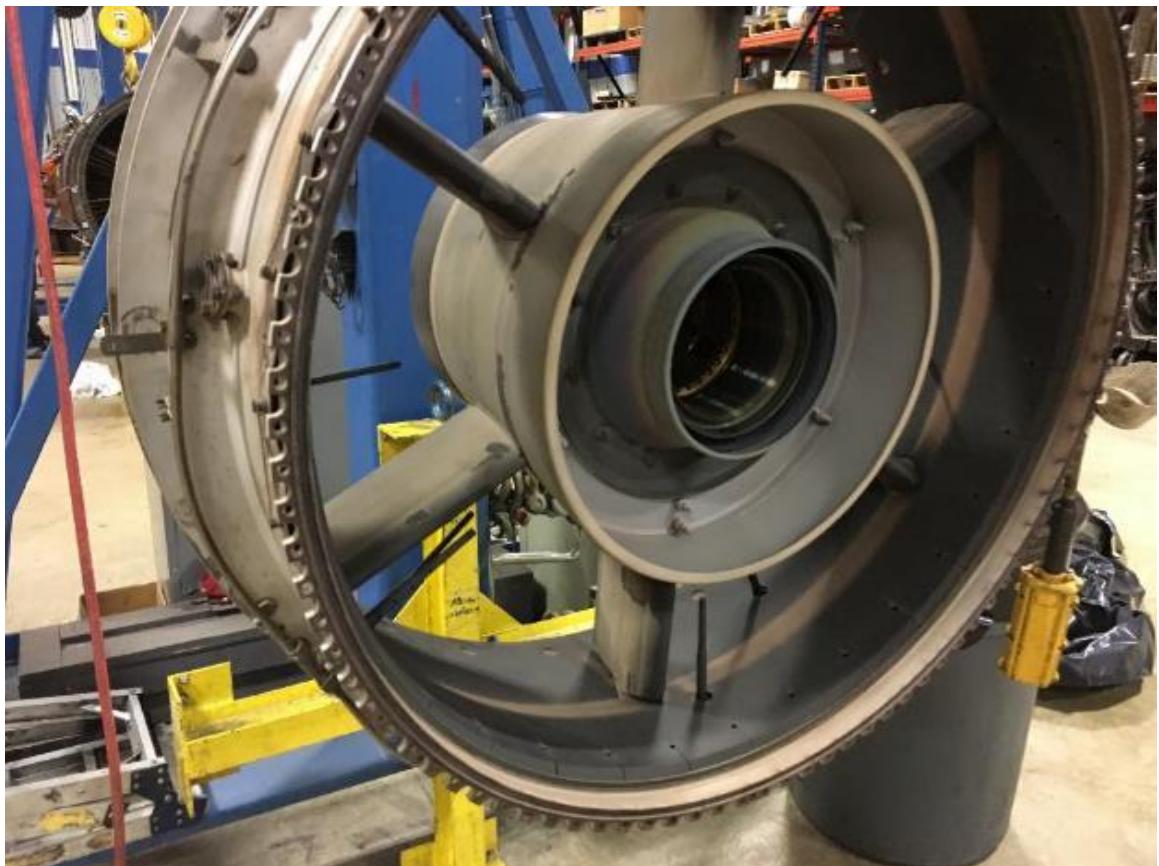
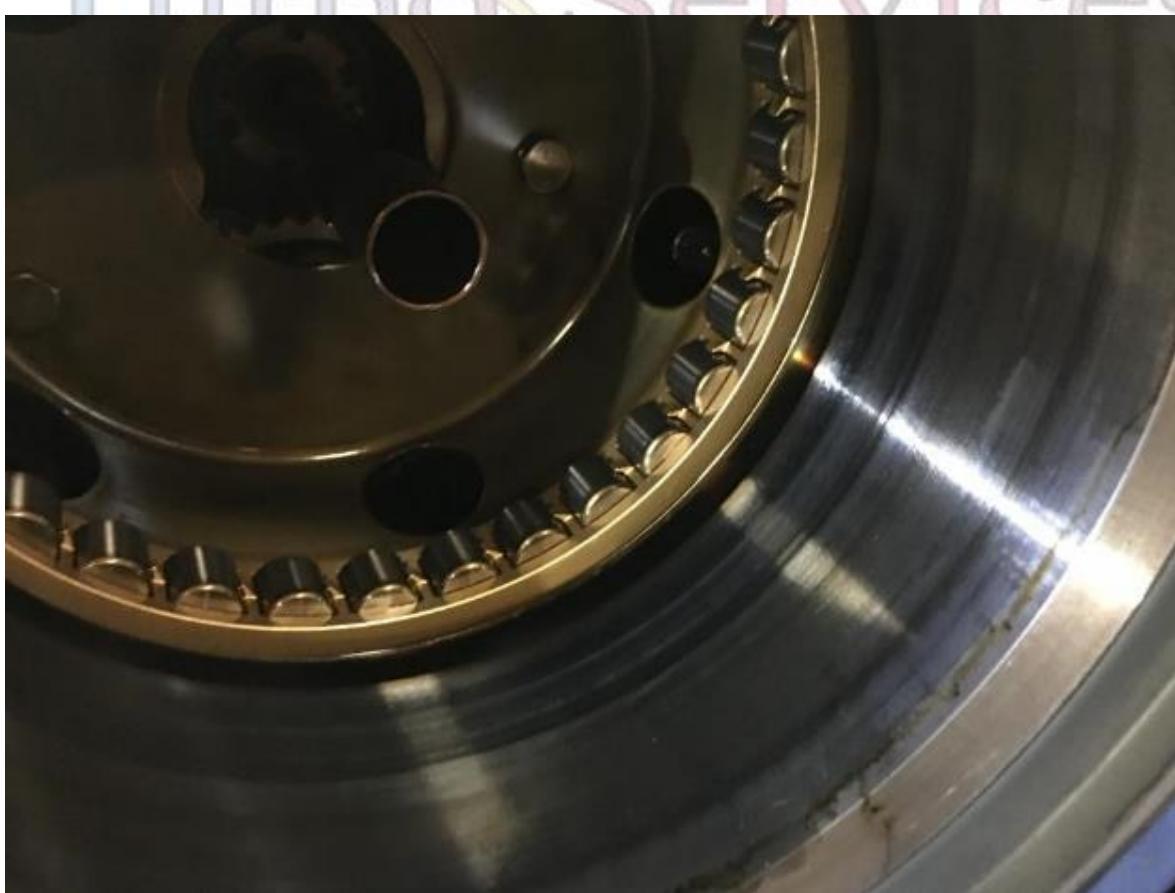
2-3-11 fig 1

Findings: Case had hardface plasma loss on the I.D. and the O.D. Outer duct had no damage but did have hardface coating loss. Inner duct and fairing was inspected with no cracks found. H-blocks were inspected with no findings. Inner, center, and outer strut rods were inspected with no findings. #6 seals liner was worn. Remaining items were inspected with no findings.

Conducted: Exhaust case assembly was exchanged with an overhauled module

from TSI. The exhaust case assembly had the following work completed.

Exhaust case was grit blasted to clean and then had plasma band applied to outside of case per SB 71B26. Also applied plasma to I.D. of rear of case per SB 74L05. Outer duct was grit blasted to clean then had plasma band applied to O.D. of duct per SB 74L05. Inner duct and fairing assembly was grit blasted to clean. H-blocks and strut rods were cleaned and anti-galled. Installed overhauled #6 seals liner.

Corrected exhaust case run outs.

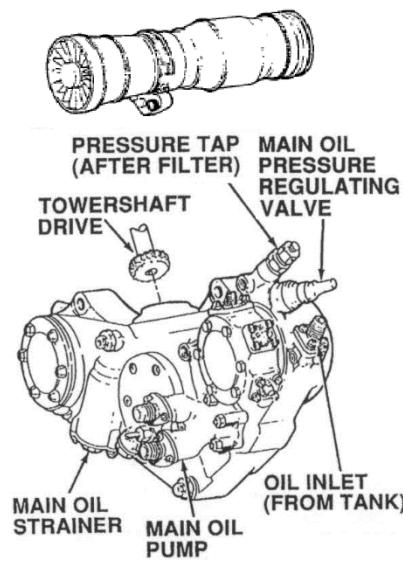
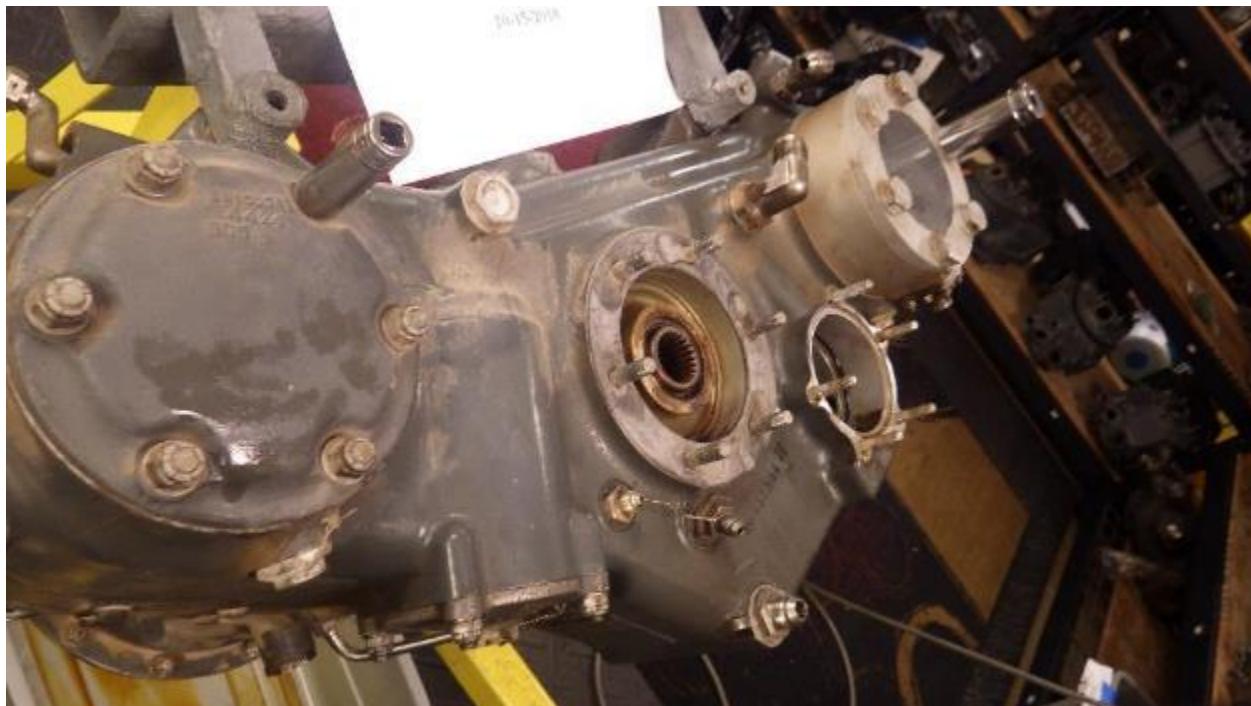
2-4-1 through 2-4-5

Findings: Gearbox was split and gears and bearings were inspected with no findings. Main oil pump 3 drive gears have wear on the journals. Scavenge housing has scored walls. Strainer was inspected with no findings.

Conducted: Gearbox case was split open flushed and inspected. Replaced carbon seals with new parts. Main oil pump 3 drive gears had the journals restored. Scavenge housing was E-poly repaired. Strainer was cleaned and reassembled.

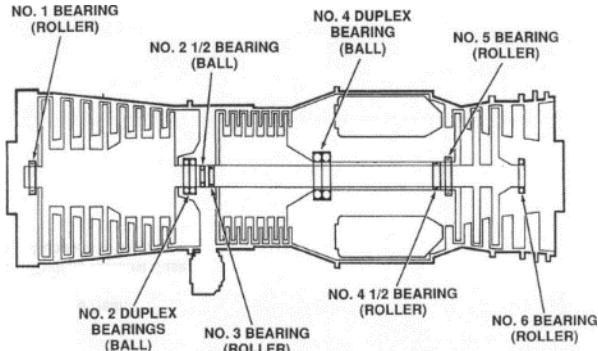
- #1 Oil damp bearing inspected with no findings
- #2 Bearing inspected with no findings
- #2.5 Bearing inspected with no findings
- #3 Bearing had scored rollers
- #4 Bearing inspected with no findings
- #4.5 Bearing inspected with no findings
- #5 Bearing had a small portion of one of the rollers missing.
- #6 Non oil damp bearing inspected with no findings

- #1 Oil damp bearing overhaul inspected. Two seal rings for oil damp bearing were replaced
- #2 Bearing overhaul inspected.
- #2.5 Bearing overhaul inspected
- #3 Bearing replaced.
- #4 Bearing overhaul inspected.
- #4.5 Bearing overhaul inspected
- #5 Bearing overhaul inspected.
- #6 Non oil damp bearing overhaul inspected.
