Oklahoma Gas and Electric

ESN: 675498

Shop Report

Model: GG4A-9

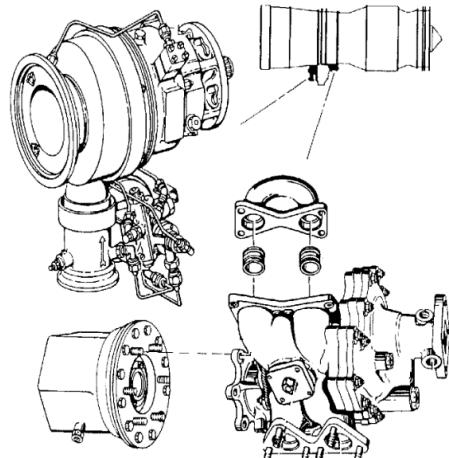
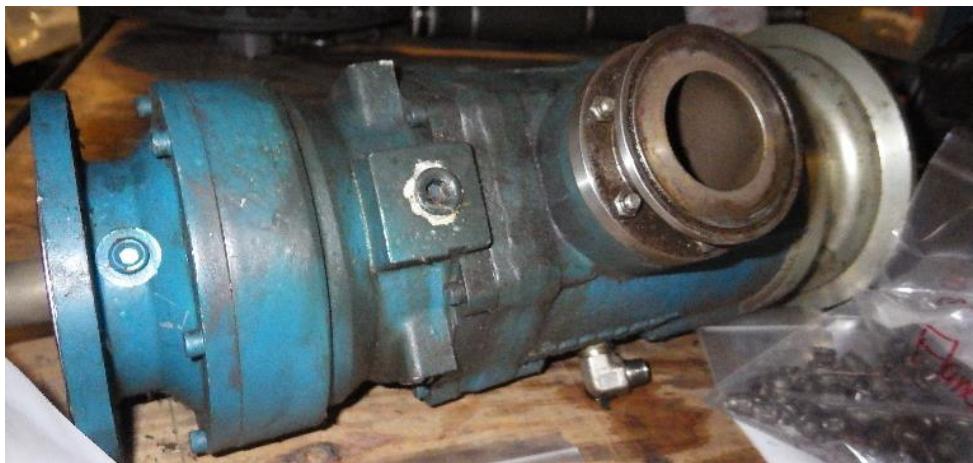
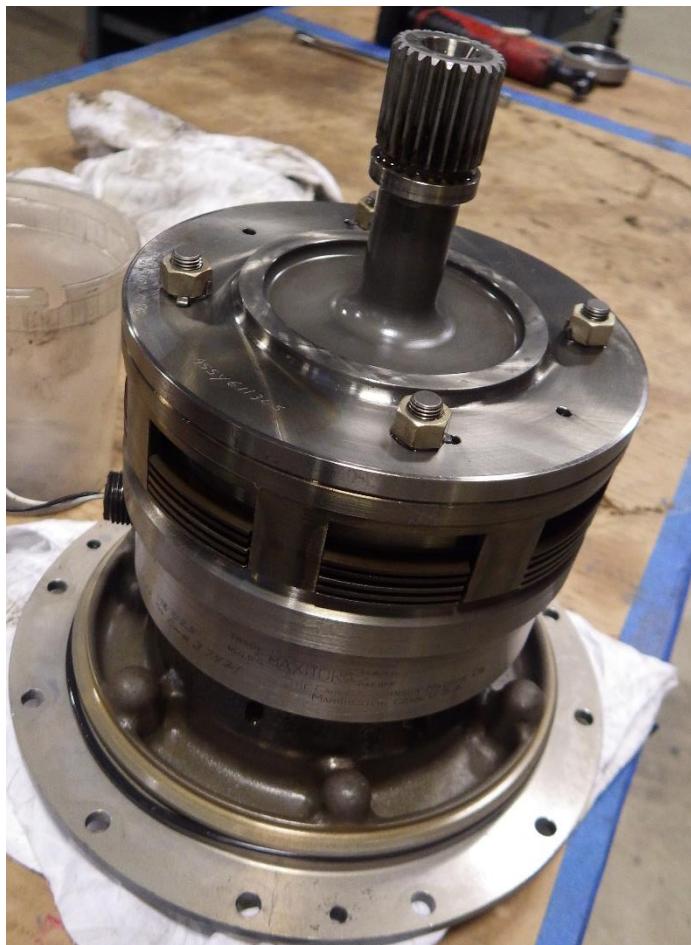
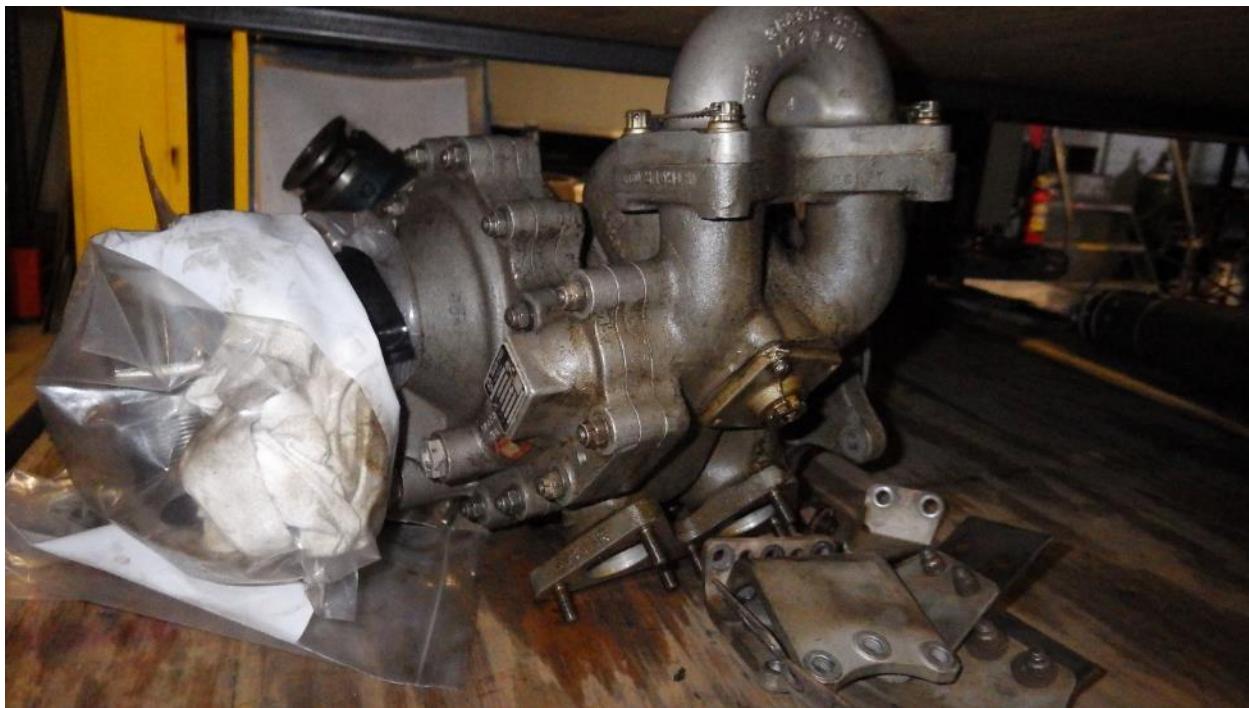
Starter, Fuel Pump and Clutch 2-1-3 fig. 4

Findings: TDI starter had no visible damage and passed function test. Fuel pump was disassembled and replaced the internal packings. No other visible damage to fuel pump. Clutch had a bad bearing which caused the drive shaft to have play side to side. Clutch housing had coating loss.

Conducted: Starter was serviced and installed back onto the engine. Fuel pump was disassembled and inspected then the packings were replaced. Pump was assembled and pressure tested. Pump was used to run engine at test cell. Painted fuel pump. Replaced bearing in clutch. Clutch pack was energized and torqued tested prior to assembly. Painted clutch housing.

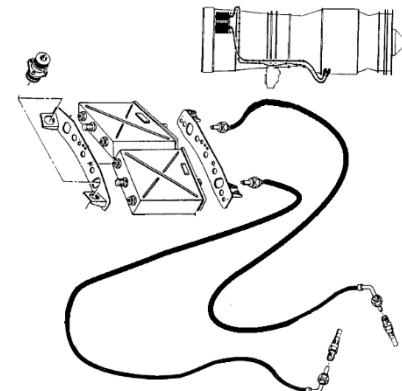
Ignition System 2-1-5 & 2-1-6 fig. 1

Findings: Igniter boxes were tested and found to be in serviceable condition. Cables were tested and both sides worked.

Conducted: Igniter boxes passed function test and were used at the test cell to start and run the engine. Ignitor cables passed function test and were used at the test cell to start and run the engine.

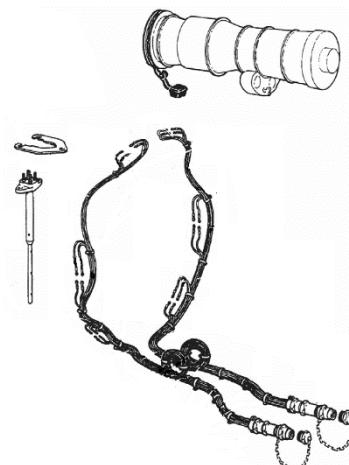
Thermocouple System 2-1-7 fig. 1

Findings: Thermocouples were function tested and found to be in serviceable condition. Cables were not received with the engine.

Conducted: Thermocouples passed function test and were used on run the engine during test.

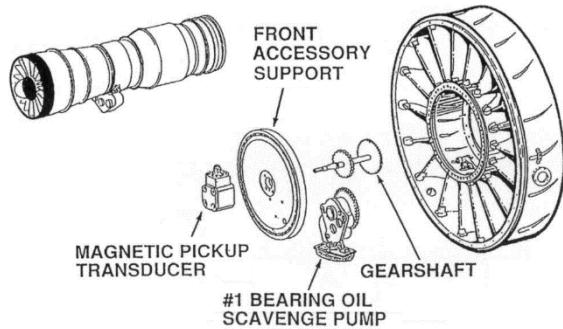
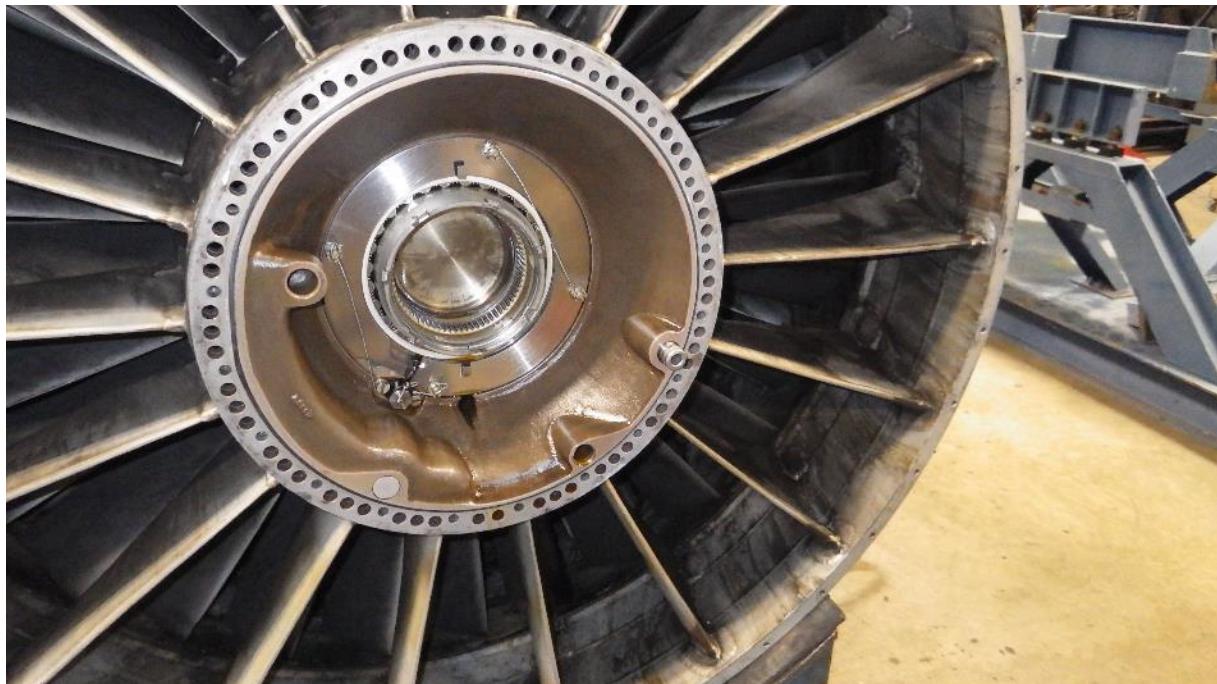
Inlet Case & #1 Housing Area 2-2-1 fig. 1

Findings: Front accessory dive was inspected with no findings. Oil scavenge pump spins freely with no binding. Transducer passed OHM check. N1 tach cable wires need to be extended. Inlet case had coating loss.

Conducted: Front accessory dive was cleaned and reassembled. Oil pump was cleaned and assembled. Transducer was OHM checked. Replaced N1 tach wires. Inlet case was stripped, NDT inspected and coated.

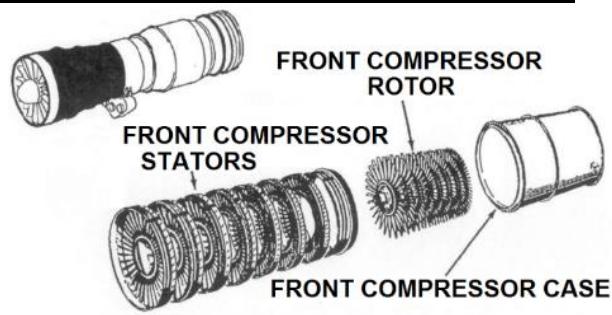
Low Pressure Compressor Rotor Package

corrosion on all LPC spacers. Snap fits to disk were good.

Blades C-1 to C-8 – Blades C-1 to C-4 require cleaning and inspection. Blades C5 to C-8 have coating loss and minor pitting. No visual indication of any blade tips rubbing.

Tierod nuts should be cleaned and plated.

LPT coupling has coating loss.

Findings: LPC Case – Coating loss.

C-8 duct – Coating loss.

Stators – All stators have coating loss and corrosion.

Disk C-1 to C-8 and rear hub – Coating loss and corrosion. LPC rear hub has service bulletin 475 performed.

Spacers 1-2 to 7-8 – Coating loss and

Conducted: LPC case – Stripped, inspected and coated.

C-8 duct – Stripped, inspected and coated.

Stator –Stator C-1 to C-7 were stripped, NDT inspected and coated.

Disk C-1 to C-8 – C-1 to C-4 disk were stripped, NDT inspected, and cadmium plated. Disk C-5 to C-8 and rear hub were stripped, NDT inspected and coated.

Spacers – Stripped, NDT inspected, and coated.

Blades C-1 to C-8 – Blades C-1 to C-4 were cleaned, blended, NDT inspected and replaced bumpers. Blades C-5 and C-8 were cleaned, NDT inspected and coated.

Tierods – Front and rear tierods were cleaned and dimensionally inspected. Tierod nuts were stripped and plated.

LPT coupling – Restored plating on coupling, lock, and lock plate

Rebuilt rotor and check balanced.

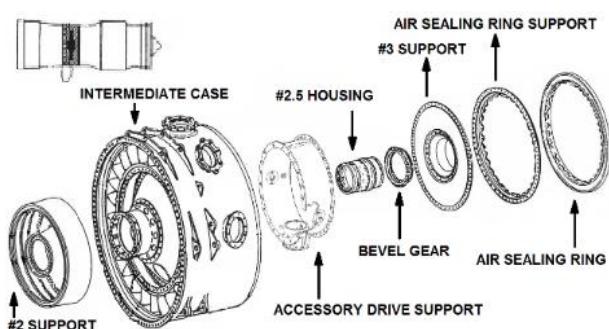
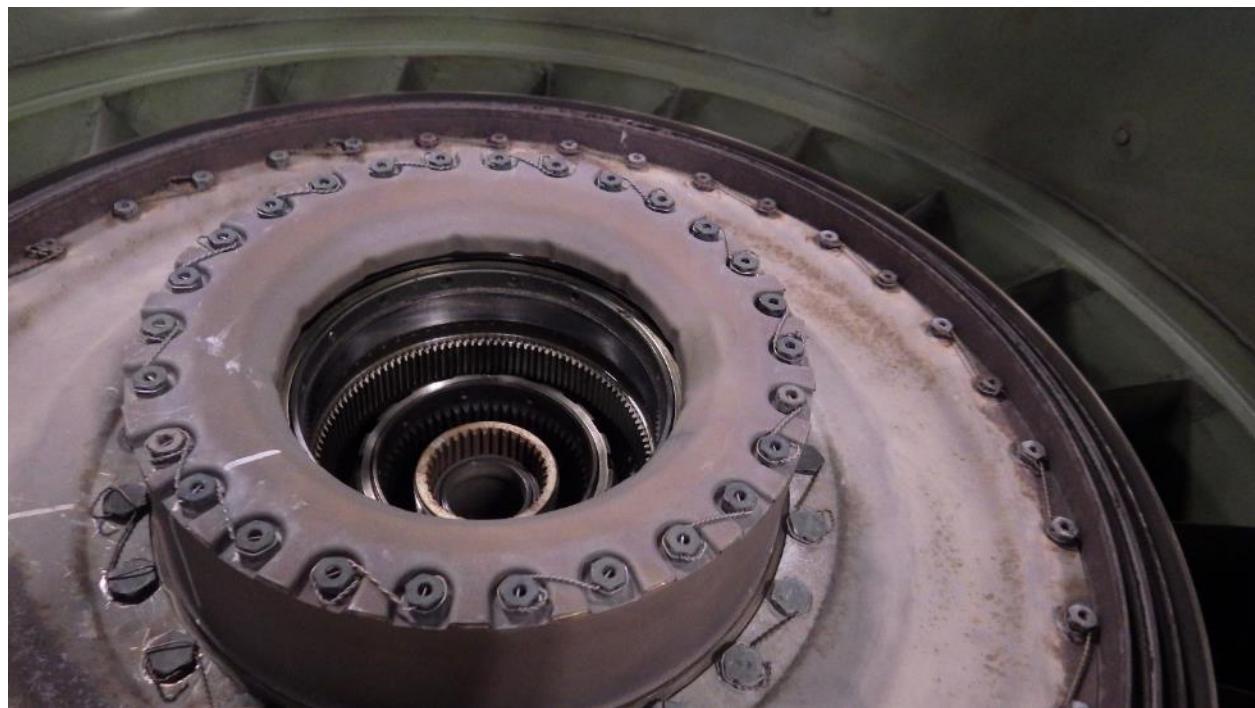
Intermediate Case & #2 Support 2-2-7 fig 1

Findings: Intermediate case had coating loss.

Gearbox mount bushings were in a good condition. #2 support has coating loss. #3 support and air sealing rings had no damage. #2.5 housing the chrome sealing surface was worn. Bevel gear need the silver plating restored.

Conducted: Intermediate case passed pressure

tested. Case was then stripped, NDT inspected and coated. #2 support was stripped, NDT inspected and coated. #3 support and air sealing rings were blasted to clean and inspected prior to assembly. #2.5 housing had the chrome plating restored. Restored silver plating on bevel gear.

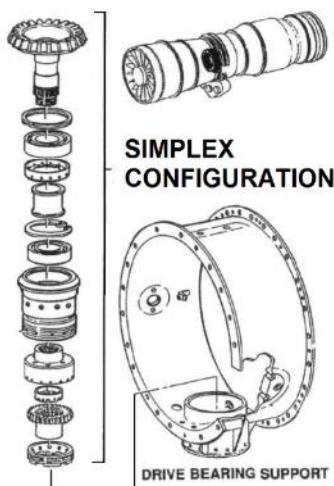
2-2-8 fig. 1

Initial Scope: Simplex configuration: inspect and report findings
Findings: Accessory drive housing and bushing were dimensionally inspected to check for proper fit per service bulletin 97B03. Replace both tower shaft bearings. Remaining parts were inspected with no visible damage found.

Conducted: Accessory drive housing and bushing were dimensionally inspected and had the proper fits per service bulletin 97B03. Upper and lower tower shaft bearings were replaced. Remaining parts were cleaned and inspected prior to use.

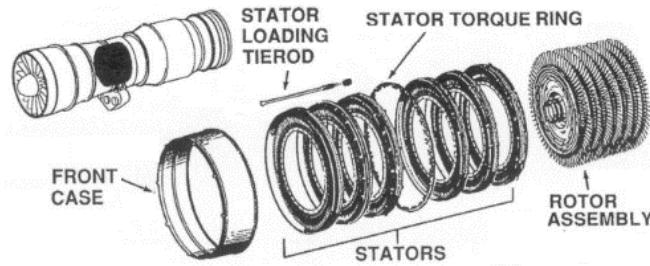
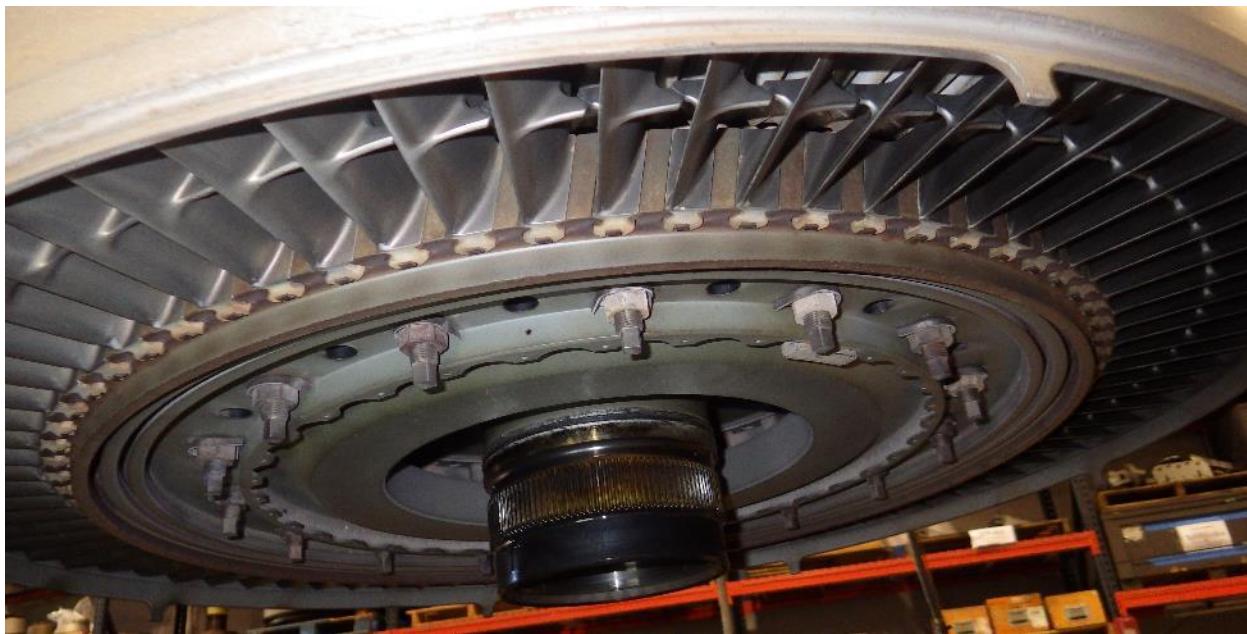
Package 2-3-1 fig 1 / 2-3-2 fig 1

Findings: HPC case – Case had coating loss. Stators – C-9 to C-14 stators have coating loss but vanes do not have signs of foreign object damage or blade tip rubs. Torque ring has no broken bolts. Tiestraps were removed and inspected with no damage found.

Disk – C-9 to C-12 disk have coating loss. C-10 hub is Fat 10 configurations. C-10 hub requires silver flash on the splines and the land. Disk C-13 to C-15 have no visible damage. Rear hub has no damage, but the center bellows tube is undersized at fits to hubs.

Spacers – 9-10 to 11-12 have coating loss. Spacer 12-13 to 14-15 require cleaning and inspection. Snap fits to disk were loose and require plasma spray and final machining to restore to proper size. Blades – C-9 blades are skinny midspan configuration. C-9 blades are loose due to having worn midspans. C-10 blades are a fat 10 configuration. C-10 to C-15 blades all require overhaul to include coating of stages C-12 to C-15.

Conducted: HPC case – Stripped and recoated.

Disk – C-9 to C-12 disk were stripped, NDT inspected and recoated. Disk C-13 to C-15 were cleaned and NDT inspected. Rear hub and center tube were cleaned and inspected. Center tube had the fits to the hubs restored to proper size.

Stators – C-9 to C-14 stator were stripped, NDT inspected and coated.

Spacers – Restored snaps to achieve proper fit to disk. 9-10 to 11-12 were stripped, NDT inspected and recoated. Spacer 12-13 to 14-15 were cleaned and inspected.

Blades – C-9 blades were overhauled including weld repair on midspan. C-10 to C-15 blades were overhauled. Stages C-12 to C-15 were recoated.

Tierods – Were dimensionally inspected and the threads were anti galled.

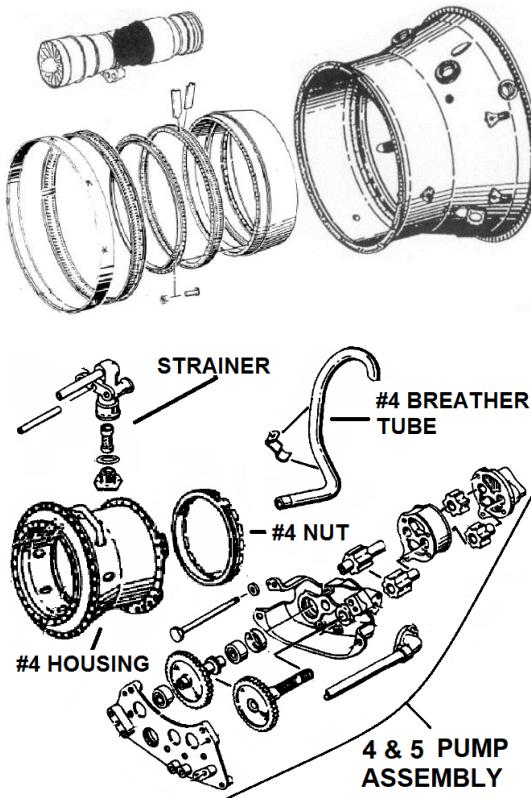
2-3-3 fig 1 / 2-3-5 fig 1 / 2-3-6 fig 1

Findings: Diffuser case has coating loss and was visually inspected with no cracks found at the struts. Case did not show sign of leaking from the breather ports. C-15 stator was found to have coating loss on the vanes. No FOD was found on the C-15 stator vanes. C-15 stator seat has coating loss. Pump was inspected with no findings and pump spun freely with no binding. #4 housing was visually and dimensionally inspected with no findings. Strainer was cleaned with no findings. Breather tube had no cracks.

Conducted: Case was stripped, pressure tested sump with no leaks found. Case was then NDT inspected, then coated. Strip and coat C-15 stator and seat. Pump was cleaned and installed back on engine. #4 housing passed dimensional inspection and was installed in the engine. Installed cleaned strainer on engine. Cleaned breather tube prior to assembly.

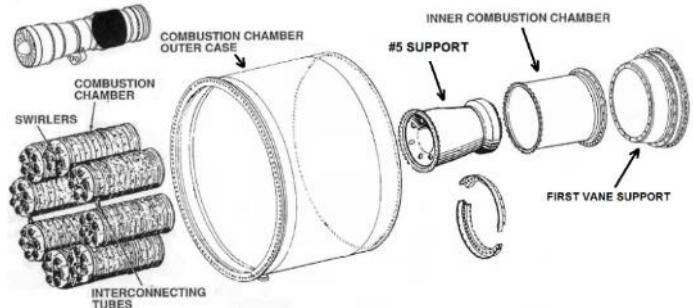
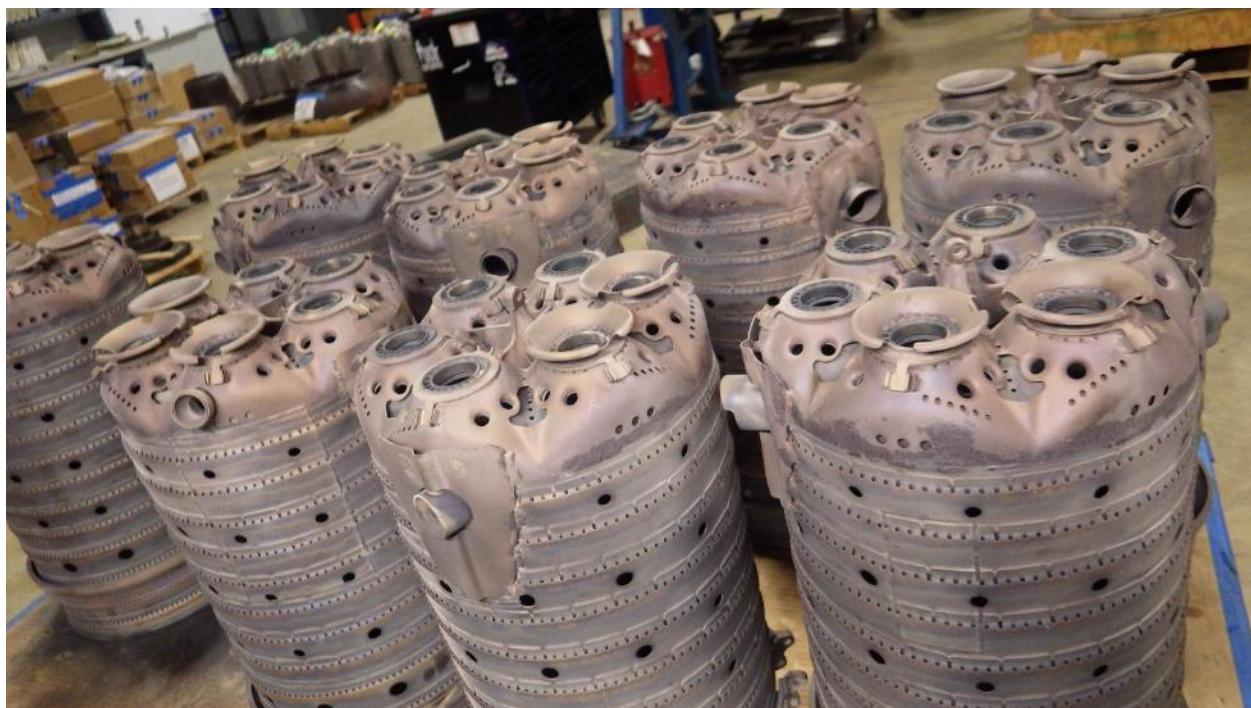
2-3-7 fig 1

Initial Scope: Inspect and report findings.
Findings: Outer combustion case has coating loss. The number 1, 3, 6, and 5 combustion chambers all require weld repair and cleaning. The remaining five combustion chambers each require cleaning. Combustion chamber clamps were inspected with no findings. Inner combustion case was inspected with no findings. #5 support passed pressure test. Half moon heatshields were both cracked and had coating loss. 1st vane support all 12 vane segment seats were worn.

Conducted: Outer combustion case was stripped and coated. Combustion chambers were weld repaired as required and grit blasted to clean. Inner combustion case was cleaned and inspected. #5 support passed pressure test and was grit blasted to clean. Half moon heatshields were both weld repaired and coated per SB 73B36. 1st vane support replaced all 12 vane segment seats and tack welded.

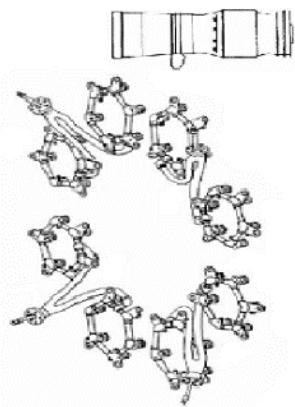
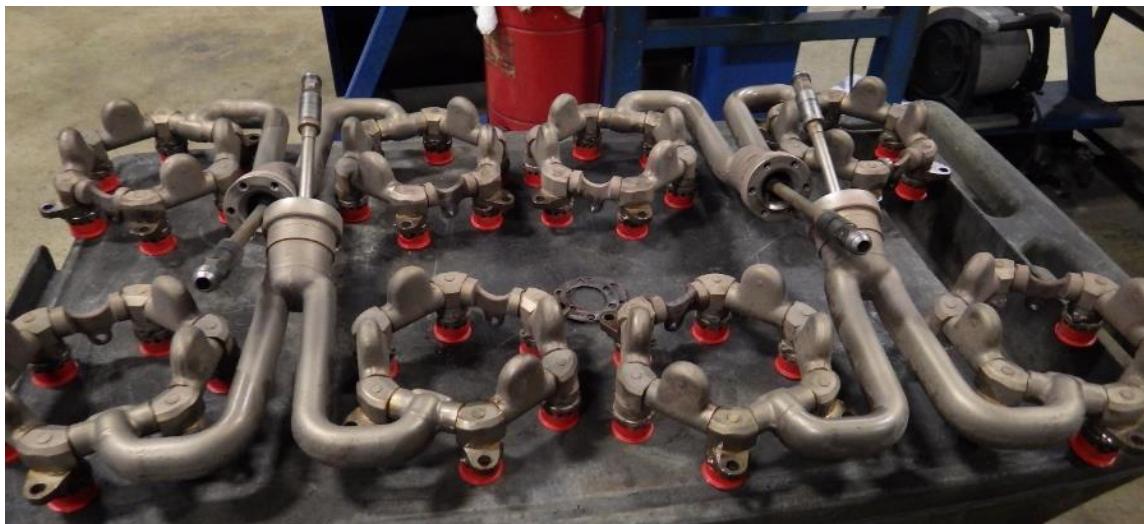
Fuel Manifolds 2-4-8 fig 3

Initial Scope: Engine had dual fuel manifolds installed. Flow check.
Findings: Performed initial flow and pressure test. Bodies passed pressure test but failed flow test. Manifolds were disassembled to clean bodies and all nozzle components.

Conducted: Fuel manifolds bodies were grit blasted to clean. Bodies were ultrasonic cleaned and flushed. Fuel nozzles were ultrasonic cleaned and individually flow tested to eliminate streaks and obtain proper cone angle. Nozzles were remapped and installed and bodies were flow tested. Manifolds were installed in engine after test.

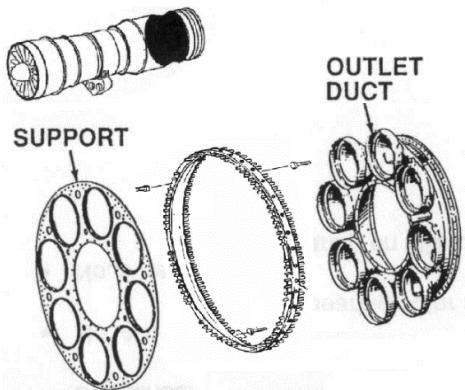
2-3-9 fig 1

Findings: T-duct is a split configuration. Loss of Mag Zirc coating, minor cracks noted. T-duct plate and bolt ring were inspected with no findings.

Conducted: T-duct has been stripped, weld repaired, and recoated with Mag Zirc. T-duct plate and bolt ring had no repairs performed.

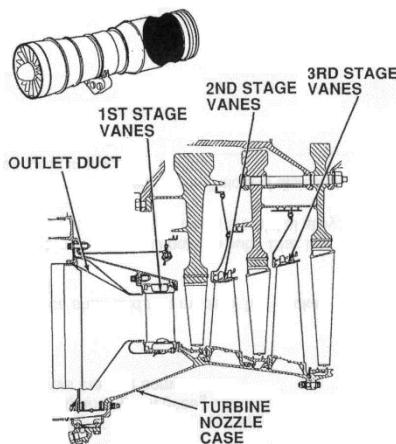
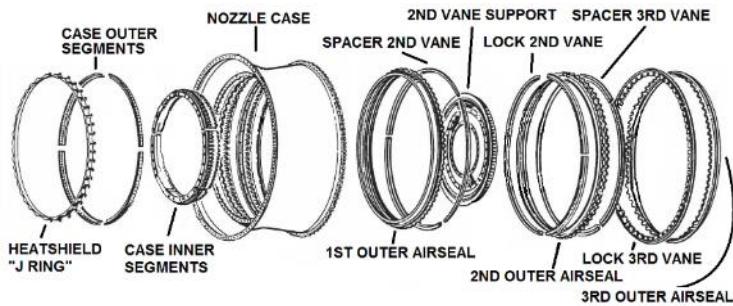
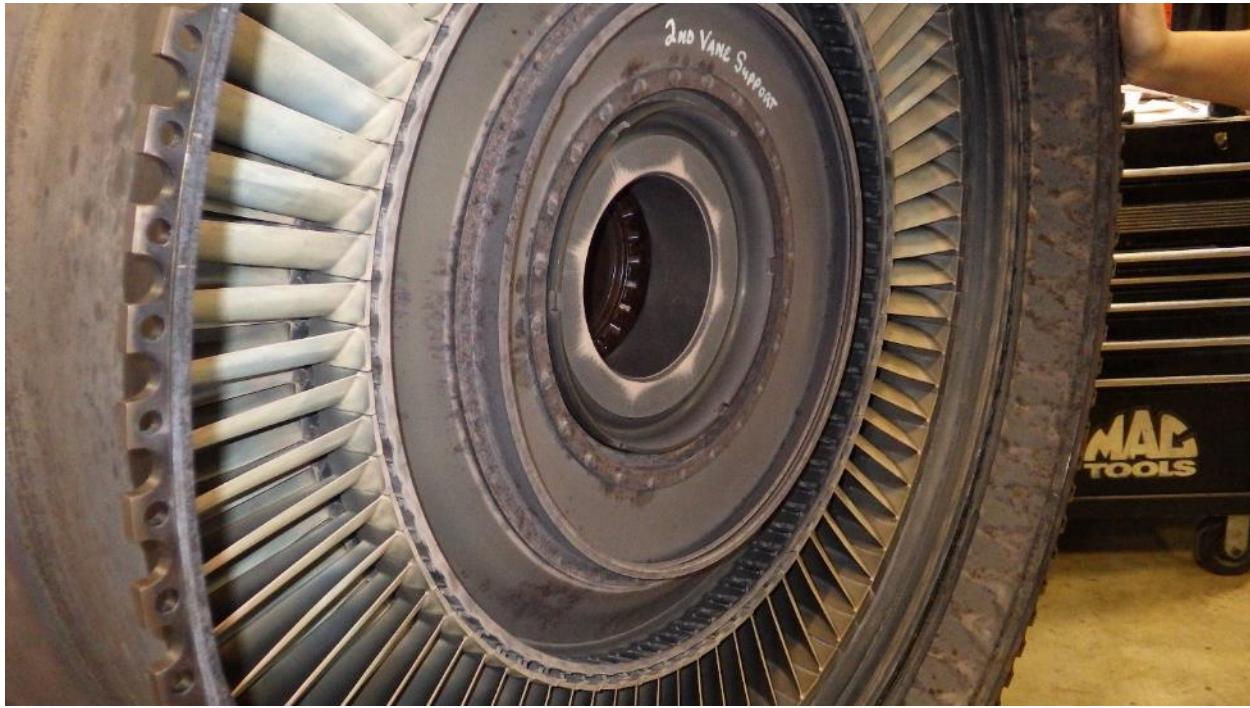
Nozzle Guide Vanes 2-3-11 fig 1

Findings: 1st stage vanes had some bowing to the airfoil.

2nd stage vanes recommend to overhaul vanes.

3rd stage vanes recommend to overhaul vanes.

Conducted: 1st stage vanes were sent out for overhaul. Issued overhauled T-1 vanes from Sulzer stock.

2nd stage vanes were sent out for overhaul. Issued overhauled T-2 vanes from Sulzer stock.

3rd stage vanes were sent out for overhaul. Issued overhauled T-3 vanes from Sulzer stock.

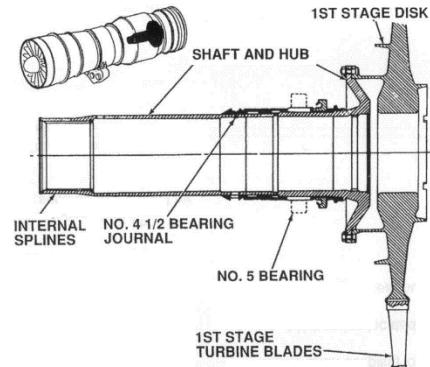
High Pressure Turbine Rotor 2-3-12 fig 1

Findings: Disk and shaft were inspected with no findings. T-1 blades and a Fat notch configuration. Overhaul T-1 blades.

Conducted: Cleaned and inspected HPT disk and shaft.

T-1 blades were sent out for overhaul.. Issued overhauled T-1 blades from Sulzer stock.

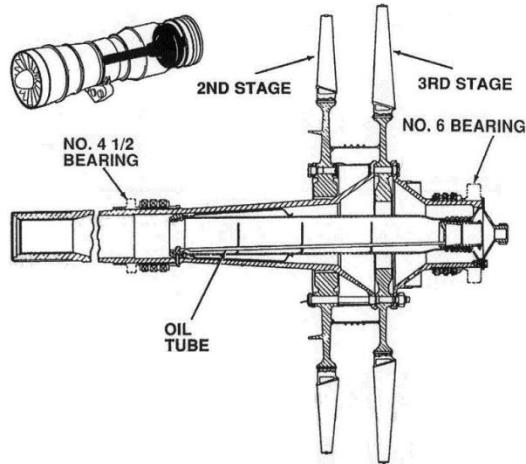
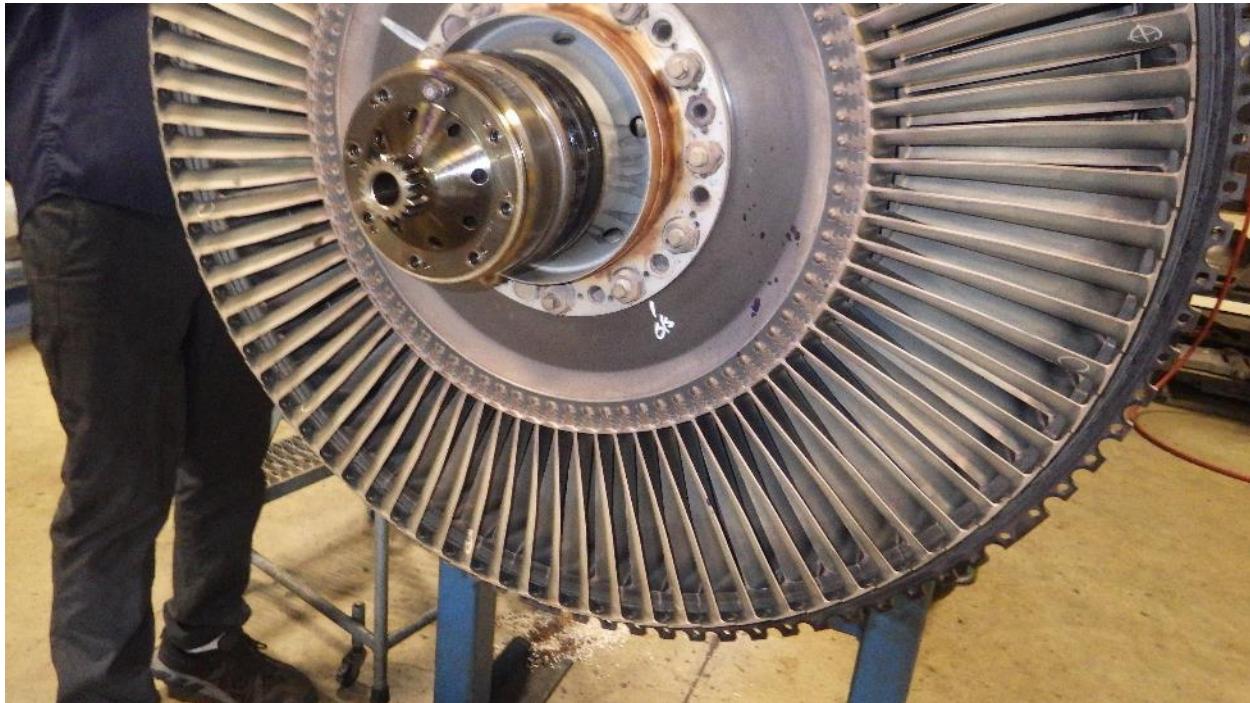
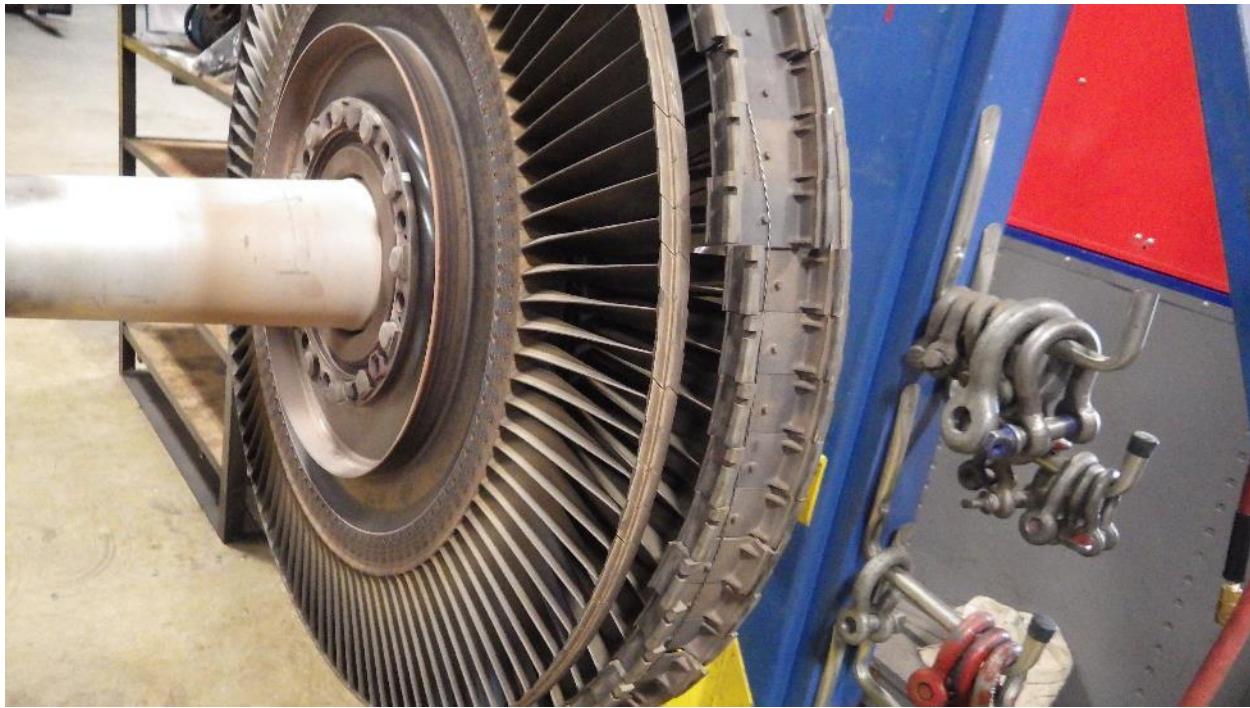
2-3-13 fig 1

Findings: 2nd blades require overhaul. 3rd blades require overhaul. LPT shaft has coating loss. Rear hub has coating loss and requires heli-coil replacement for four counterweight holes. 2nd and 3rd stage disk were cleaned and inspected with no findings. Inner airseal had no damage to the knife edges and the snap fits were a good fit to the disk. 3rd vane support was inspected with no findings. Tierod ring and support spacer were inspected with no findings. Tierods were visually and dimensionally inspected with no findings.

Conducted: T-2 blades were sent out for overhaul.

Issued overhauled T-2 blades from Sulzer stock. T-3 blades were sent out for overhaul. Issued

overhauled T-3 blades from Sulzer stock. LPT shaft and rear hub were both stripped, inspected and coated. The rear hub also had four counterweight holes heli-coiled repaired. Turbine disk were both cleaned and inspected. Inner airseal was stripped and coated. 3rd vane support was cleaned and inspected. Tierod ring and support spacer were both cleaned and inspected. Tierods were dimensionally inspected and anti-galled.

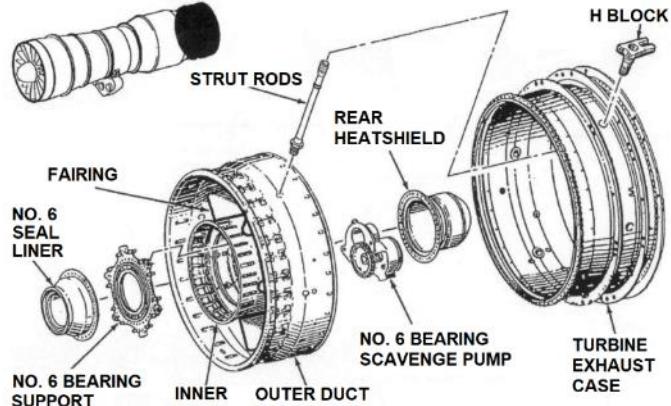
2-3-11 fig 1

Findings: Case had hard face plasma loss on the I.D. and the O.D. Outer duct had no damage but did have hard face coating loss. Inner duct and fairing were inspected with no cracks found. H-blocks were inspected with no findings. Inner, center, and outer strut rods had wear on the land surfaces. #6 N.O.D. seals liner was worn. #6 pump was inspected with no findings and pump spun freely with no binding.

Conducted: Exhaust case was grit blasted to clean and then had plasma band applied to outside of case per SB 71B26. Also applied plasma to I.D. of rear of case per SB 74L05. Outer duct was grit blasted to clean then had plasma band applied to O.D. of duct per SB 74L05. Inner duct and fairing assembly was grit blasted to clean. H-blocks were cleaned and applied anti gallant during assembly. Inner, center, and outer strut rods had the worn land surfaces plasma sprayed and machined to size. Applied anti gallant to strut rods during assembly. Installed overhauled #6 N.O.D. seals liner. #6 pump was cleaned and installed back on engine.

Exhaust case was reassembled and run outs were corrected.

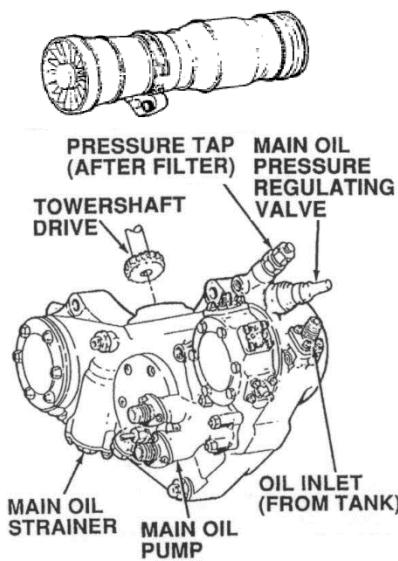
2-4-1 through 2-4-5

Findings: Gearbox was split, and gears and bearings were inspected with no findings. Main oil pump 2 drive gears have wear on the journals. Scavenge housing had scored walls. Strainer was inspected with no findings.

Conducted: Gearbox case was split open flushed and inspected. Replaced carbon seals with new parts. Main oil pump 2 drive gears had the journals restored. Scavenge housing was E-poly repaired. Strainer was cleaned and reassembled. Gearbox was stripped and coated.
