STI External Inspection Report

FACILITY: ADM-Fort Collins Rodelle Facility		FLOC #: 403377240	SAP EQUIP #: 3820361
EQUIPMENT #: 0300-TK-09	DESCRIPTION: Large Mix Tank (0300-TK-09)		
DESIGN CODE: ASME Sec. VIII Div.1	MFG.SN #: 861029	NATL BRD #:	P&ID #:
TYPE OF INSPECTION		INSPECTOR(S)	INSPECTION DATE
<input checked="" type="checkbox"/> - EXTERNAL <input checked="" type="checkbox"/> - UT SURVEY <input type="checkbox"/> - INTERNAL		Levi Whitney # 84647	3/20/2024

API 653 Low Pressure Storage Tank Report For:
Equipment No.: Large Mix Tank

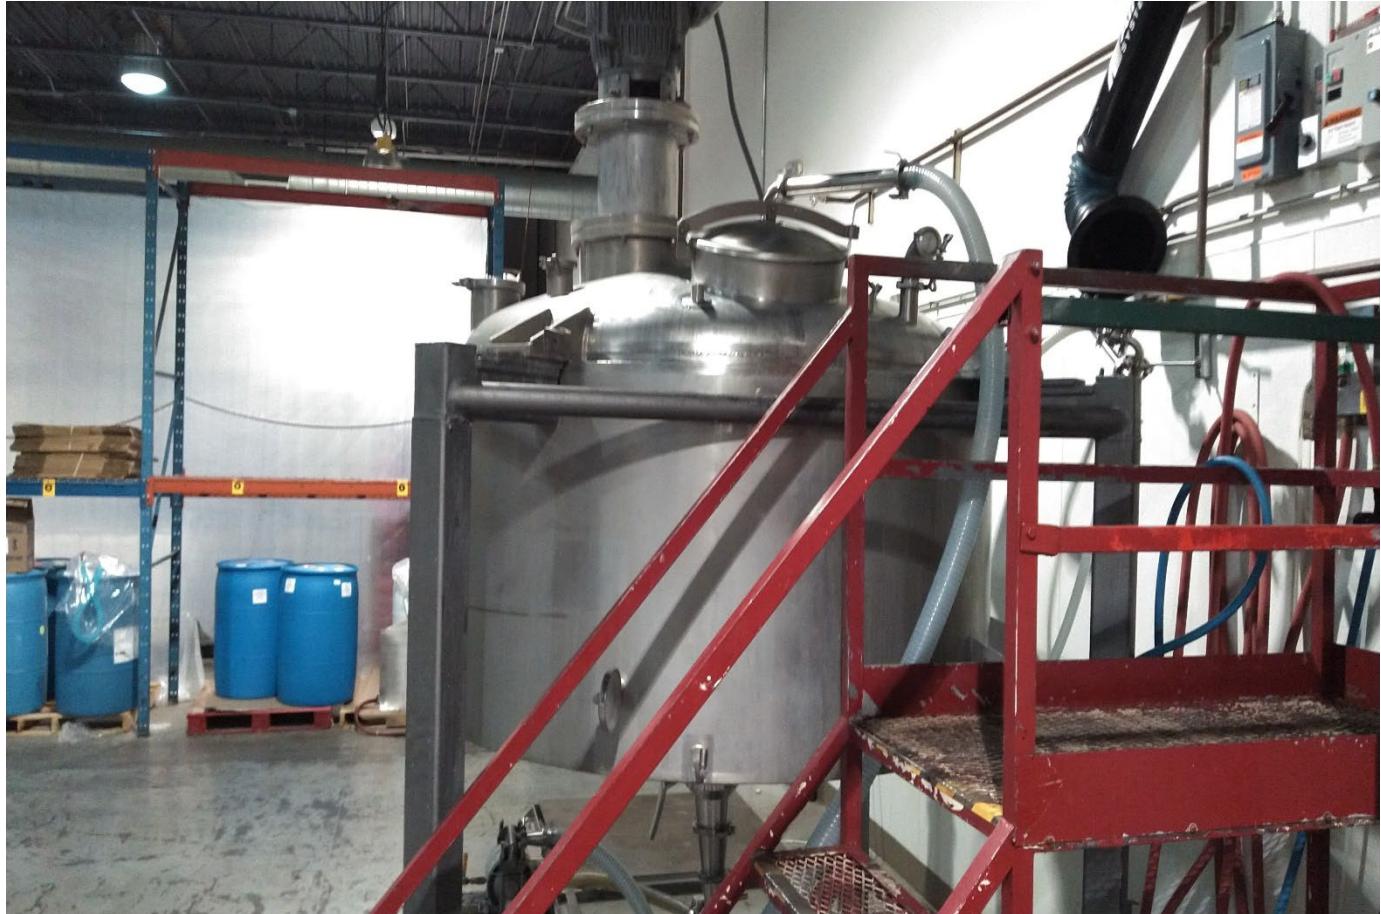
Equipment Overview Picture.

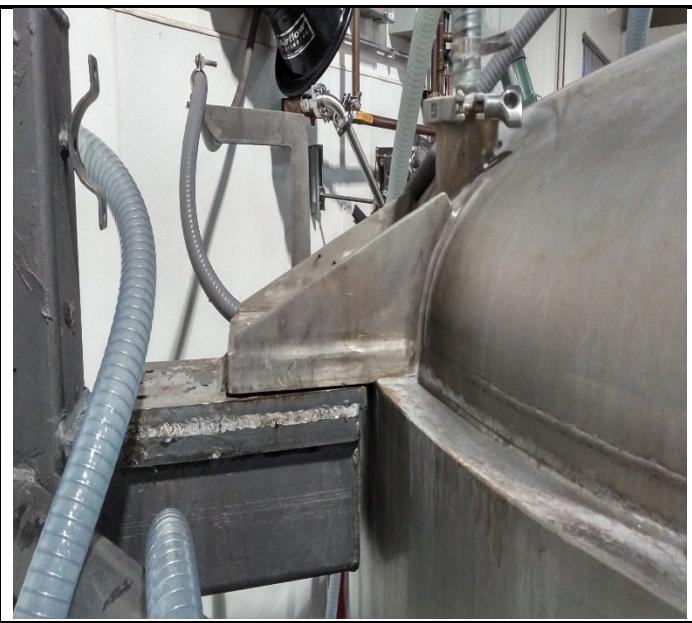
4.	Anchor Bolts & Supports	1 <input type="checkbox"/>	2 <input checked="" type="checkbox"/>	3 <input type="checkbox"/>	4 <input type="checkbox"/>	5 <input type="checkbox"/>		Stainless steel tank welded to carbon steel frame support. Dissimilar metal welds on equipment are considered to be an acceptable company practice

Tank welded to carbon steel frame	Gauge

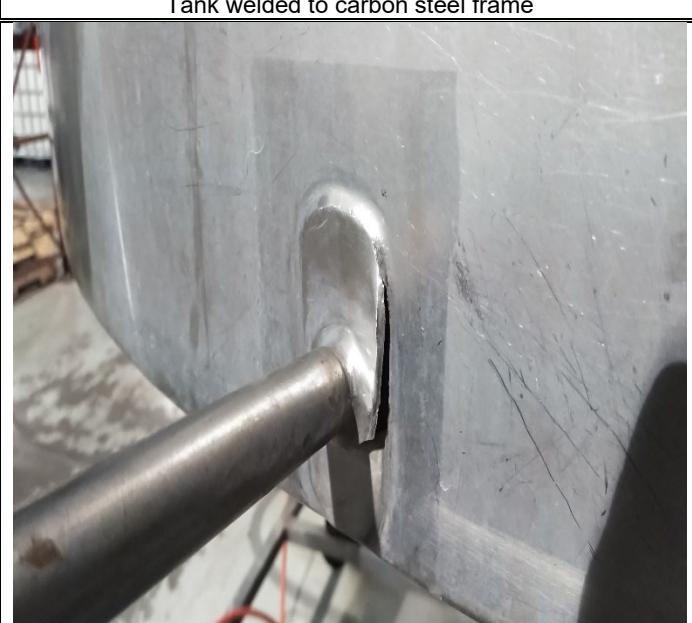
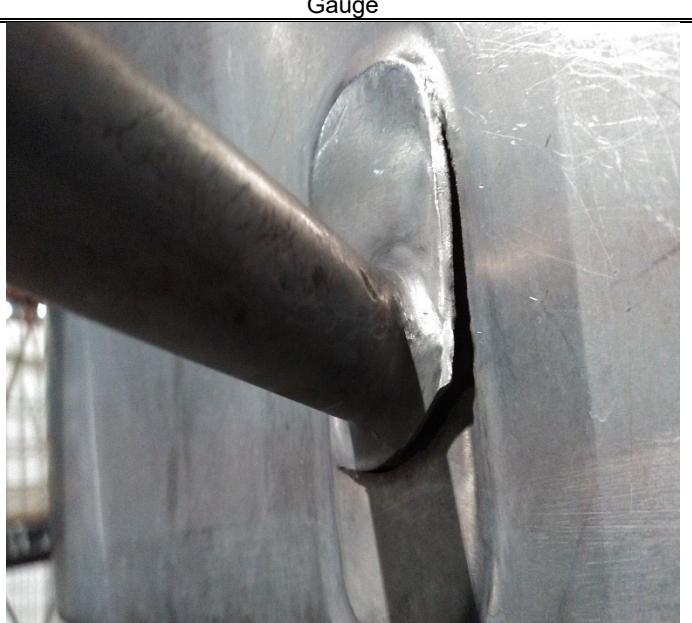
7.	Shell	1 <input type="checkbox"/>	2 <input type="checkbox"/>	3 <input type="checkbox"/>	4 <input checked="" type="checkbox"/>	5 <input type="checkbox"/>	DA	Heavy mechanical damage at tank shell handle. Metal has been peeled back on jacketing. Not detrimental to the normal service of the tank.

7. **Shell:** Heavy mechanical damage at tank shell handle. Metal has been peeled back on jacketing. Not detrimental to the normal service of the tank.

Jacketing handle mechanical damage	Jacketing handle mechanical damage

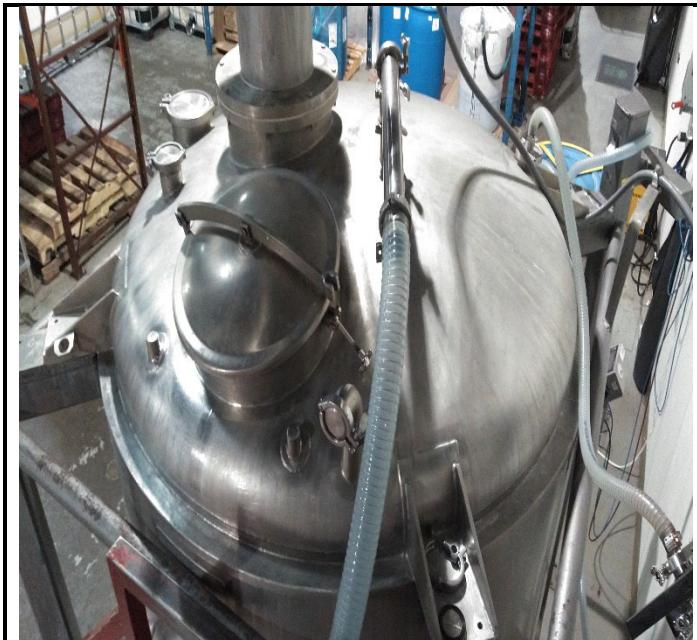
6.	Top Head	1 <input type="checkbox"/>	2 <input checked="" type="checkbox"/>	3 <input type="checkbox"/>	4 <input type="checkbox"/>	5 <input type="checkbox"/>		No signs of mechanical damage or bulging throughout the head. Circ welds appear to be full profile with no adverse conditions.

Tank top head

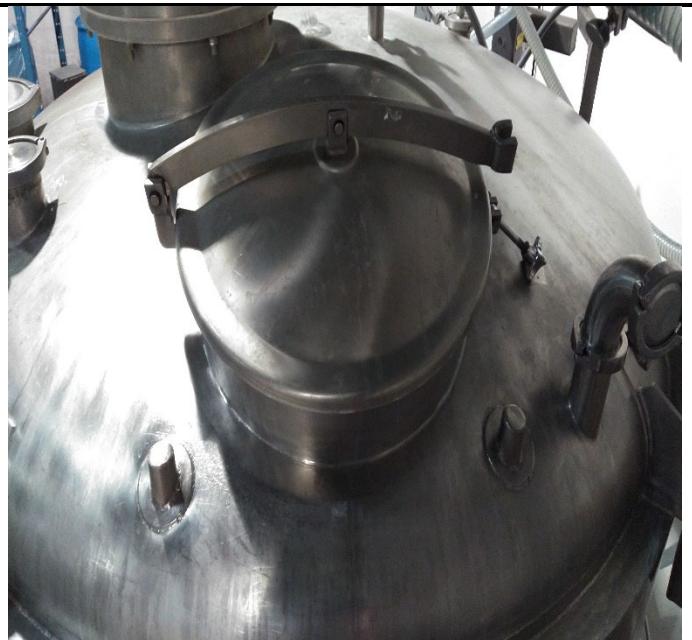
Top head hatch
