**1st Stop Auto Care Centers**

Inspection Report

2017 FORD F150 King**Ranch**VIN: 1FTFW1EG6H~~K~~**C27651**

Pre-Buy Inspection

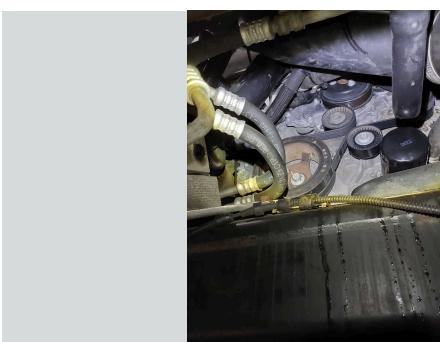
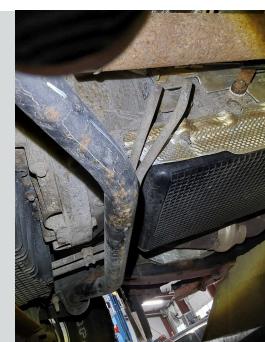
Attachments- 2

Brakes	ABS System Check	CHECKED & OK
Underhood	Brake Fluid	CHECKED & OK
	Color is good	
Underhood	Transmission Fluid	CHECKED & OK
Underhood	Engine Coolant	CHECKED & OK
	Added a little coolant to max line.	
Underhood	Power Steering Fluid	CHECKED & OK
Underhood	Washer Fluid	CHECKED & OK
Underhood	Major Leaks	CHECKED & OK
	Vehicle is dry underneath.
