2016 PETERBILT 337 | 2XP2AJ7X8GM348770

Specifications

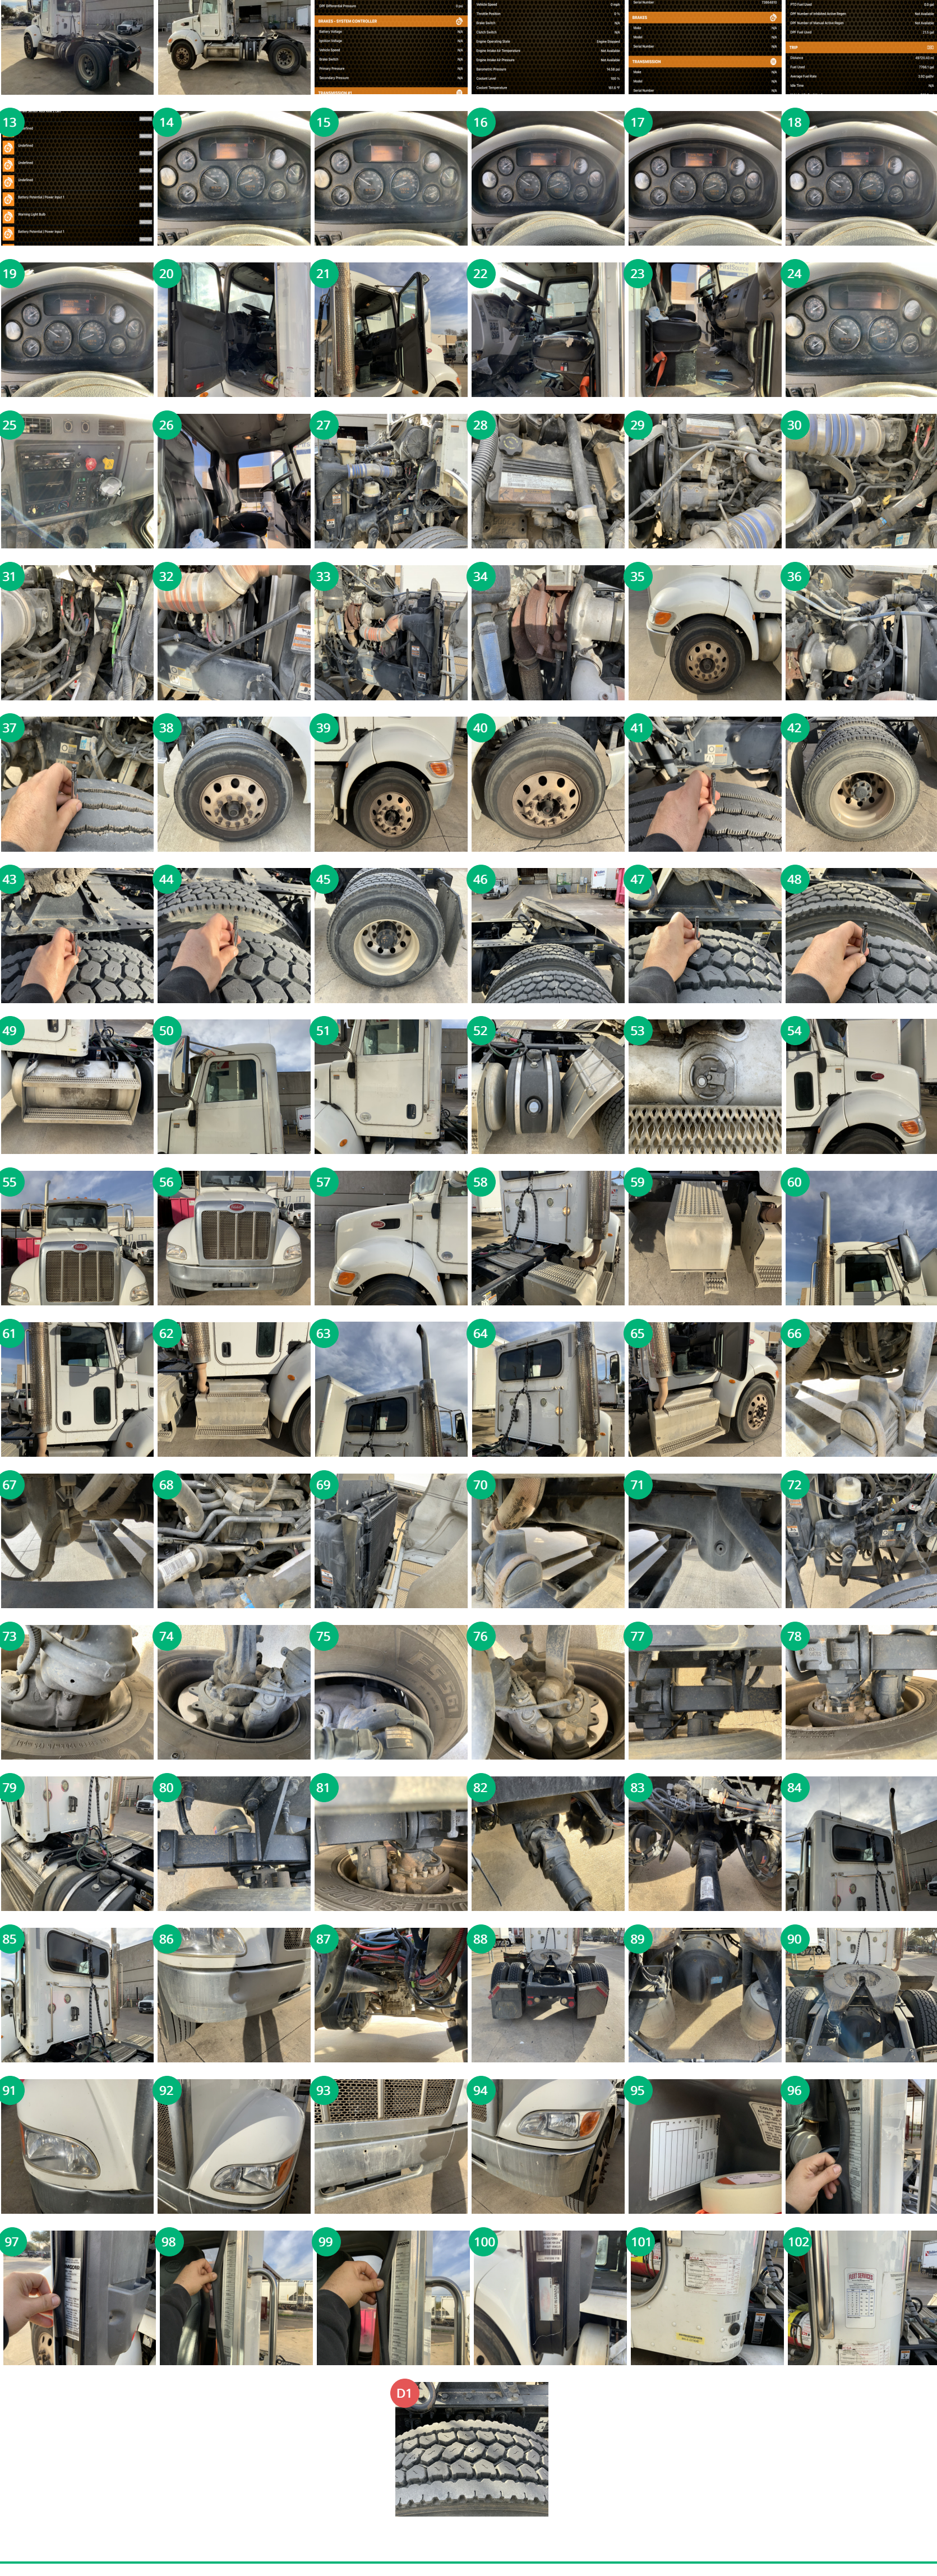
Photos

| Issue # | Check | Comment | Photo |
|---|---|---|---|
| D1 | Tires | Drive axle driver outside has nail on tire | |
