OKLAHOMA GAS & ELECTRIC
MUSTANG/TINKER STATION
5A GENERATOR ROTOR REWIND
FALL 2011 OUTAGE
Document No. 11G799

Prepared by
Nick Spanoudakis
and
Josh Schweinsberg
Generator & Motor Services, LLC

BGMS GENERATOR ROTOR REWIND REPORT
for
OKLAHOMA GAS & ELECTRIC
Mustang/Tinker Unit 5A Generator

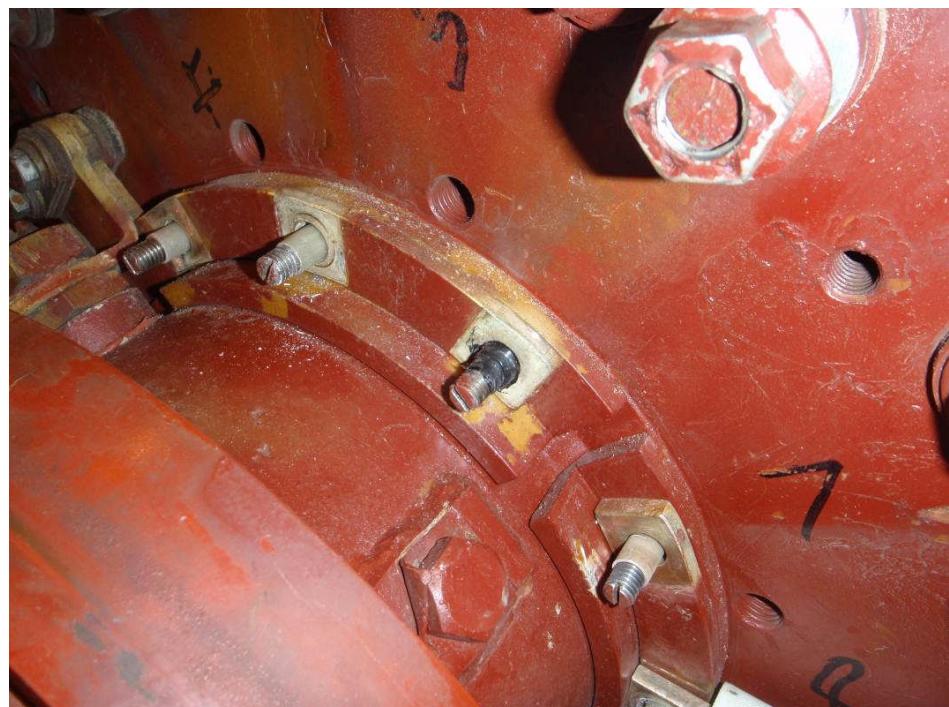
- General condition of the exciter appeared to be acceptable for reconditioning. See Appendix A, Figure 1
- During disassembly of the diode wheel, the insulating bushing around the bolt for the #6 fuse was found to be missing. The insulation had been replaced by wrapping the bolt in electrical tape. See Appendix A, Figure 2. *BGMS recommended replacing all insulating components.*

Figure 2: Missing Insulating Bushing; Replaced with Electrical Tape

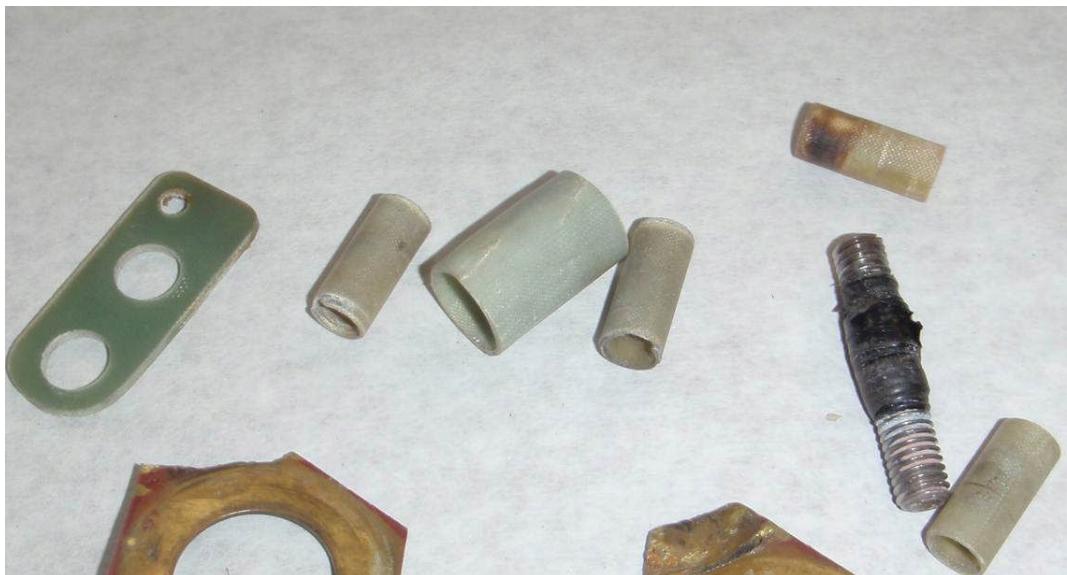
- Many of the insulating components for the diode wheel hardware were found to be poor condition. See Appendix A, Figure 3. *BGMS recommended replacing all insulating components.*

Figure 3: Worn Insulating Components

- After machining, NDE tests were repeated to ensure that all indications found on tooth tops had been removed.
- All diode wheel insulating components were replaced.

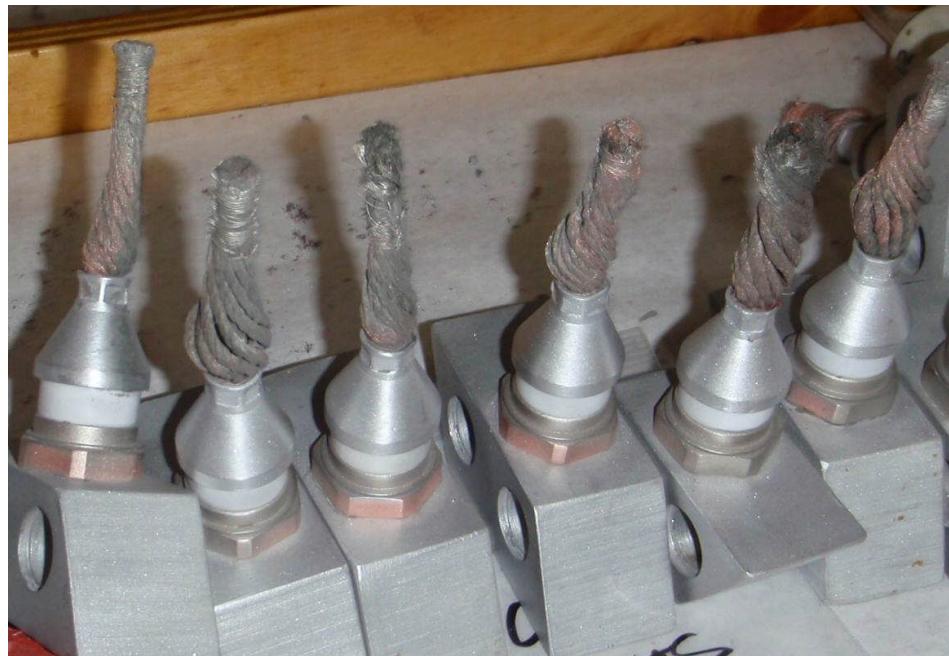
- All twelve diodes were found to be in poor condition. The ends of the flexible connectors were most likely trimmed, twisted to reduce overall length and then tied with wire (see Appendix A, Figures 4 and 5). The diodes should appear as shown in Figure 6. *BGMS recommended replacing all twelve (12) diodes with new properly manufactured diodes.*

Figure 5: Wire Tied around Ends of Flexible Connectors

- Twelve new diodes were procured for installation into the diode wheel. Electrical test data from the replacement components was satisfactory as shown in Appendix B-11 and B-12.

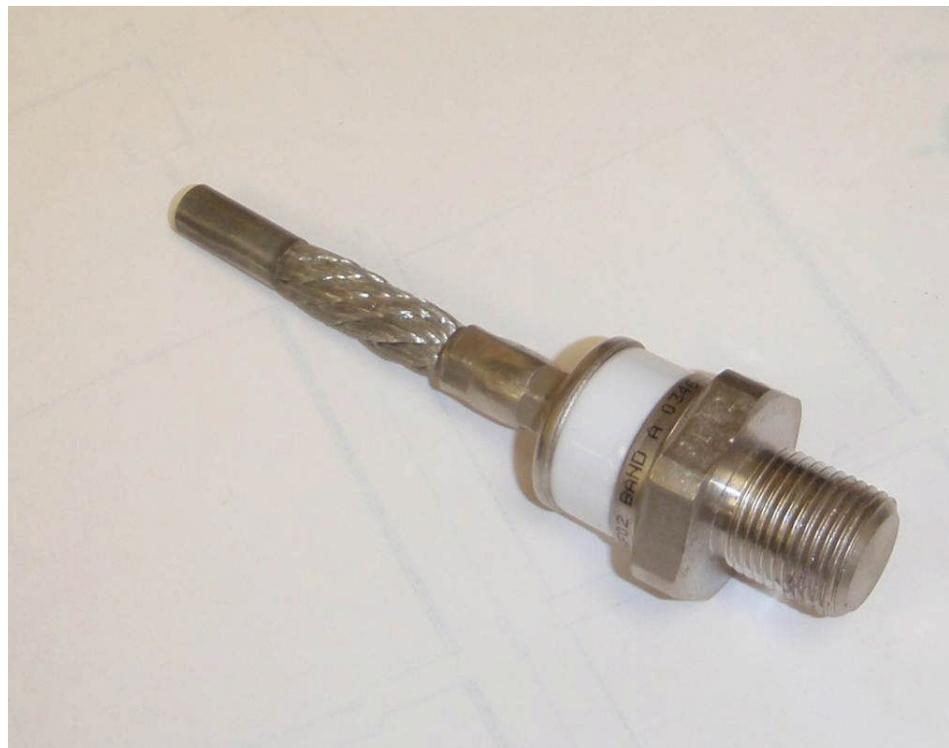
Figure 6: Properly Manufactured Diode for an EM Diode Wheel

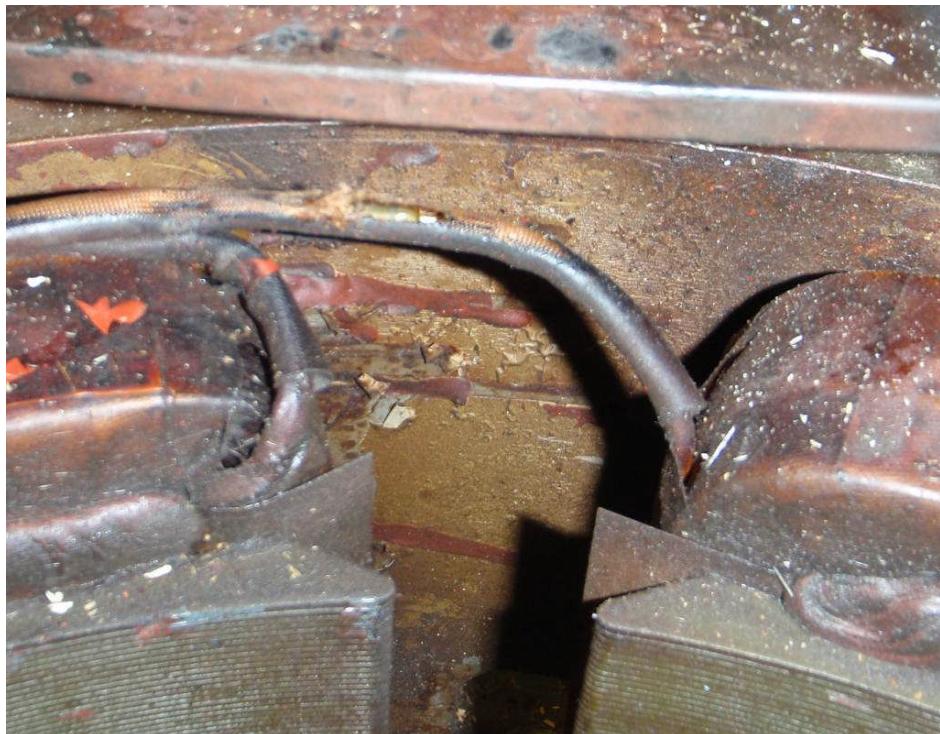
- Insulation on the exciter stator connection wires was found to be brittle and damaged in several areas, see Appendix A, Figure 7. *BGMS recommended removing existing insulation from all connections and replacing with new insulation.*

Figure 7: Cracked and Brittle Insulation

- New end blocking kits were procured for both ends of the rotor.
- All stator connection wires and associated insulation were replaced.
- All outboard armature banding surfaces were repaired and painted.

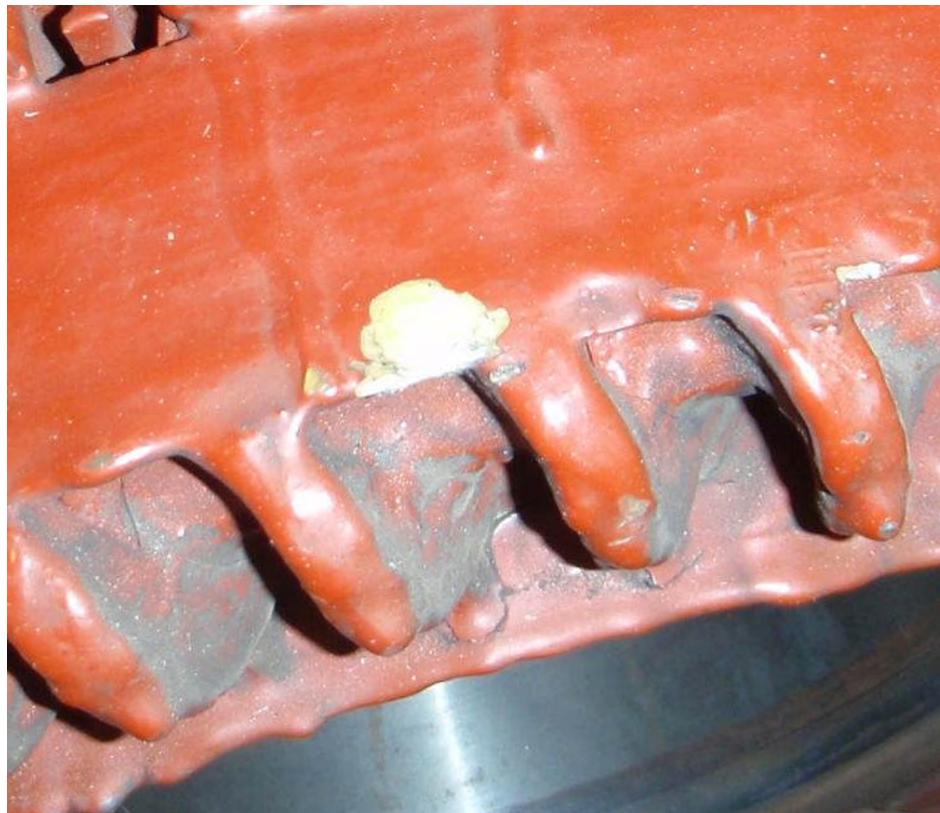
- Minor damage was found on the outboard exciter armature band, see Appendix A, Figure 9. In addition, some cracking was found in the paint on the bottom of the armature coil series connections. *BGMS recommended light sanding of the exposed band surface and applying a coat of epoxy resin to the banding and to areas of the armature coils.*

Figure 9: Minor Damage Found on Outboard Band

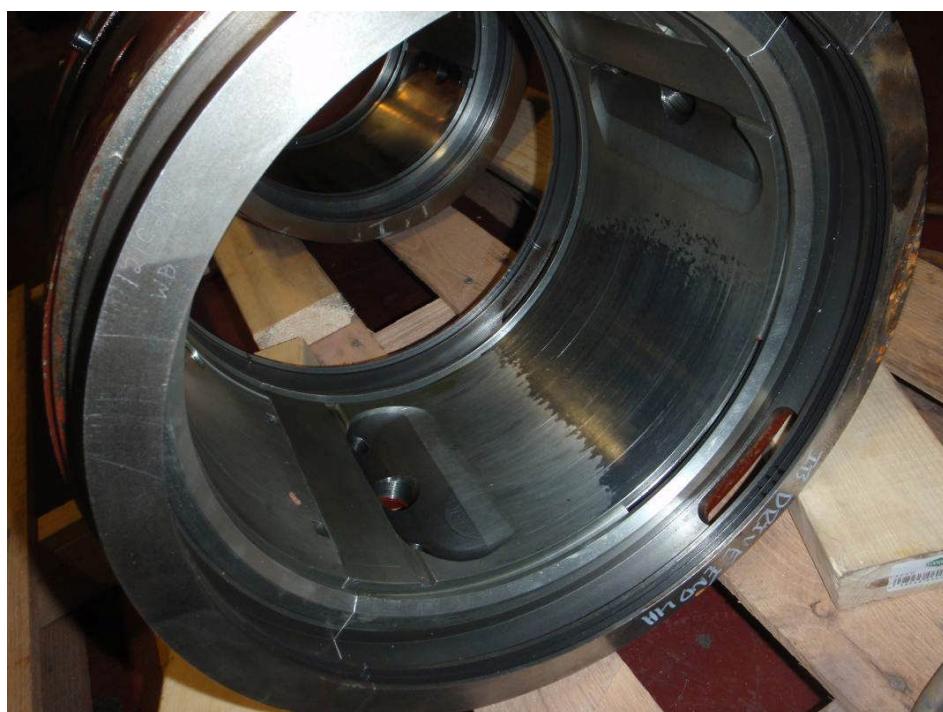
- The rotor bearings were found to be wiped as shown in Appendix A, Figure 10. *BGMS recommended Babbitt replacement on both bearings.*
- Upon removal, the rotor end winding blocking was found in poor condition. See Appendix A, Figure 11. *BGMS recommended replacing all rotor blocking.*
- Multiple J-lead wedges were found to be in poor condition. See Appendix A, Figure 12. *BGMS recommended replacing all J-lead wedges.*
- The retaining ring keys were highly deformed and sheared in multiple areas upon removal. *BGMS recommended replacing both retaining ring keys.*

Figure 10: Condition of Drive End Bearing

- The bearings were sent to a subcontractor for refurbishment including replacement of all Babbitt material. Refurbished bearing inspection results are presented in Appendix B-9 (Drive End) and B-10 (Exciter End).

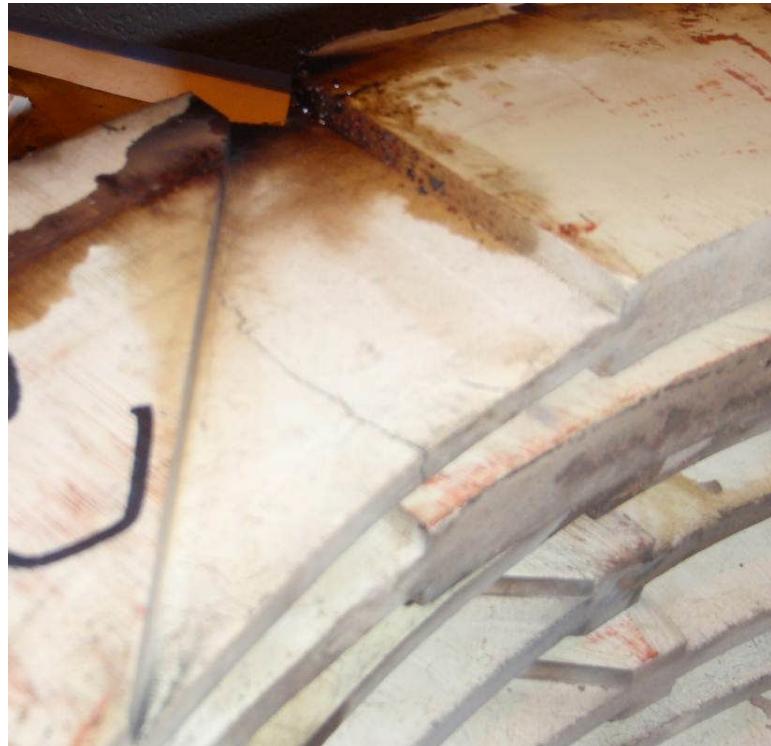
Figure 11: Cracking in End Winding Blocking

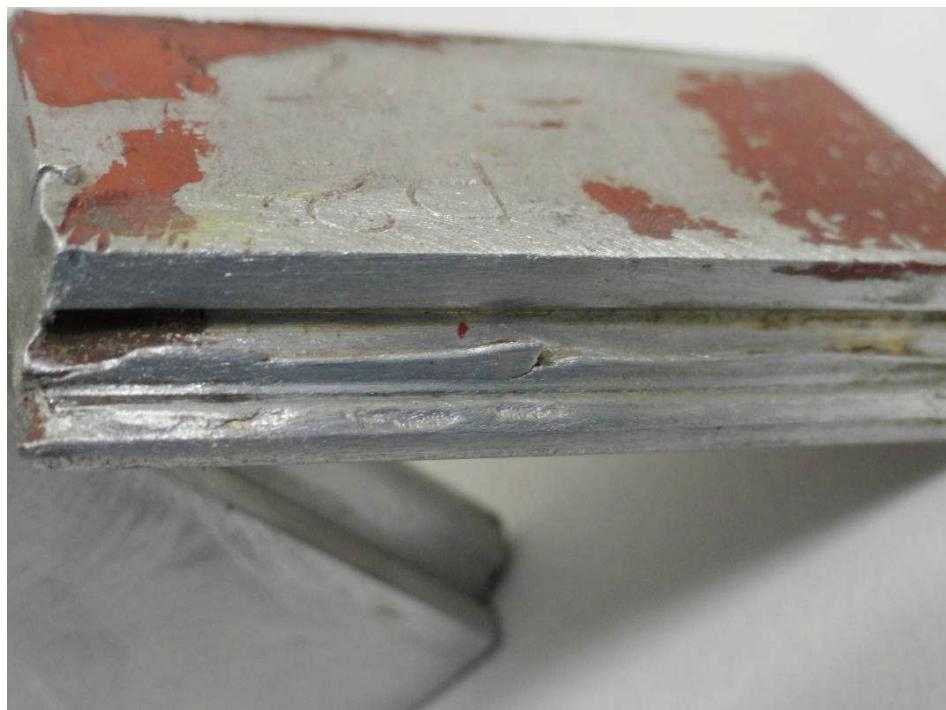
Figure 12: J-Lead Wedge in Poor Condition as found

- All J-lead wedges were remanufactured. The new J-Lead wedges were liquid penetrant test with satisfactory results as shown in Appendix C-17.
- New ASTM A288-91 magnetic retaining ring forges were procured and the rings were final machined for the “Long Ring Modification.” Appendix D contains certifications for the two rings. Magnetic Particle inspection results for the finish-machined rings are presented in Appendix C-18.

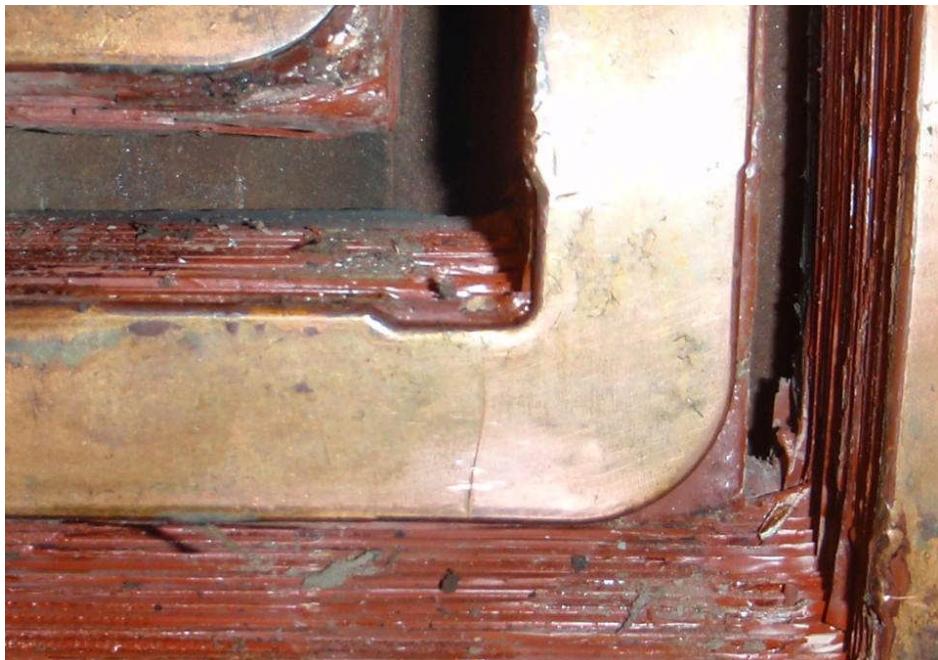
- Cracks were found in multiple copper turns during inspection conducted while coils were being removed from the rotor. See Appendix A, Figure 13. A more complete assessment was made after the bonded insulation material has been removed from the coils. *BGMS recommended grinding minor cracks and filling with brazing material and in more severe cases, replacement of whole sections of material was found to be required.*

Figure 13: Crack Found on Top Turn of Coil 5, Exciter End

- All cracks found in copper coils were repaired.
- Aluminum deposits found on rotor forging retaining ring fit areas were removed.
- The “Long Ring Modification” machining was completed on the rotor body.

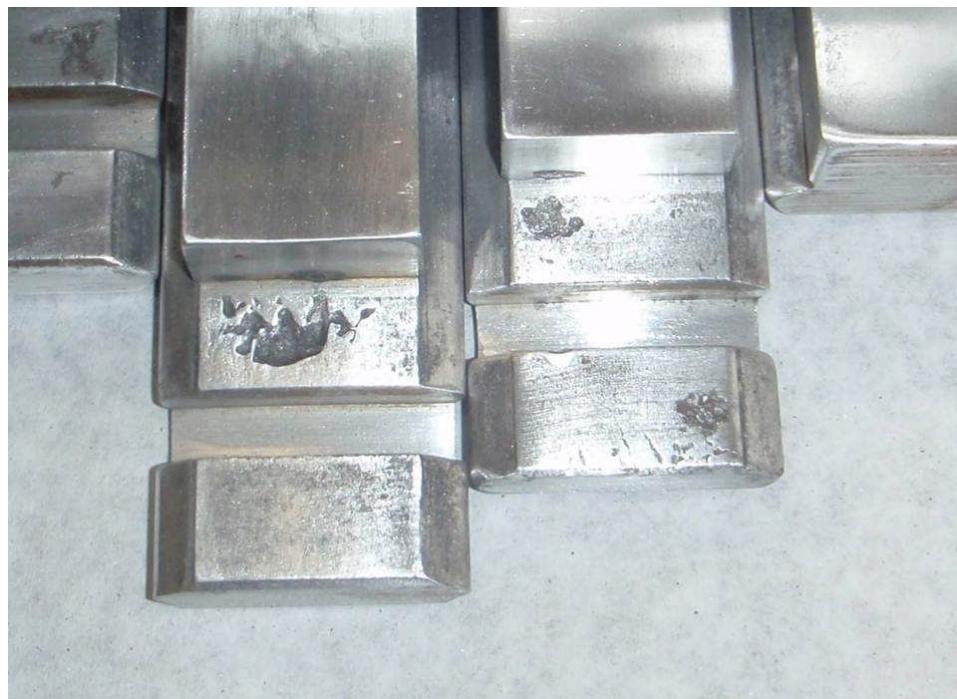
- The rotor end wedges had significant loss of material, most likely due to electrical arcing. Three rotor end wedges were damaged during retaining ring removal and required replacement. See Appendix A, Figure 14. *BGMS recommended sending the end wedge material out for analysis and replacing the three wedges damaged during ring removal. Subsequent NDE test results led to an expansion of this recommendation to include replacing all rotor slot wedges (see below).*

Figure 14: Arcing Damage to Slot Wedges

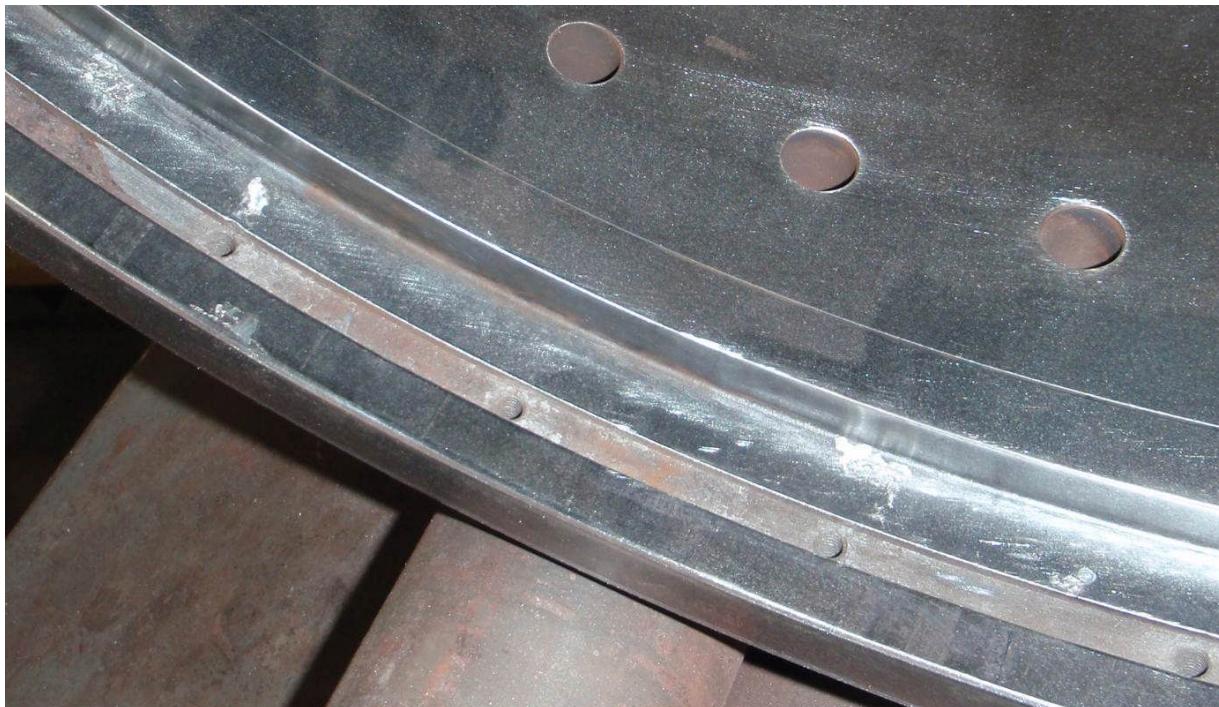
- Aluminum deposits were found on the fit-surface of the retaining ring as shown in Appendix A, Figure 15. It is believed to have been a material transfer from the end wedges due to arcing. The presence of this aluminum prevented visual inspection as well as NDE of the fit area in those regions. *BGMS recommended performing machining of the raised aluminum material to evaluate pitting beneath the transferred material.*

Figure 15: Aluminum on Retaining Ring Fit Area

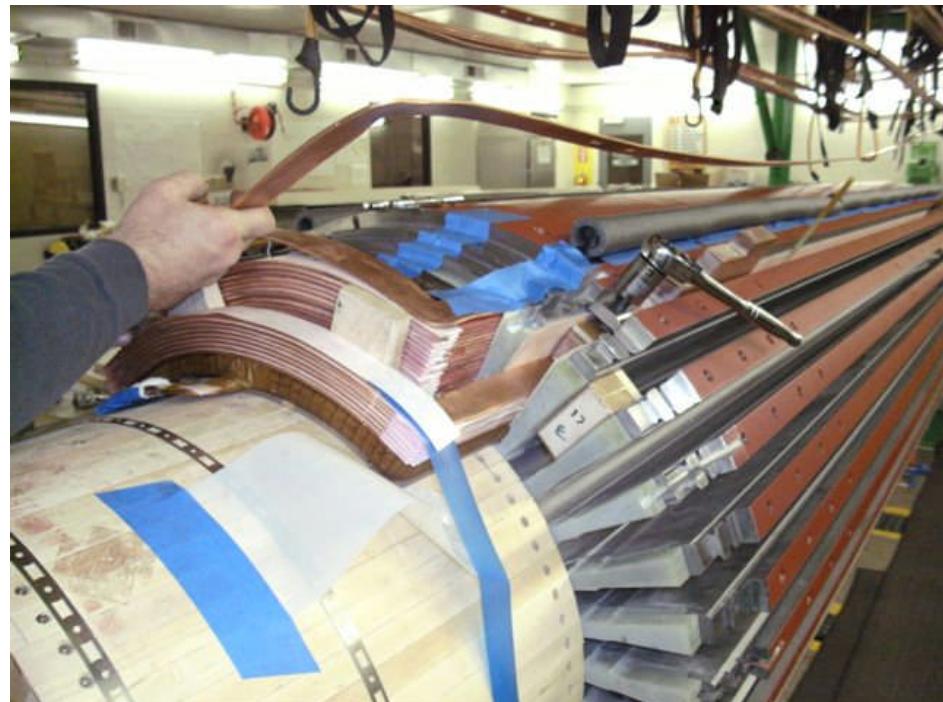
Figure 22: Initiation of Rotor Rewind Process

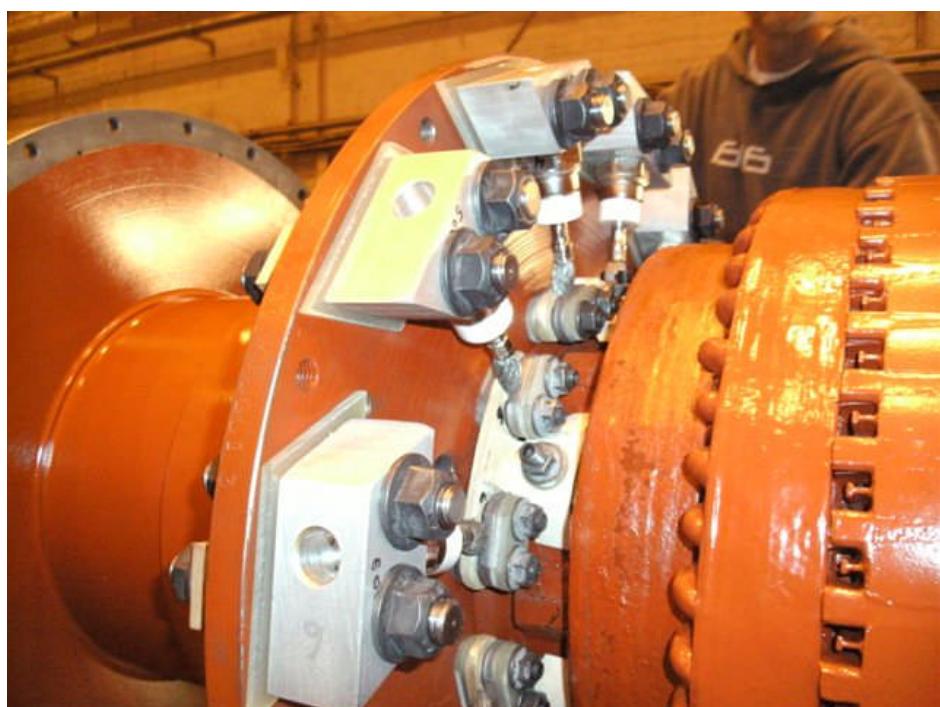
Figure 24. Installing New Diodes on Diode Wheel

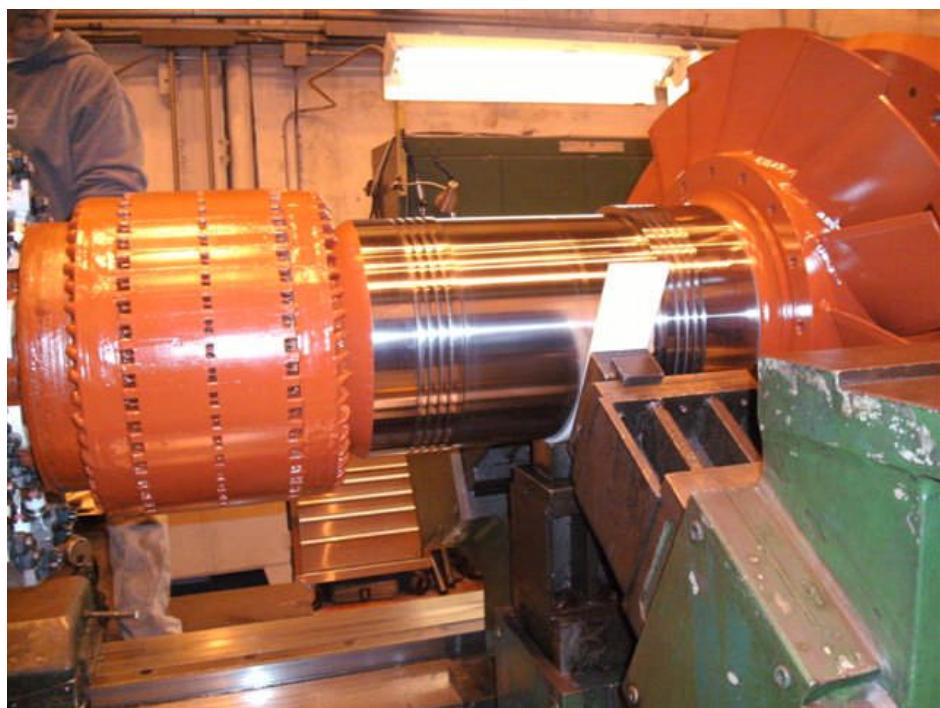
Figure 26. Final Cleanup of Journals and Seal Areas

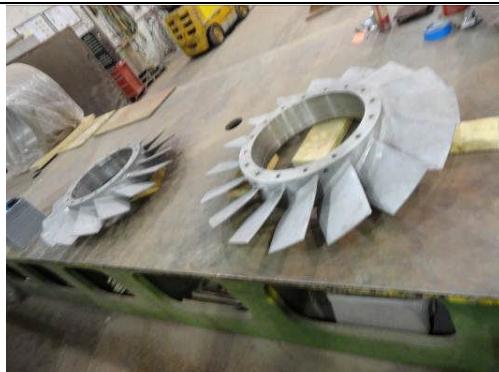
Blower Fans

Remarks: 1. No Linear Indications were found.

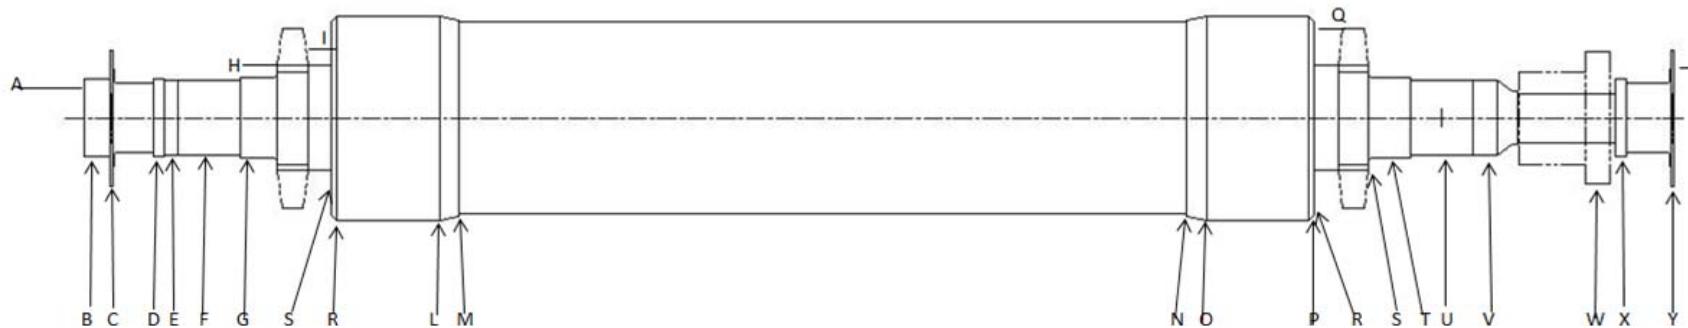
Job No.: J11-05627
Measurements made with rotor supported on journals.

Face		0	1	2	3	4	5	6	7	8	9	10	11	12	13	14	15	16	17	18	19	20	21	22	23	24
	A(RT)	A(L)	B	C	D	E	F	G	H	I	J	K	L	M	N	O	P	Q	R	S	T	U	V	W	X	Y	Z
0	0	0	0	0	0	0	0	0	0	0	0	0	0	0	0	0	0	0	0	0	0	0	0	0	0	0	
45	4	-1		20	10	5	0	0	30	-40	-20	-60	-100	20	10	-90	-55	-5	-10	-10	0	-2	0	10	10	-30	
90	5	-1		40	0	-5	5	0	50	30	-35	-60	-110	35	0	-75	-50	8	-15	0	0	-3	-5	-10	-5	-50	
135	2	0		40	0	5	5	0	40	30	-50	0	-70	40	-5	-30	10	-5	-25	10	0	-3	-5	10	0	-15	
180	2	0		42	0	0	0	0	35	20	-45	50	-10	40	-8	30	10	10	0	30	0	-3	0	10	-10	5	20
225	6	-3		30	-10	0	-2	0	20	40	-30	0	-70	20	0	-50	-30	10	10	30	0	-3	-1	10	-25	-10	45
270	2	-1		0	-10	-5	0	0	10	150	-10	-70	-80	-10	8	-50	-20	0	25	35	0	-5	-5	-10	-55	-40	50
315	0	-1		-20	-10	0	0	0	-10	50	0	-50	-70	-10	10	-46	0	0	10	20	0	-5	-5	-10	-60	-30	18
0	0	0	0	0	0	0	0	0	0	0	0	0	0	0	0	0	0	0	0	0	0	0	0	0	0	0	
Min	0	-3	0	-20	-10	-5	-2	0	-10	-40	-50	-70	-110	-10	-8	-90	-55	-8	-25	-10	0	-5	-10	-60	-40	-50

Face		B	C	D	E	F	G	H	I	J	K	L	M	N	O	P	Q	R	S	T	U	V	W	X	Y	Z
	A																										
0	0.0000	0.0000	0.0020	0.0010	0.0005	0.0002	0.0000	0.0010	0.0040	0.0050	0.0070	0.0110	0.0010	0.0008	0.0090	0.0055	0.0008	0.0025	0.0010	0.0000	0.0005	0.0005	0.0010	0.0060	0.0040	0.0050	
45	0.0005	0.0000	0.0040	0.0020	0.0010	0.0002	0.0000	0.0040	0.0000	0.0030	0.0010	0.0010	0.0030	0.0018	0.0000	0.0000	0.0003	0.0015	0.0000	0.0000	0.0003	0.0005	0.0020	0.0070	0.0050	0.0020	
90	0.0006	0.0000	0.0060	0.0010	0.0000	0.0007	0.0000	0.0060	0.0070	0.0015	0.0010	0.0000	0.0045	0.0008	0.0015	0.0005	0.0000	0.0010	0.0010	0.0000	0.0002	0.0002	0.0005	0.0050	0.0035	0.0000	
135	0.0002	0.0000	0.0060	0.0010	0.0010	0.0007	0.0000	0.0050	0.0070	0.0000	0.0070	0.0040	0.0050	0.0003	0.0060	0.0065	0.0003	0.0000	0.0020	0.0000	0.0002	0.0000	0.0020	0.0060	0.0032	0.0035	
180	0.0002	0.0000	0.0062	0.0010	0.0005	0.0002	0.0000	0.0045	0.0060	0.0005	0.0120	0.0100	0.0050	0.0000	0.0120	0.0065	0.0018	0.0025	0.0040	0.0000	0.0002	0.0005	0.0020	0.0050	0.0045	0.0070
