**STORAGE EQUIPMENT
SAFETY SERVICE LTD**

RACK INSPECTION REPORT FOR:

**PARKER HANNIFIN
MANUFACTURING LTD**

27th JANUARY 2025

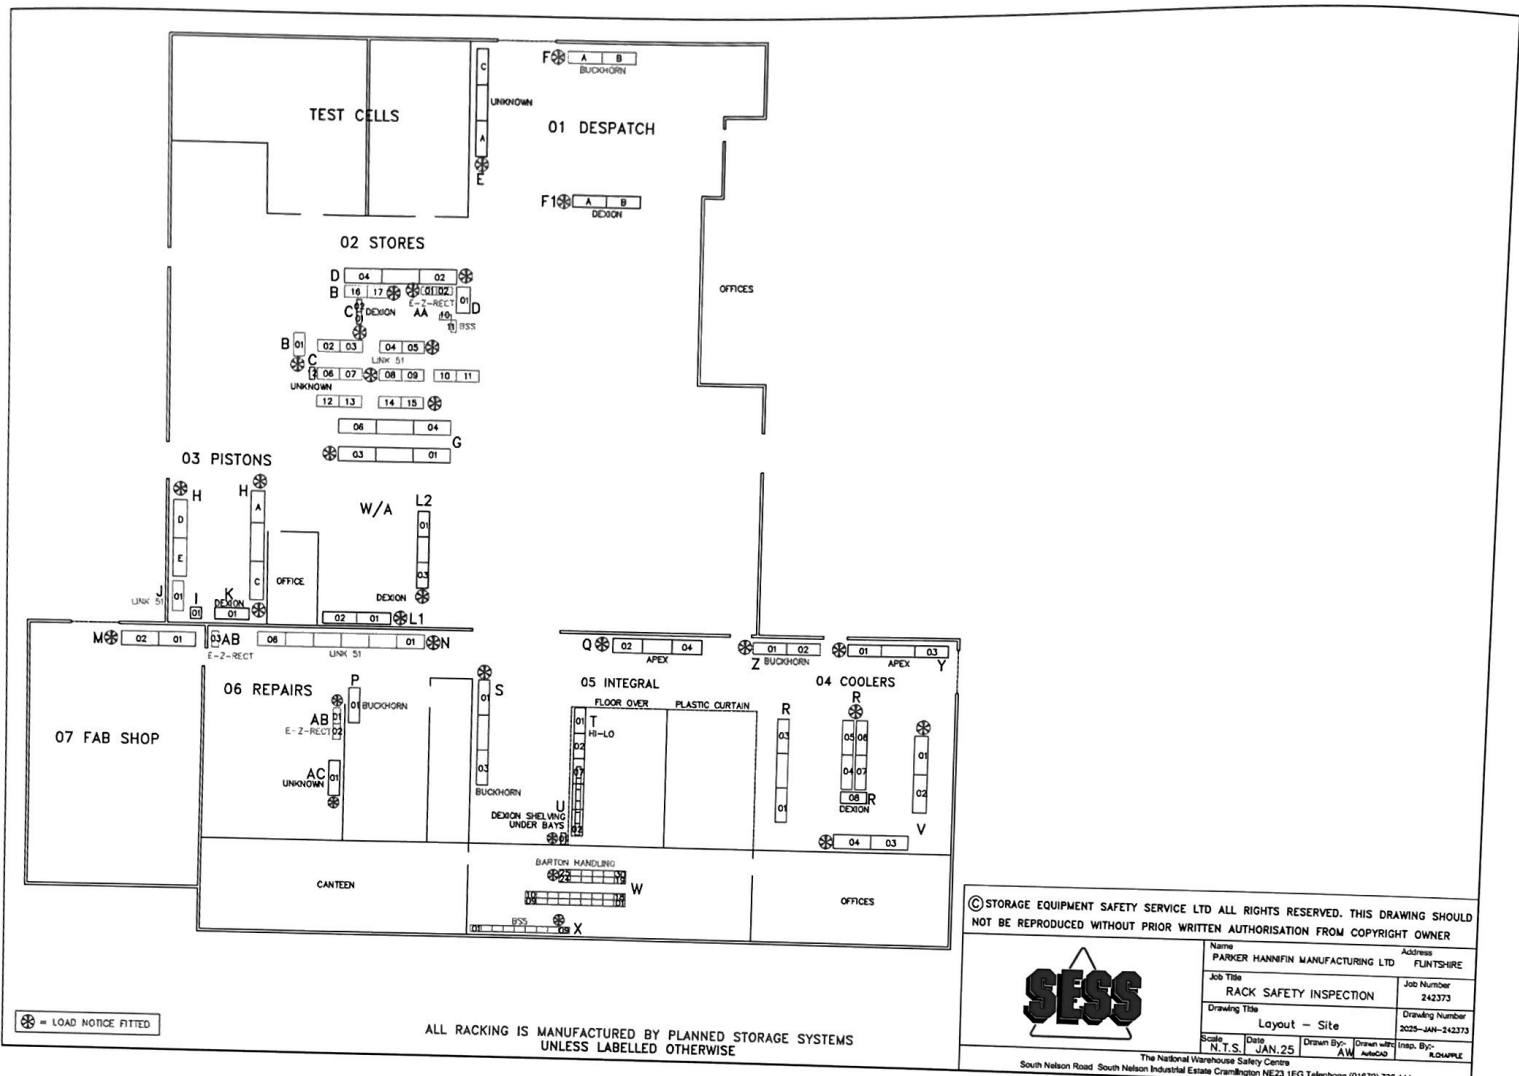
| WH-AREA-RACK | LOCATION | LEVEL | FRAME TYPE | COMPONENT | POSITION | DEFECT | ACTION | QTY | REPAIR |
|--|---|---|---|---|---|---|---|---|---|
| Front Baseplate observed sitting in rainwater from ingress under warehouse shutter door -serve rust will develop if action to reduce water not taken | | | | | | | | | |
| 06-Repairs-AC | 01/End | 1 | Welded | Bracing Diagonal | N/A | Damaged | Monitor | 1 | - |
