Oklahoma Gas & Electric

ESN:675497

Shop Report

Model: GG4A-9

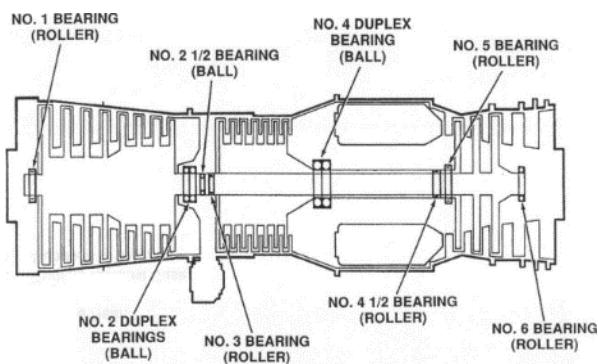
#2 Bearing inner and outer races were hazed as a result of downstream oil contamination from the tower shaft failure.

#3 Bearing outer race and rollers were hazed as a result of downstream oil contamination from the failure tower shaft.

#5 Bearing was inspected with no findings.

#6 Bearing was inspected with no findings.

Conducted:

- #1 Bearing was reinstalled back in engine.
- #2 Bearing was replaced.
- #2.5 Bearing was reinstalled in the engine.
- #3 Bearing was replaced.
- #4 Bearing was reinstalled in the engine.
- #4.5 Bearing reinstalled in the engine.
- #5 Bearing was reinstalled in the engine.
- #6 Bearing was reinstalled in the engine.
