Oklahoma Gas and Electric

ESN:675502

Shop Report
1/11/2019

Model GG4A-9

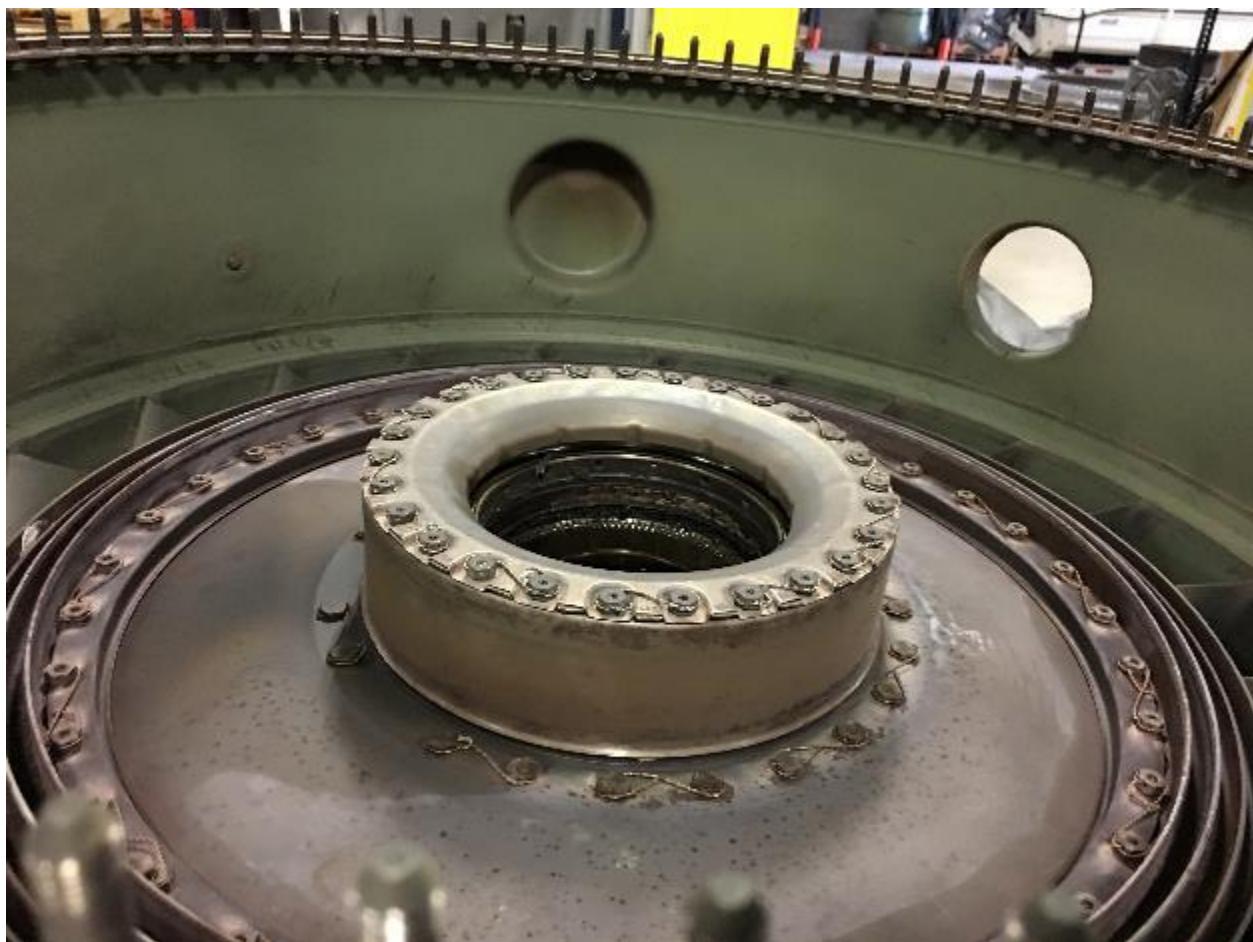
Findings: Intermediate case had coating loss. Broken nut on one gang nut plate. #2 support has coating loss. #3 support and seal rings were cleaned and inspected with no findings. Heatshields for #3 support were old configuration which allowed for carbon build up in the compartment. #2.5 housing was worn.

Conducted: Intermediate case was dimensionally inspected, and pressure tested with no findings. Case was then stripped, NDT inspected and coated. Replaced damaged gang nut. #2 support was stripped, NDT inspected and coated. #3 support and seal rings were blasted to clean and inspected. Installed upgraded heat shields per SB72B19. #2.5 housing had the silver plating restored. Restored silver plating on bevel gear.

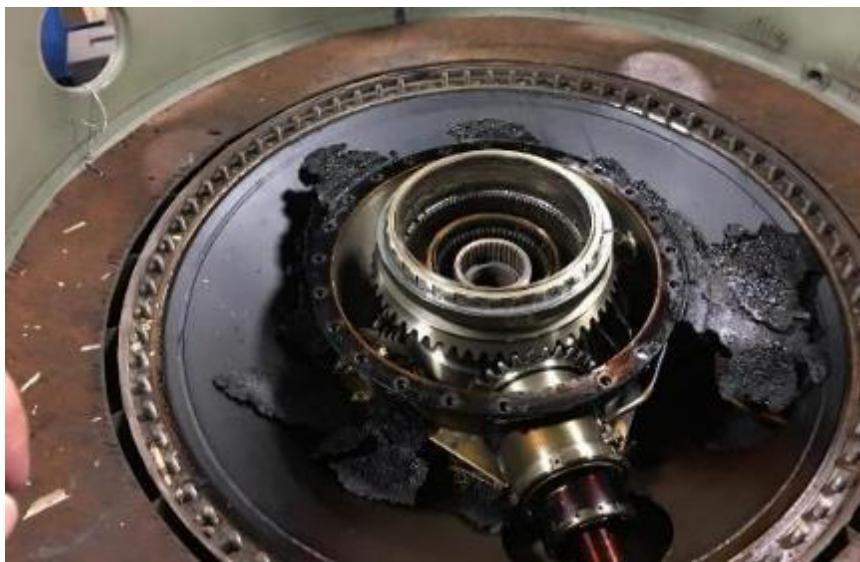
Accessory Drive

Findings: Accessory drive housing and bushing should be dimensionally inspected. One broken nut on gang nut plate. Replace both tower shaft bearings.

Conducted: Accessory drive housing and bushing were dimensionally inspected. Replaced one gang nut channel. Upper and lower tower shaft bearings were replaced. Remaining parts were cleaned and inspected prior to use.
